**AQUATIC PLANT MANAGEMENT PLAN**

**CATFISH LAKE  
VILAS COUNTY, WISCONSIN**

June 25, 2007  
Revised August 3, 2007

Northern Environmental Technologies, Incorporated  
1203 Storbeck Drive  
Waupun, Wisconsin 53963

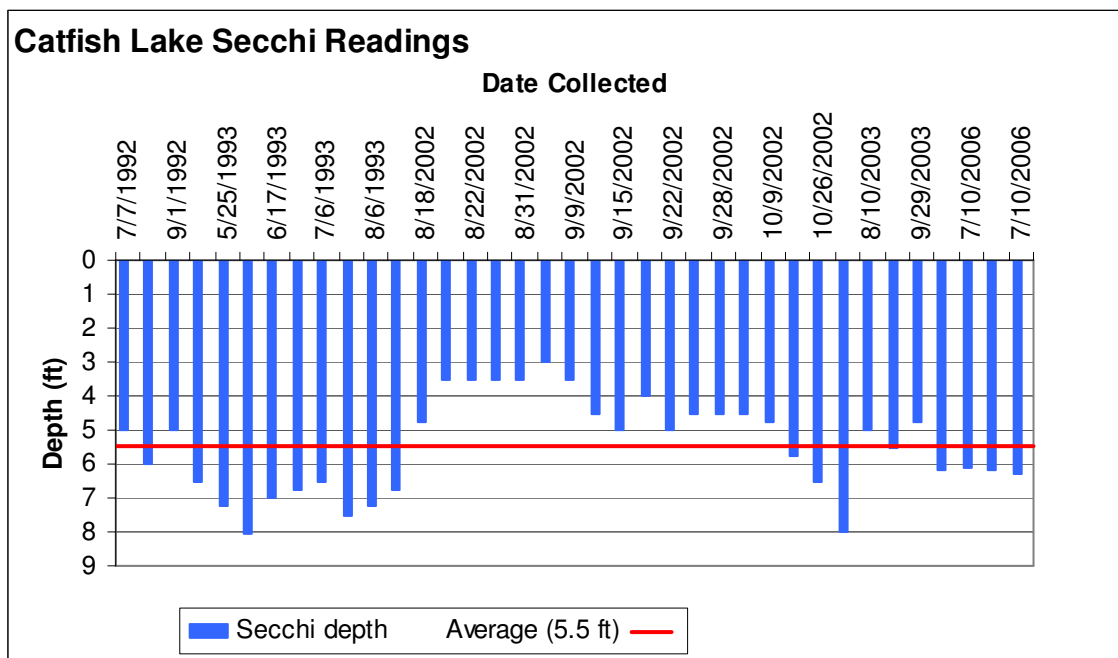
The historical water clarity average is 5.5 feet (1.7 meters). The following graph illustrates historical and current water clarity measurements on Catfish Lake.

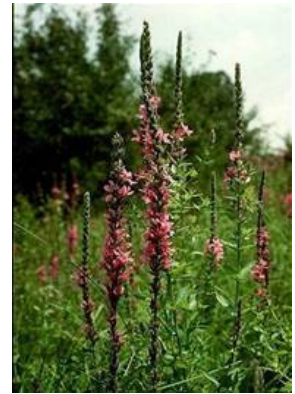
Purple loosestrife is a perennial herb 3-7 feet tall with a dense bushy growth of 1-50 stems. The stems, which range from green to purple, die back each year. Showy flowers vary from purple to magenta, possess 5-6 petals aggregated into numerous long spikes, and bloom from July to September. Leaves are opposite, nearly linear, and attached to four-sided stems without stalks. It has a large, woody taproot with fibrous rhizomes that form a dense mat

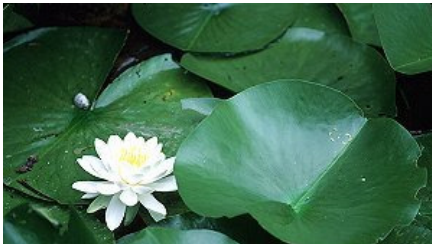
White Water Lily  
Source: UW Herbarium Website

*Nymphaea odorata* (White Water Lily) has a flexible stalk with a round floating leaf. White Water Lily can be found growing in a variety of sediment types in less than 6 feet of water. Fragrant white flowers occur throughout the summer. The floating leaves provide shelter and shade for fish as well as habitat for invertebrates (Borman, et al., 1997).

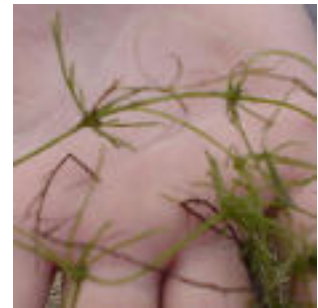
Although *Chara, sp.* (Muskgrass / Chara) looks like a vascular plant, it actually is a multi-celled algae (macroalgae). Muskgrass is usually found in hard waters and prefers muddy or sandy substrate and can often be found in deeper water than other submergent plants. Muskgrass beds provide valuable habitat for small fish and invertebrates. Muskgrass is also a favorite waterfowl food. Its rhizoids slow the movement and suspension of sediments and benefit water quality in the ability to stabilize the lake bottom (Borman, et al., 1997). It can easily be identified by its characteristic “musty” odor.

Chara sp.  
Source: UW Herbarium Website

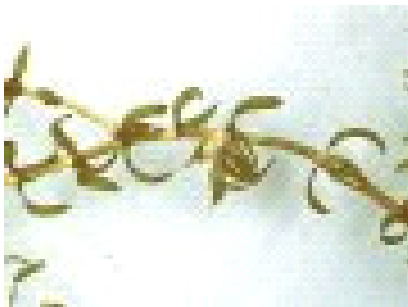
Elodea  
Source: UW Herbarium Website

*Elodea canadensis* (Elodea or common waterweed) is an abundant native plant species that is distributed statewide. It prefers soft substrate and water depths to 15 feet (Nichols, 1999). Elodea reproduces by seed and sprigs (USDA, 2002). The stems of elodea offer shelter and grazing to fish, but very dense elodea can interfere with fish movement. Elodea can be considered invasive at times and out-competes other more desirable plants.

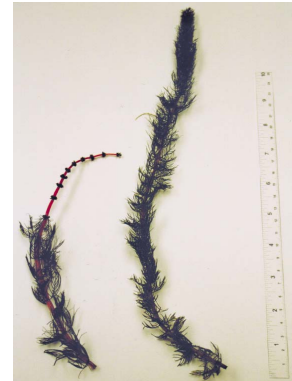
*Myriophyllum sibiricum* (Northern watermilfoil) is usually found growing in soft sediment in fairly clear-water lakes. Leaves are divided like a feather, with five to twelve pairs of thread-like leaflets. Leaves are arranged in whorls. Northern watermilfoil is more desirable than its invasive cousin, Eurasian watermilfoil. Waterfowl eat the foliage and fruit, while beds of this plant provide cover and foraging opportunities for fish and invertebrates.

Northern watermilfoil  
Source: UW Herbarium Website

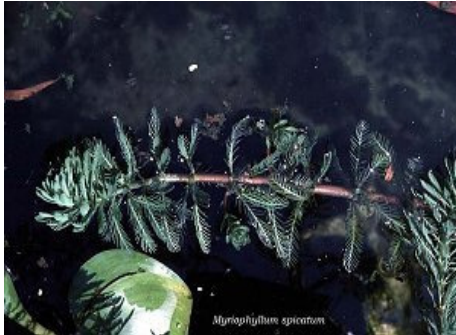
Eurasian watermilfoil  
Source: UW Herbarium Website

*Myriophyllum spicatum* (Eurasian watermilfoil or EWM) is a submersed aquatic plant native to Europe, Asia and northern Africa. It was introduced to the United States by early European settlers. EWM was first detected in Wisconsin lakes during the 1960's. In the past three decades, this AIS has significantly expanded its range to about 61 of

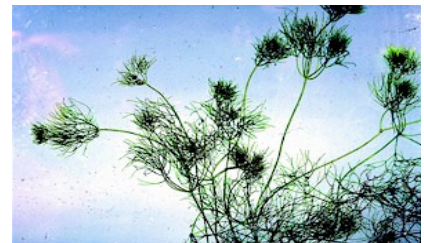
*Nitella sp.* (Nitella) is another type of macroalgae that looks like a vascular plant. Nitella is similar in appearance to muskgrass and is often found in similar habitats. However, Nitella can be distinguished from muskgrass by its smooth stems and branches, which are smooth (Borman, et al., 1997).

Nitella sp.  
Source: UW Herbarium Website

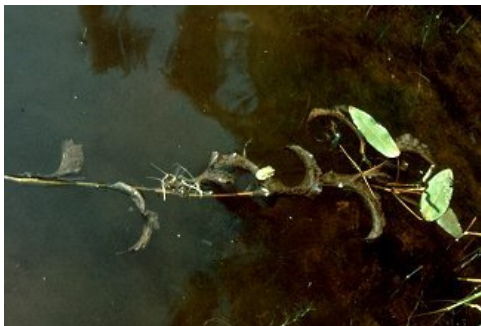
Large-leaf Pondweed  
Source: UW Herbarium Website

*Potamogeton amplifolius* (Large-leaf Pondweed) is also often referred to as musky weed or cabbage by anglers. Large leaf pondweed has robust stems and broad submersed leaves, which are slightly folded and lined with many veins. Floating leaves are oval and on long stalks. It is found mainly in soft sediments in water one to several feet deep and is sensitive to increased turbidity. The plant is commonly grazed by waterfowl, offers habitat for invertebrates, and foraging opportunities for fish (Borman, e al., 1997).

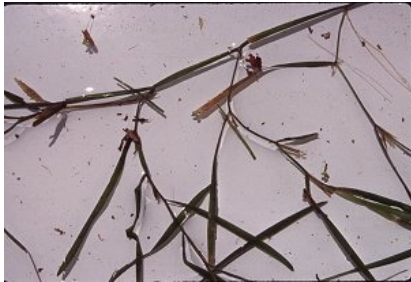
Flat- Stem Pondweed  
Source: UW Herbarium Website

Potamogeton zosteriformis (Flat-Stem Pondweed) is a submergent pondweed with freely-branched flattened stems. Flat stem pondweed is commonly confused with water stargrass (*Zosterella dubia*) but Flat-stem Pondweed can be distinguished by its prominent mid-vein and many fine, parallel veins.

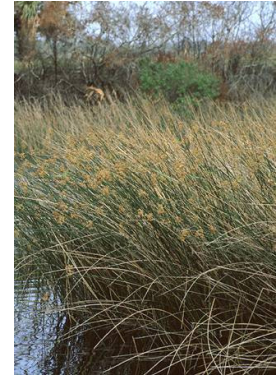
*Schoenoplectus tabernaemontanti* (Softstem Bulrush) has tall cylindrical, bluish-green stems. They are spongy when pressed between your fingers. Softstem bulrush usually grows in water less than 2 meters deep, but it has been found considerably deeper and shows no preference for substrate (Nichols, 1999). Softstem bulrush offers habitat for invertebrates and shelter for young fish, especially northern pike. The nutlets are consumed by a wide variety of waterfowl, marsh birds and upland birds. (Borman, et al., 1997).

Softstem Bulrush  
Source: UW Herbarium Website
