Presque Isle Wilderness Waters Program

Aquatic Plant Management Plan – Dunn Lake

Date: March 2014

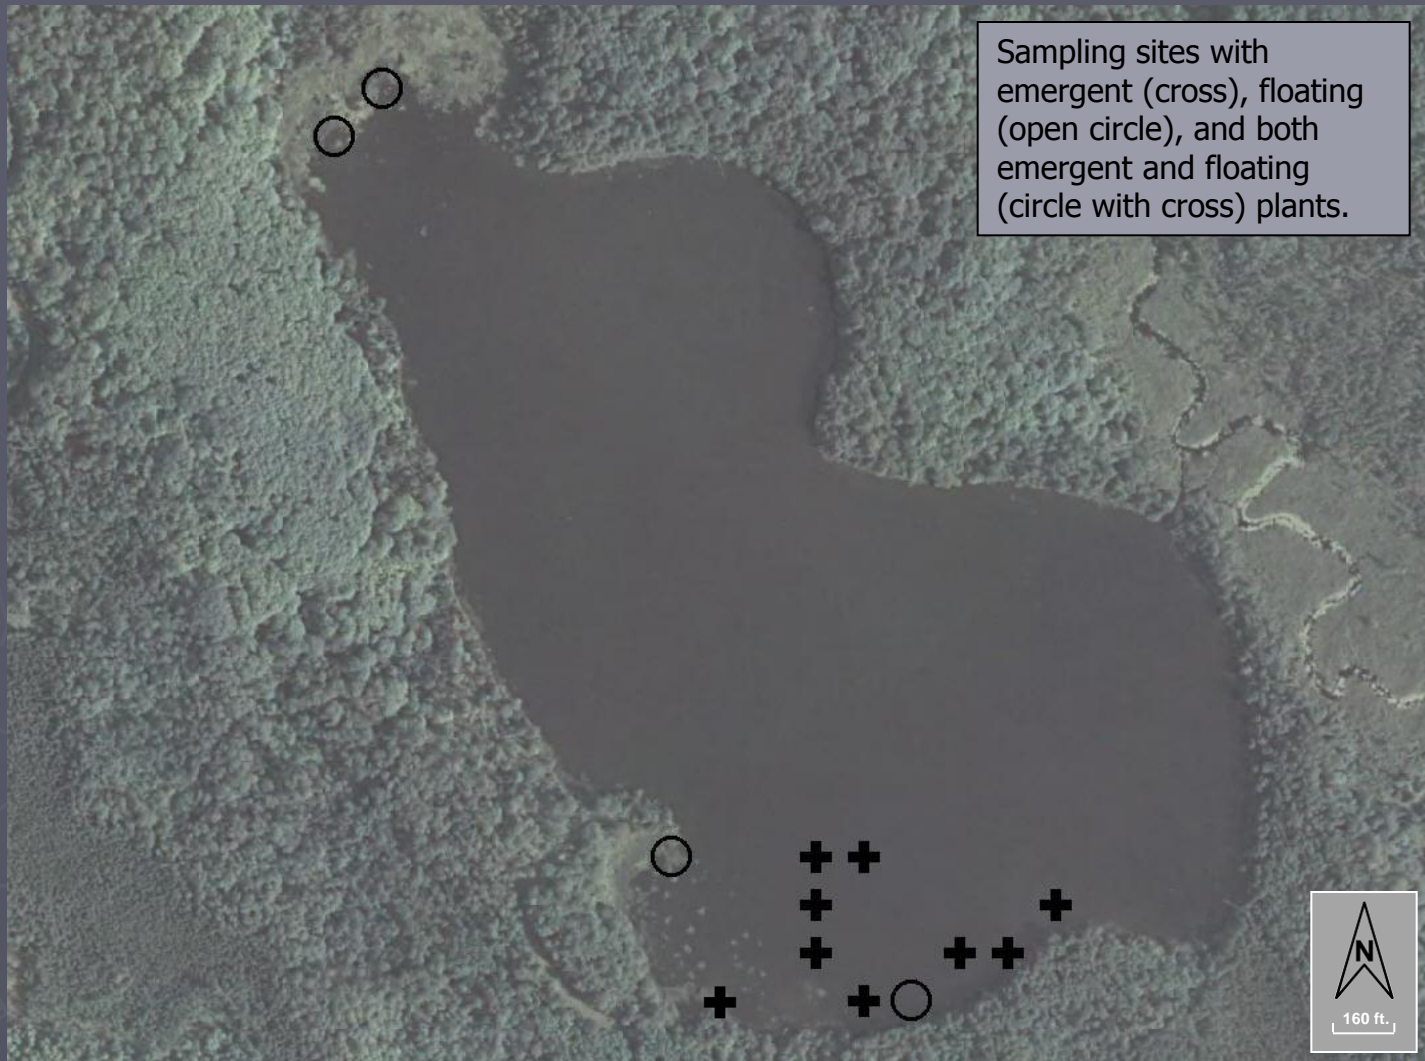
Figure 8. Distribution of plant species, Dunn Lake (2011).

Table 2 provides information about the frequency of occurrence of the plant species recorded in the lake. Several metrics are provided, including total number of sites in which each species was found and frequency of occurrence at sites \leq the maximum depth of rooted vegetation. This frequency metric is standardized as a “relative frequency” (also shown in Table 2) by dividing the frequency of occurrence for a given species by the sum of frequency of occurrence for all plants and multiplying by 100 to form a percentage. The resulting relative frequencies for all species total 100%. The relative frequencies for the plant species collected with a rake are graphically displayed in descending order on Figure 6. This display shows that *Elodea canadensis* (Common waterweed) had the highest relative frequency followed by *Najas flexilis* (Slender naiad). The lowest relative frequencies are at the far right of the graph. Figure 7 displays the distribution sampling sites where plants classified as “emergent” or “floating” were recorded. As examples of individual species distributions, we show the occurrences of a few of the most frequently and least frequently encountered plants in Figures 8-13.

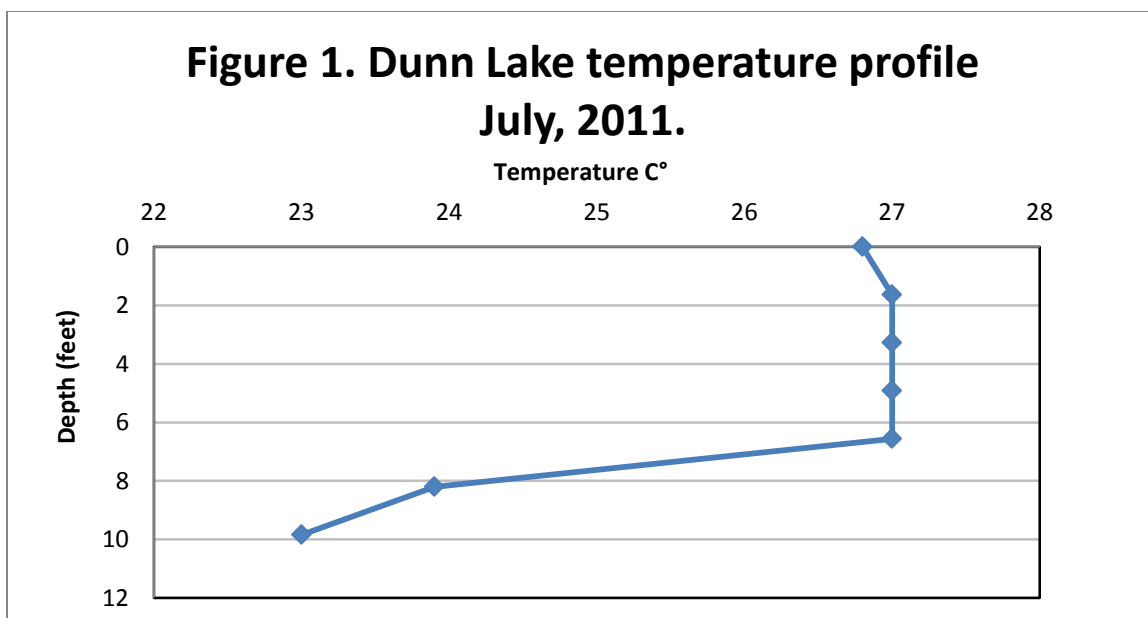
Measuring the temperature of a lake at different depths will determine the influence it has on the physical, biological, and chemical aspects of the lake. Lake water temperature influences the rate of decomposition, nutrient recycling, lake stratification, and dissolved oxygen (D.O.) concentration. Temperature can also affect the distribution of fish species throughout a lake. Figure 1 shows that Dunn Lake stratified at 6.5 feet.

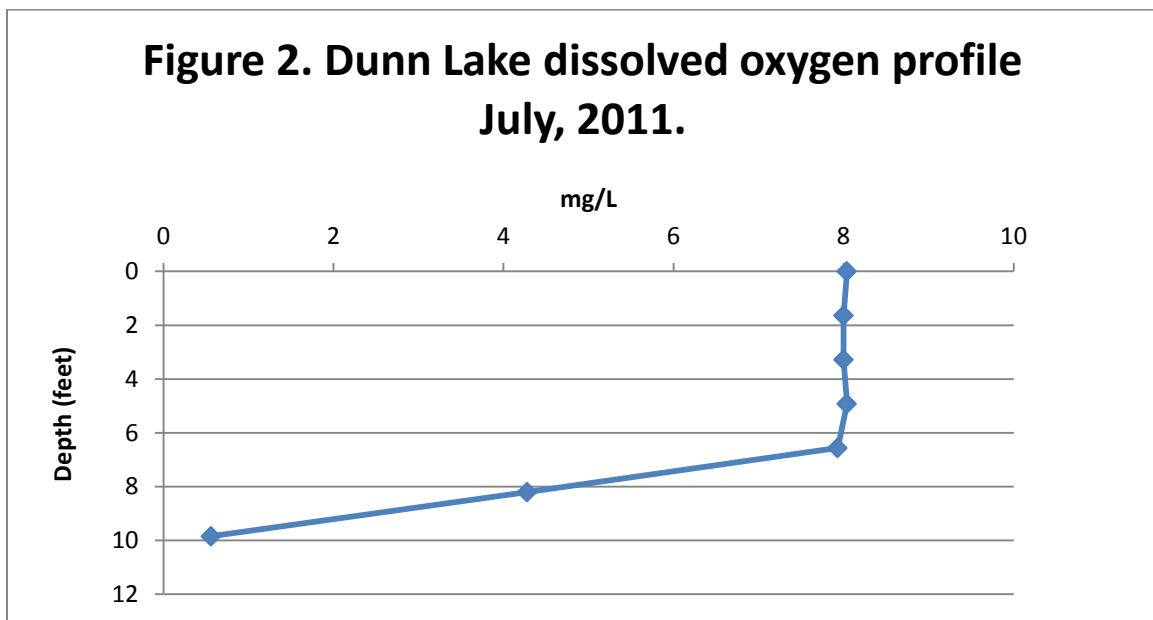
The dissolved oxygen content of lake water is vital in determining presence of fish species and other aquatic organisms. Dissolved oxygen also has a strong influence on the chemical and physical conditions of a lake. The amount of dissolved oxygen is dependent on the water temperature, atmospheric pressure, and biological activity. Oxygen levels are increased by aquatic plant photosynthesis, but reduced by respiration of plants, decomposer organisms, fish, and invertebrates. The amount of dissolved oxygen available in a lake, particularly in the deeper parts of a lake, is critical to overall health. The dissolved oxygen level in July, 2011 remained constant until 6.5 feet deep, and then decreased (Figure 2).

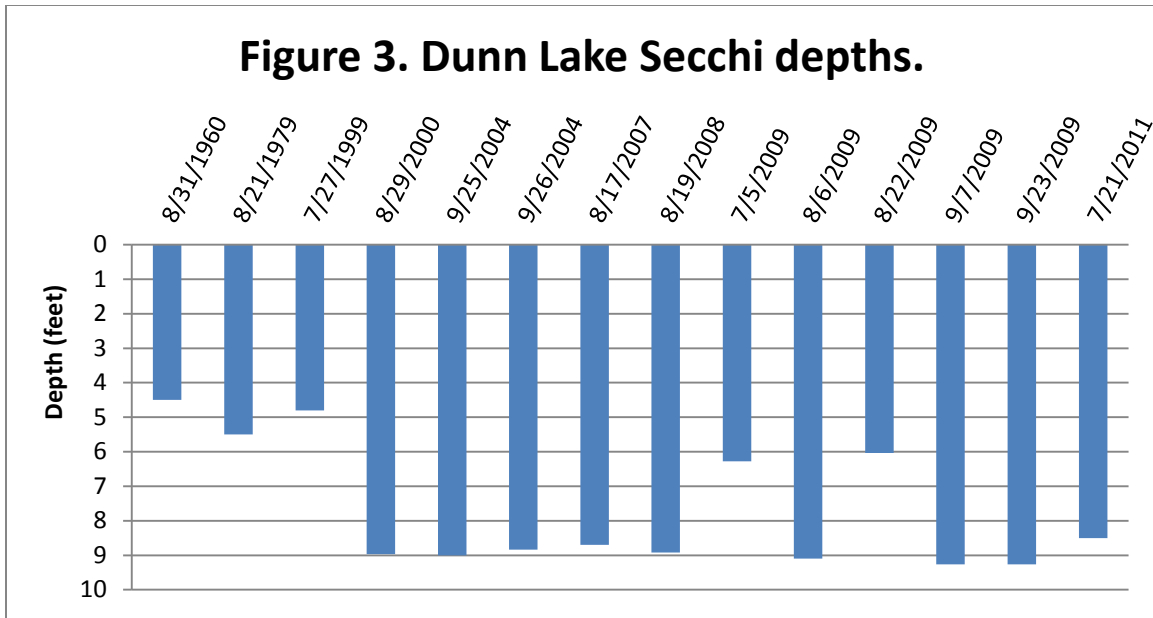
Figure 3 illustrates the Secchi measurements taken in Dunn Lake. In 1979 and 2011, the Secchi depths were taken on site, and in all remaining sample years, Secchi depths were collected by a Landsat satellite (WDNR, June 2012). The minimum Secchi disk reading was 4.5 feet, and the maximum was 9.27 feet, with the average being 7.6 feet. This classifies Dunn Lake as “fair,” with respect to water clarity (Table 1).
