Presque Isle Wilderness Waters Program Aquatic Plant Management Plan – Round Lake

Date: March 2014

Cite as: Premo, Dean, Angie Stine, Caitlin Clarke and Kent Premo. 2014. Presque Isle Wilderness Waters Program: Round Lake Aquatic Plant Management Plan. White Water Associates, Inc.

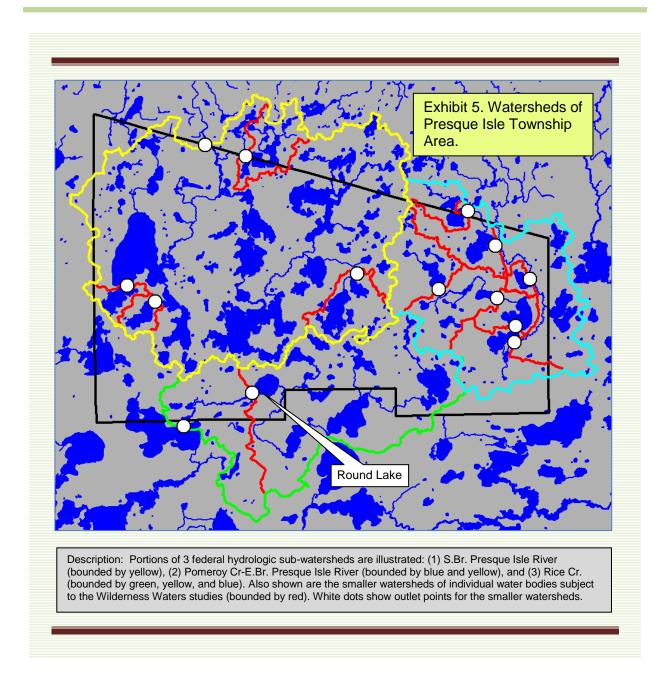
The Presque Isle Township waterscape sits on a large-scale watershed divide. Some of the water drains north through the Presque Isle River system and eventually enters Lake Superior. Some of the water drains into the Wisconsin River system to the Mississippi River and to the Gulf of Mexico. In fact there are two federal hydrologic sub-basins (designated by 8-digit HUC codes) that include Presque Isle Township. The Black-Presque Isle Rivers sub-basin (HUC#04020101) drains north to Lake Superior and the Flambeau River sub-basin (HUC#0705002) drains southwesterly to the Mississippi River. The Black-Presque Isle Rivers sub-basin contains two federal hydrologic sub-watersheds within Presque Isle Township: the South Branch Presque Isle River sub-watershed (HUC#040201010303) and the Pomeroy Creek-East Branch Presque Isle River sub-watershed (HUC#040201010301). The Flambeau River sub-basin contains one sub-watershed within Presque Isle Township: the Rice Creek sub-watershed (HUC#07050020103). Exhibit 5 illustrates these watersheds and the watersheds of the water bodies subject to the Wilderness Waters Program studies. Round Lake is contained within the Rice Creek sub-watershed (Exhibit 5).

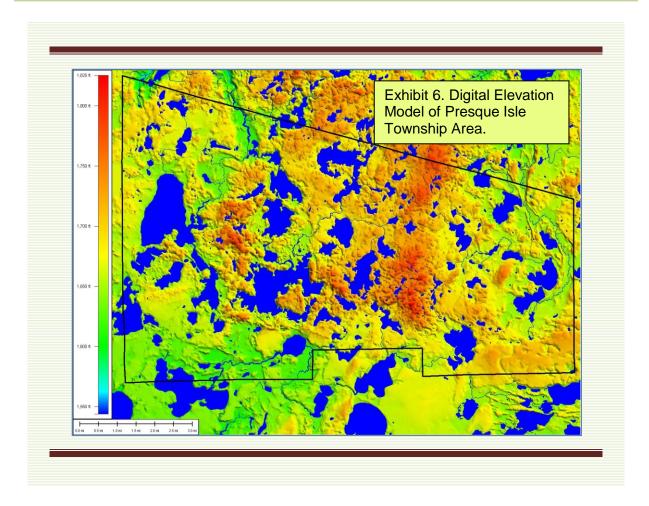
The elevation in Presque Isle Township ranges from around 1,550 feet above sea level to 1,750 feet above sea level. A digital elevation model is provided as Exhibit 6 and shows the relative elevations for the area with orange areas of the landscape being the highest elevations and greens and blues being the lowest elevations.

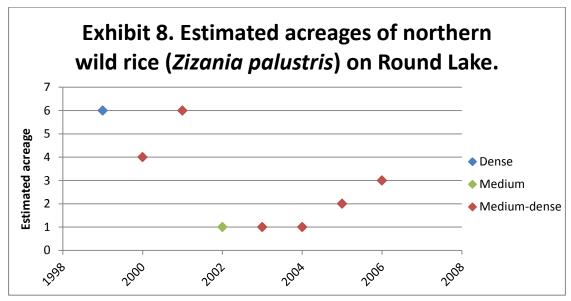
Exhibit 8 displays GLIFWC's estimated acreages (via aerial survey) of wild rice in Round Lake. During each survey, estimated density was also recorded (different colors in Exhibit 8). As we can see, the densest rice stand was observed in 1999. Overall, wild rice stands in Round Lake maintained an estimated medium-dense density, even if estimated acreages varied.

(Adapted from David, 1999-2010)

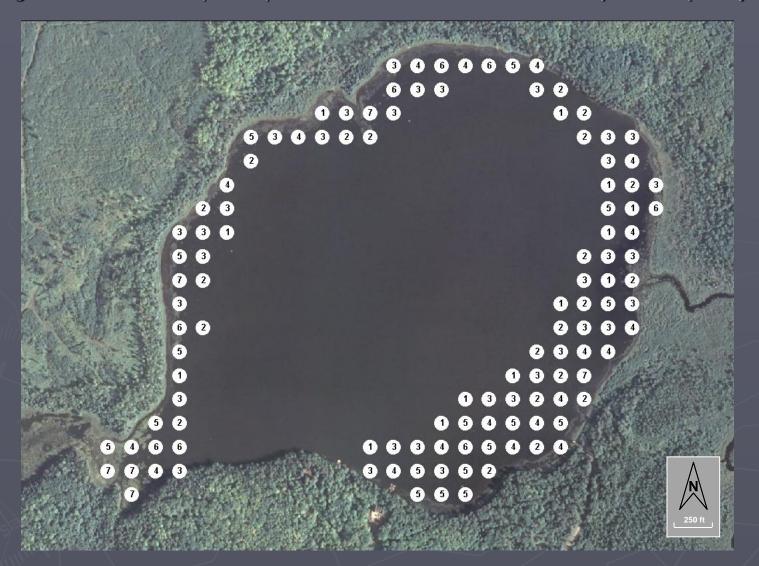
Figure 1. Number of plant species recorded at Round Lake sample sites (2010).

Species richness refers to the total number of species recorded. We recorded 24 species of aquatic plants. Of these, 22 were collected at sampling sites and the others were observed from the boat. Table 1 displays summary statistics for the survey. Table 2 provides a list of the species encountered, including common and scientific name along with summarizing statistics.² The number of species encountered at any given sample point ranged from 0 to 7 and 119 sample points were found to have aquatic vegetation present. The average number of species encountered at these vegetated sites was 3.43. The actual number of species encountered at each of the vegetated sites is graphically displayed on Figure 1. Plant density is estimated by a "rake fullness" metric (3 being the highest possible density). These densities (considering all species) are displayed for each sampling site on Figure 2.

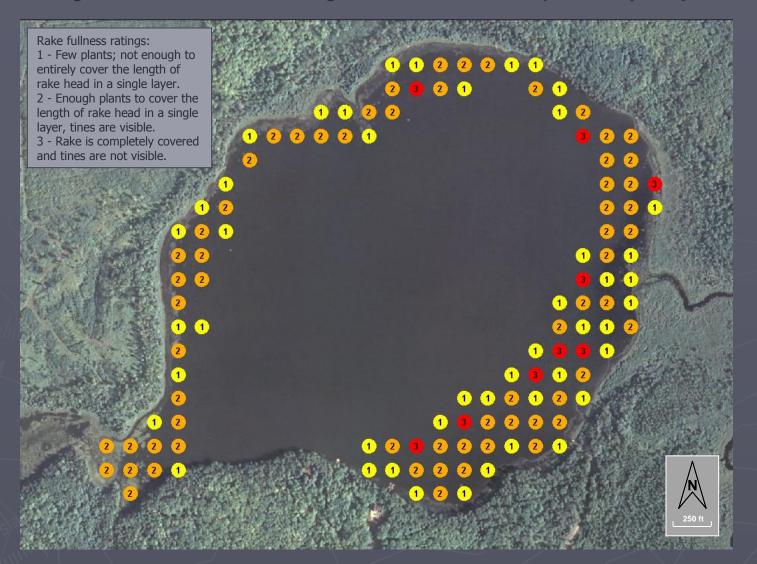
Figure 2. Rake fullness ratings for Round Lake sample sites (2010).

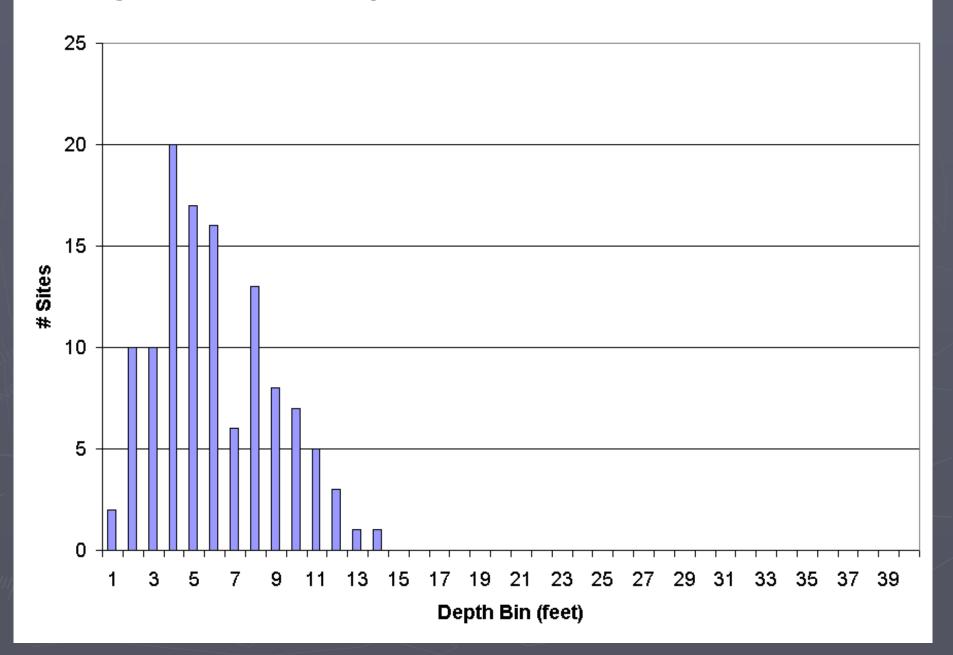
Figure 3. Maximum Depth of Plant Colonization in Round Lake.

The maximum depth of plant colonization is 14 feet (Table 1 and Figure 3). Rooted vegetation was found at 119 of the 151 sample sites with depth \leq the maximum depth of plant colonization (79% of sites). These sites are displayed as a black dot within a circle on Figure 4. This indicates that although availability of appropriate depth may limit the distribution of plants, it is not the only habitat factor involved. Substrate is another feature that influences plant distribution (e.g., soft substrate often harbors more plants than hard substrate). Figures 5 presents the substrates encountered during the aquatic plant survey (mud, sand, or rock).

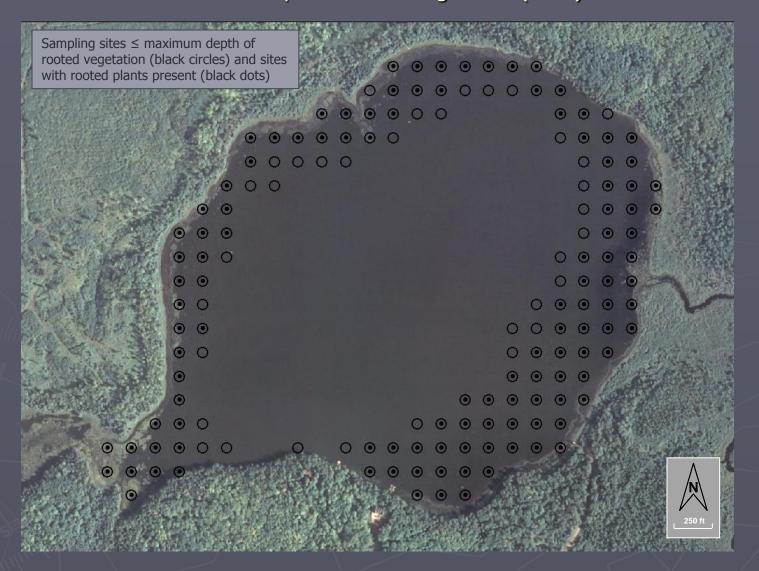
Figure 4. Round Lake sampling sites less than or equal to maximum depth of rooted vegetation (2010).

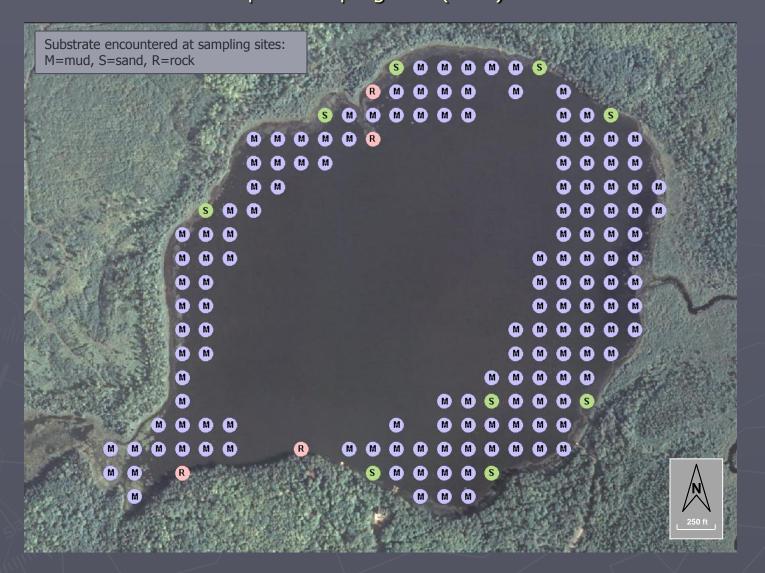
Figure 5. Round Lake substrate encountered at point-intercept plant sampling sites (2010).

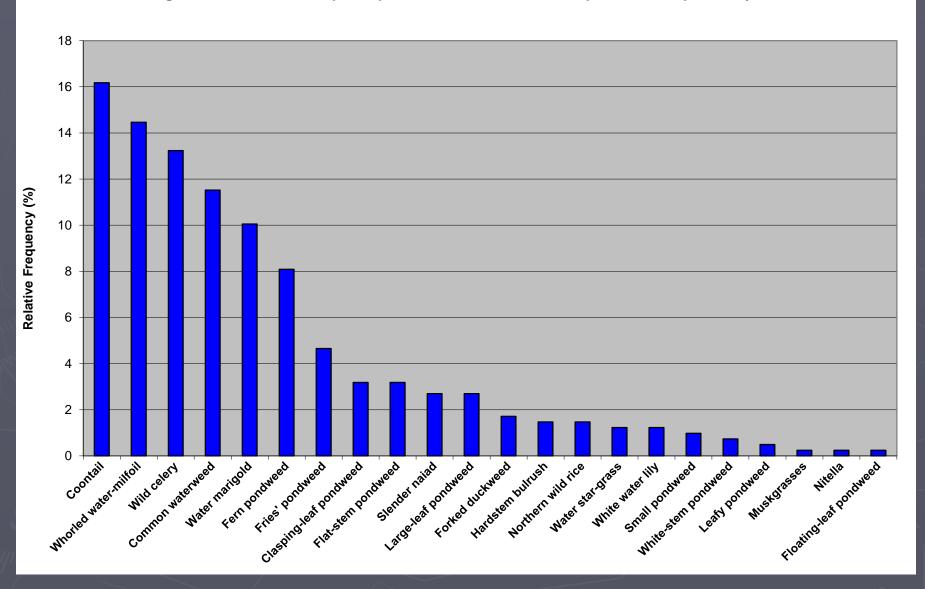
Figure 6. Round Lake aquatic plant occurrences for 2010 point-intercept survey data.

Table 2 provides information about the frequency of occurrence of the plant species recorded in the lake. Several metrics are provided, including total number of sites in which each species was found and frequency of occurrence at sites ≤ the maximum depth of rooted vegetation. This frequency metric is standardized as a "relative frequency" (also shown in Table 2) by dividing the frequency of occurrence for a given species by the sum of frequency of occurrence for all plants and multiplying by 100 to form a percentage. The resulting relative frequencies for all species total 100%. The relative frequencies for the plant species collected with a rake are graphically displayed in descending order on Figure 6. This display shows that

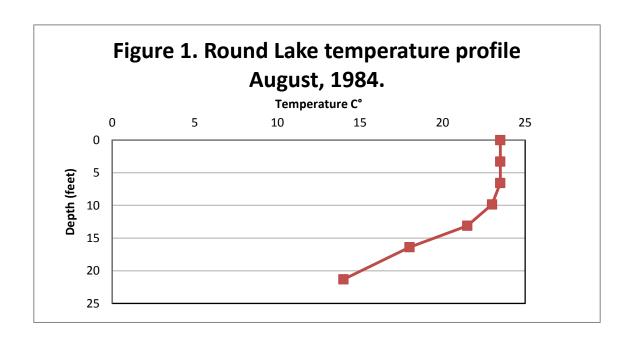
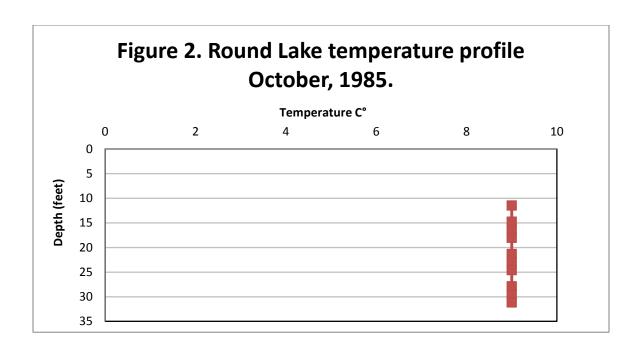
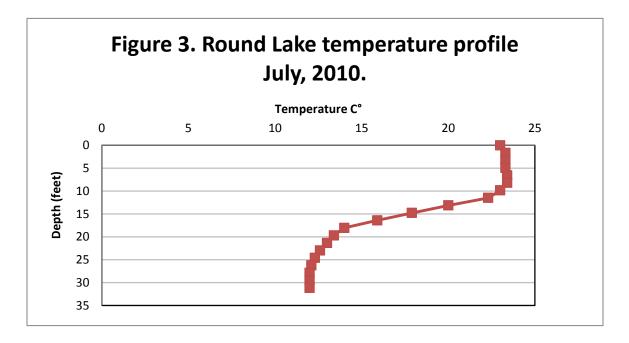
Measuring the temperature of a lake at different depths will determine the influence it has on the physical, biological, and chemical aspects of the lake. Lake water temperature influences the rate of decomposition, nutrient recycling, lake stratification, and dissolved oxygen (D.O.) concentration. Temperature can also affect the distribution of fish species throughout a lake. Figure 1 indicates that the lake stratified between 9 and 16 feet in August, 1984. Figure 2 shows the lake in October, 1985 had no stratification, which is normal at that time of year. Figure 3 indicates that Round Lake stratified between 8 and 16 feet.

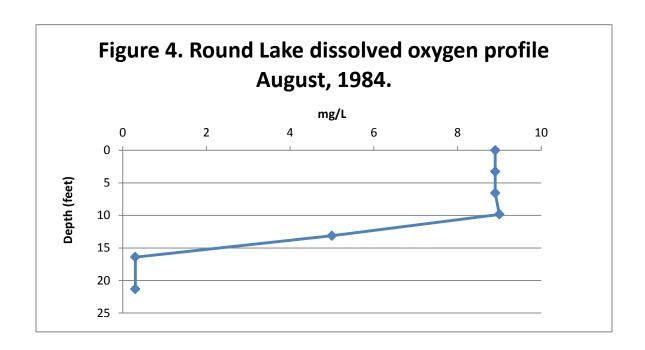
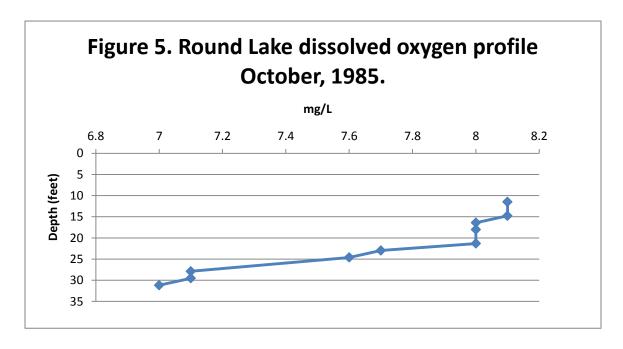
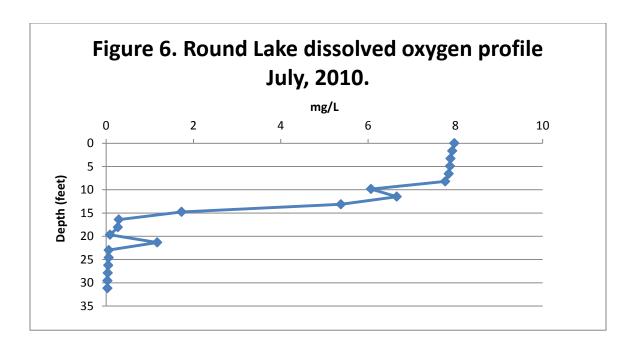
The dissolved oxygen content of lake water is vital in determining presence of fish species and other aquatic organisms. Dissolved oxygen also has a strong influence on the chemical and physical conditions of a lake. The amount of dissolved oxygen is dependent on the water temperature, atmospheric pressure, and biological activity. Oxygen levels are increased by aquatic plant photosynthesis, but reduced by respiration of plants, decomposer organisms, fish, and invertebrates. The amount of dissolved oxygen available in a lake, particularly in the deeper parts of a lake, is critical to overall health. Figure 4 shows that, in August 1984, oxygen levels were near zero at 16 feet. In October, 1985, dissolved oxygen levels

ranged from 8.1 mg/L at 11.5 feet to 7 mg/L at 31 feet deep (Figure 5). Similar to 1984, oxygen levels in 2010 were near zero at 16 feet (Figure 6).

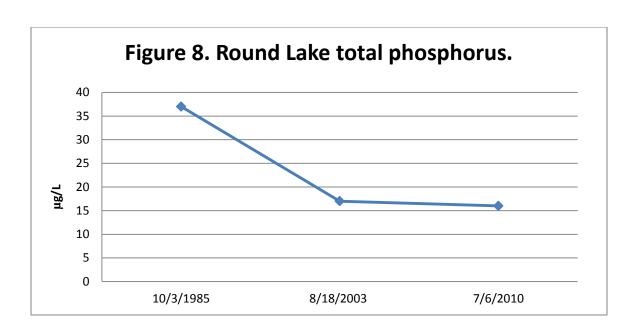
Phosphorus originates from a variety of sources, many of which are related to human activities. Major sources include human and animal wastes, soil erosion, detergents, septic systems and runoff from farmland or lawns (Shaw et al., 2004). Phosphorus provokes complex reactions in lakes. An analysis of phosphorus often includes both soluble reactive phosphorus and total phosphorus. Soluble reactive phosphorus dissolves in the water and directly influences plant growth (Shaw et al., 2004). Its concentration varies in most lakes over short periods of time as plants take it up and release it. Total phosphorus is considered a better indicator of a lake's nutrient status than soluble reactive phosphorus because its levels remain more stable (Shaw et al., 2004). Total phosphorus includes soluble phosphorus and the phosphorus in plant and animal fragments suspended in lake water. Ideally, soluble reactive phosphorus concentrations should be $10 \mu g/L$ or less at spring turnover to prevent summer algae blooms (Shaw et al., 2004). A concentration of total phosphorus below $20 \mu g/L$ for lakes should be maintained to prevent nuisance algal blooms (Shaw et al., 2004). Round Lake's total phosphorus levels were below nuisance levels in 2003 and 2010 (Figure 8). In 1985, the total phosphorus exceeded $20 \mu g/L$. Figure 9 classifies Round Lake as "fair" in 1985, and "good" in 2003 and 2010, with respect to phosphorus.

Figure 9. Total phosphorus concentrations for Wisconsin's natural lakes and impoundments (Shaw et al., 2004).

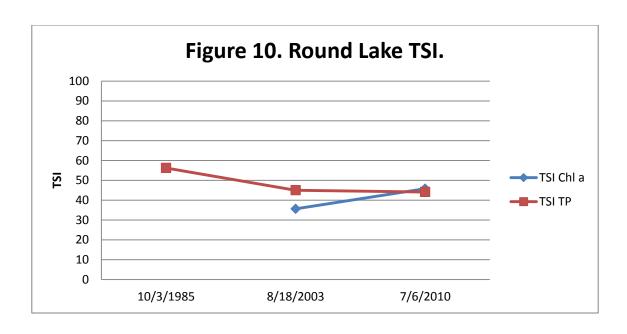
Figure 10 illustrates the Trophic State Index for Round Lake, using chlorophyll a and total phosphorus. The TSI shows Round Lake to be "mesotrophic" (Table 2).

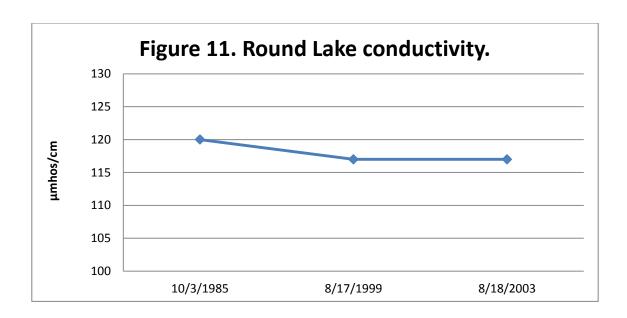
Conductivity is a measure of the ability of water to conduct an electric current. Conductivity is reported in micromhos per centimeter (µmhos/cm) and is directly related to the total dissolved inorganic chemicals in the water. Usually, values are approximately two times the water hardness, unless the water is receiving high concentrations of human-induced contaminants (Shaw et al., 2004). Conductivity in Round Lake was around 120 µmhos/cm in 1985, but remained around 117 µmhos/cm in 1999 and 2003 (Figure 11).

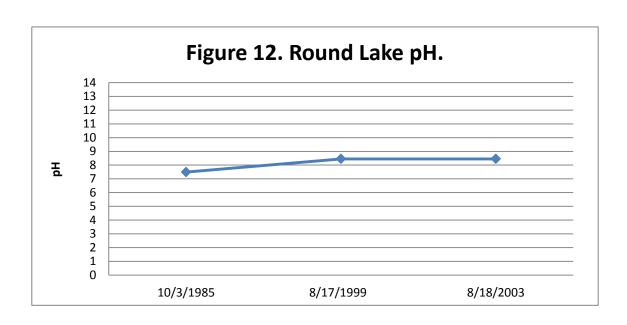
The acidity level of a lake's water regulates the solubility of many minerals. A pH level of 7 is considered neutral. The pH level in Wisconsin lakes ranges from 4.5 in acid, bog lakes to 8.4 in hard water, marl lakes (Shaw et al., 2004). Natural rainfall in Wisconsin averages a pH of 5.6. Some minerals become available under low pH (especially aluminum, zinc, and mercury) and can inhibit fish reproduction and/or survival. Mercury and aluminum are not only toxic to many kinds of wildlife, but also to humans (especially those that eat tainted fish). The pH scale is logarithmic, so every 1.0 unit change in pH increases the acidity tenfold. Water with a pH of 6 is 10 times more acidic than water with pH of 7. A lake's pH level is important for the release of potentially harmful substances and affects plant growth, fish reproduction and survival. A lake with neutral or slightly alkaline pH is a good lake for fish and plant survival. Figure 12 indicates that Round Lake is alkaline (pH higher than 7).

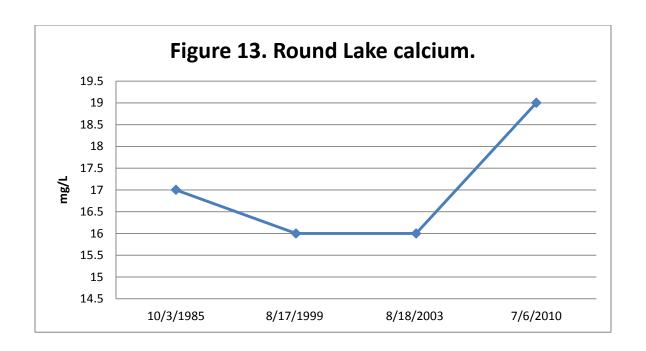
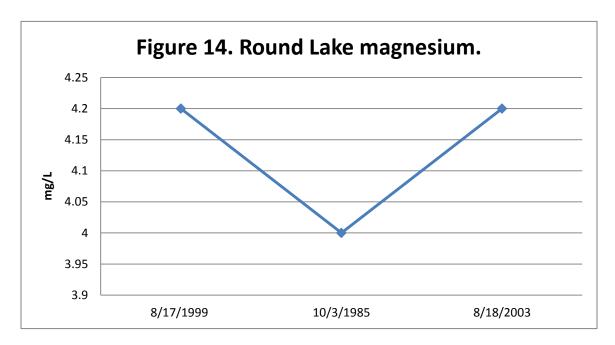
The carbonate system provides acid buffering through two alkaline compounds: bicarbonate and carbonate. These compounds are usually found with two hardness ions: calcium and magnesium (Shaw et al., 2004). Calcium is the most abundant cation found in Wisconsin lakes. Its abundance is related to the presence of calcium-bearing minerals in the lake watershed (Shaw et al., 2004). Aquatic organisms such as native mussels use calcium in their shells. The aquatic invasive zebra mussel tends to need calcium levels greater than 20 mg/L to maintain shell growth. Round Lake's calcium levels were near the threshold necessary for zebra mussels, which indicate they could flourish (Figure 13). Figure 14 shows that magnesium levels in Round Lake remained near 4 mg/L.
