Presque Isle Wilderness Waters Program

Aquatic Plant Management Plan – Stateline Lake

Date: March 2014

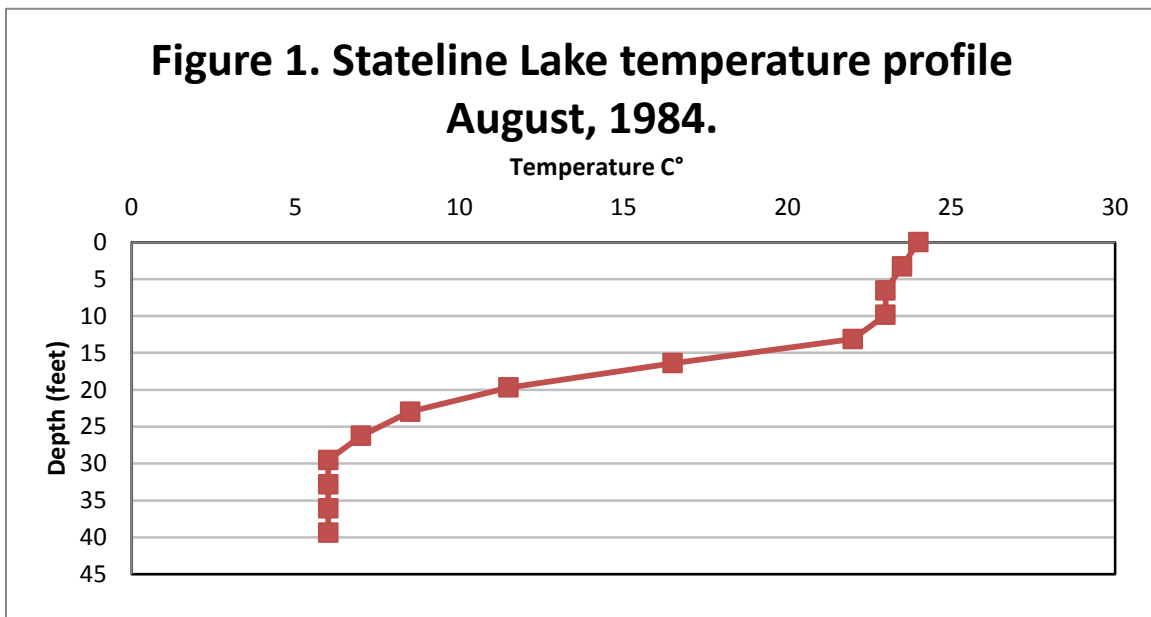
Measuring the temperature of a lake at different depths will determine the influence it has on the physical, biological, and chemical aspects of the lake. Lake water temperature influences the rate of decomposition, nutrient recycling, lake stratification, and dissolved oxygen concentration. Temperature can also affect the distribution of fish species throughout a lake. Figure 1 indicates that the Stateline Lake stratified between 13 and 20 feet in 1984. Figure 2 shows that the lake stratifies between 9 and 20 feet. There is an increase in about 3 degrees in the surface water temperature from 1984 to 2010.
