2014 EWM Control Strategy

Professional Hand Removal

Map 1
Upper Kaubashine Lake
Oneida County, Wisconsin
**2014 Professional EWM
Hand-Removal Areas**

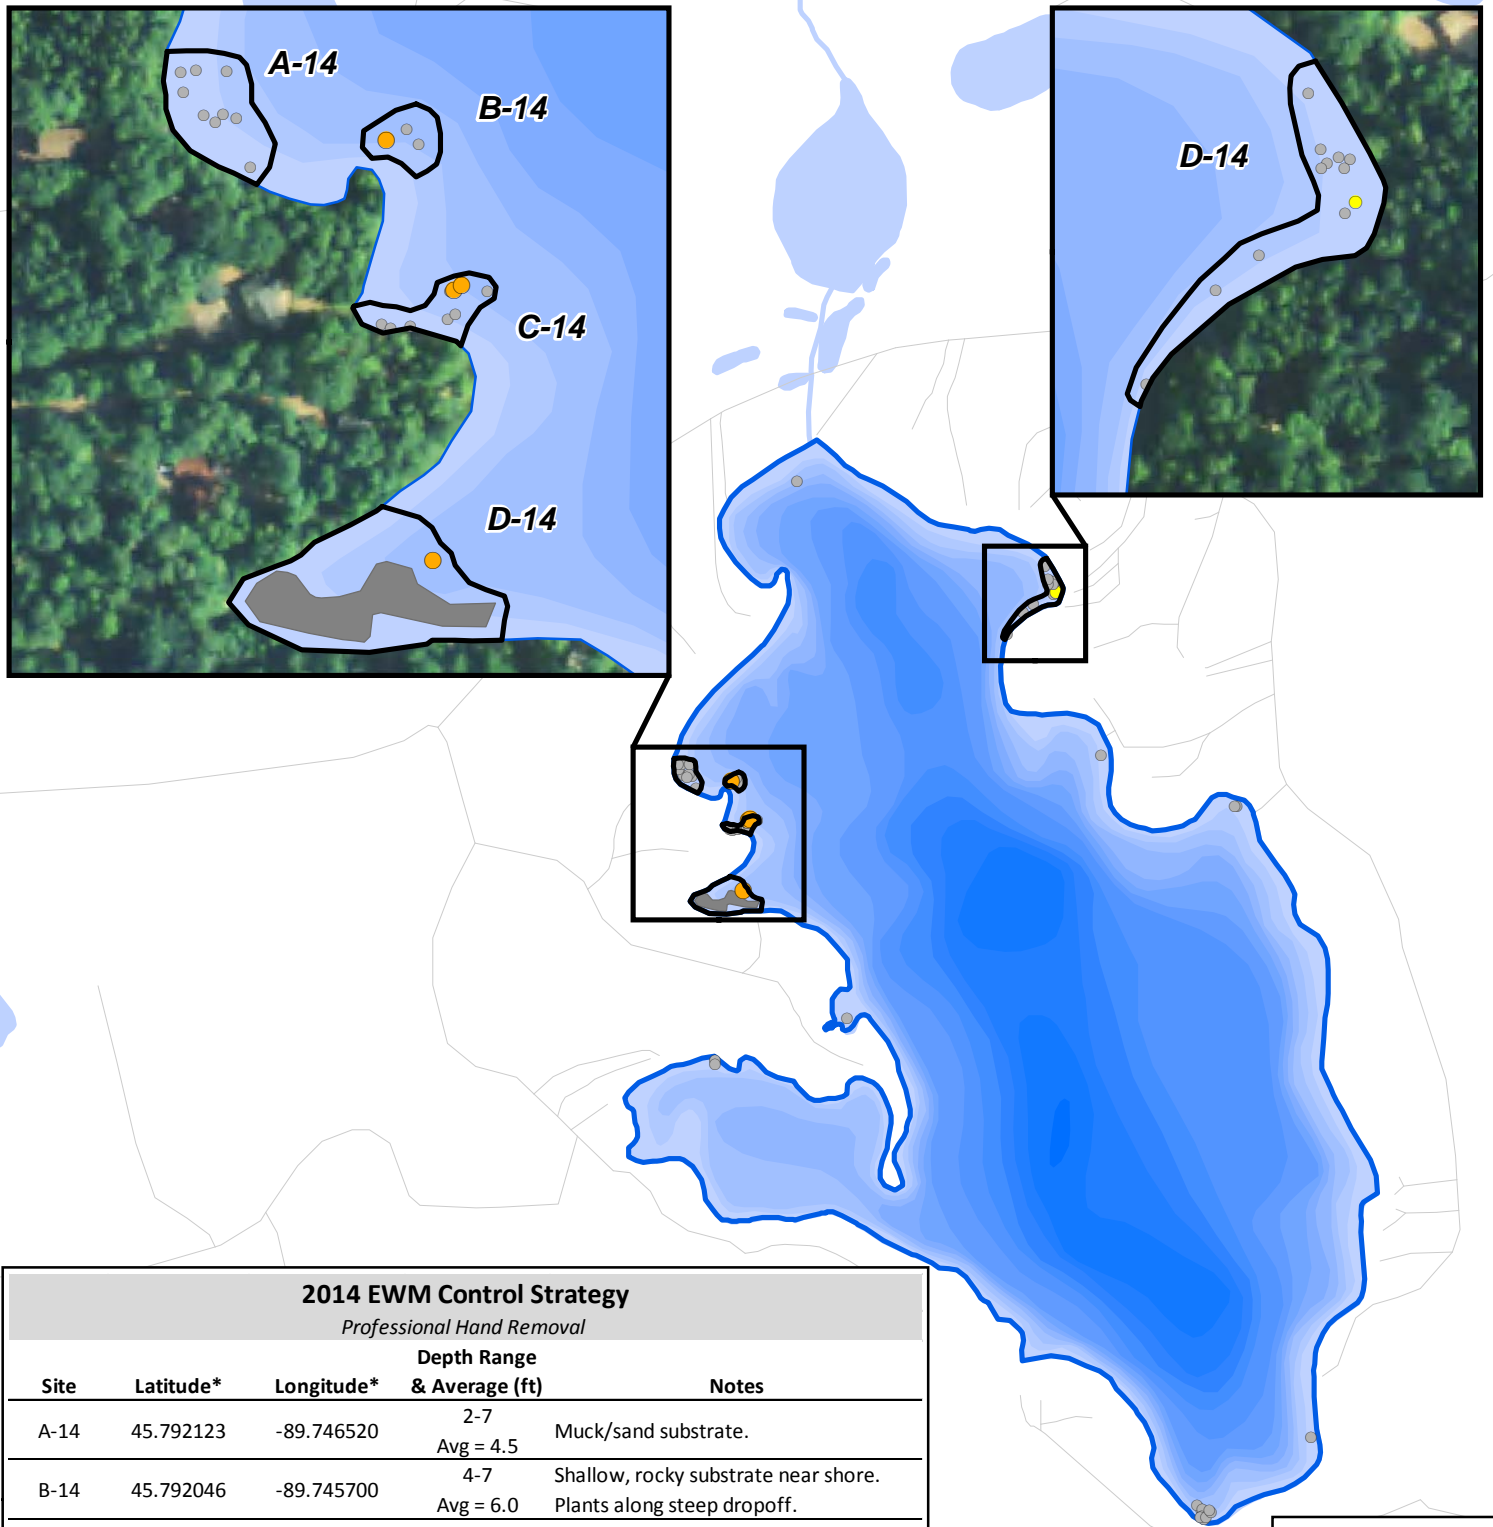
Site	Latitude*	Longitude*	Depth Range & Average (ft)	Notes
A-14	45.792123	-89.746520	2-7 Avg = 4.5	Muck/sand substrate.
B-14	45.792046	-89.745700	4-7 Avg = 6.0	Shallow, rocky substrate near shore. Plants along steep dropoff.
C-14	45.791479	-89.745425	2-5 Avg = 3.5	Muck/sand substrate.
D-14	45.790723	-89.745495	1-7 Avg = 3.5	Many plants in shallow (2 ft) water. Mucky substrate.
E-14	45.794446	-89.740163	1-8 Avg = 3.5	Many plants in shallow water near downed tree. Mostly solid substrate.

* Latitude/Longitude of center of Hand-Removal site
