Lake Management Plan for the Pike Chain of Lakes Price and Vilas Counties, Wisconsin

[Pike Lake Chain includes Pike Lake, Round Lake,
Amik Lake, and Turner Lake]

2003

Prepared by **Steve McComas, Blue Water Science**
with significant contributions from the Pike Lake Chain of Lakes
Association, and Wisconsin Department of Natural Resources

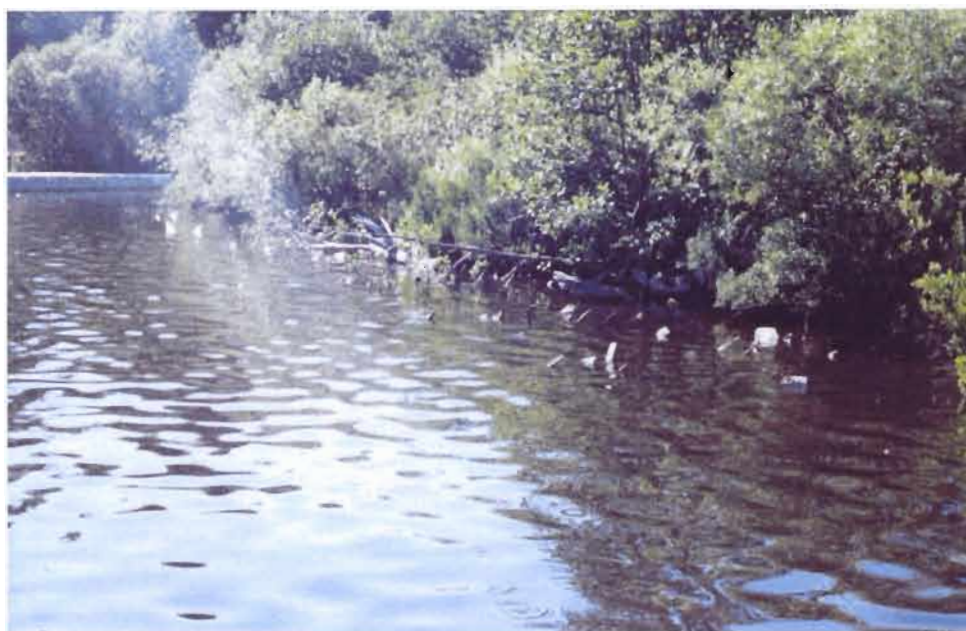
Figure 25. Discarded wooded slabs from the sawmill operation are still found in a southern bay of Pike Lake.

A unique feature of Pike Lake is the bottom covering of wooden slabs in the north shore of the southern bay. They were discarded into the bay during the sawmill operation. No aquatic plants were found (Transect 10 on the map, Figure 27), but they offer some habitat for fish and invertebrates.
