Lake Management Plan for the Pike Chain of Lakes Price and Vilas Counties, Wisconsin

[Pike Lake Chain includes Pike Lake, Round Lake,
Amik Lake, and Turner Lake]

2003

Prepared by **Steve McComas, Blue Water Science**
with significant contributions from the Pike Lake Chain of Lakes
Association, and Wisconsin Department of Natural Resources

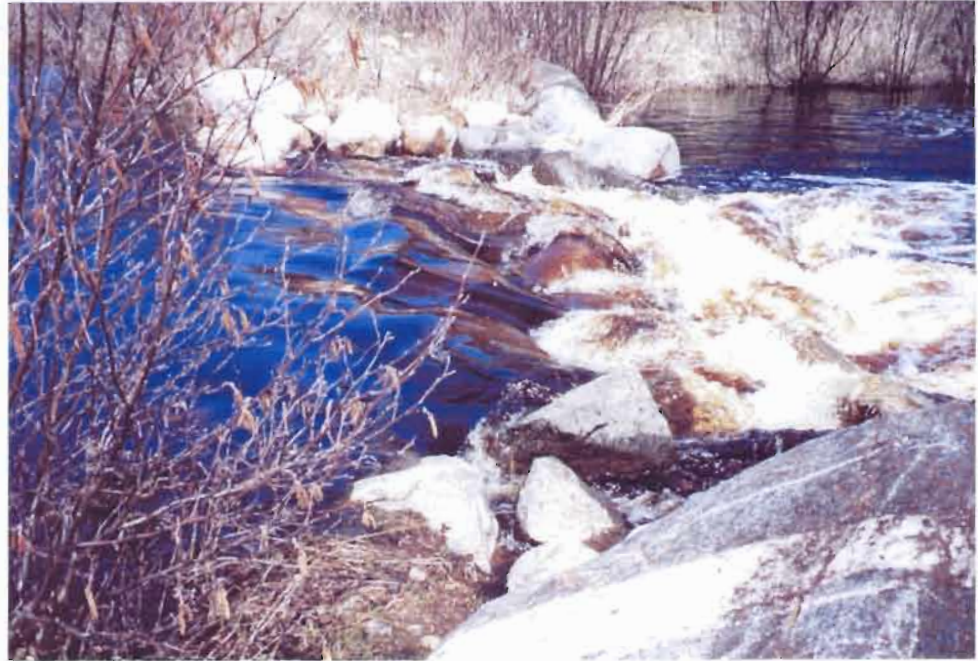
Figure 8. Foulds Creek - April 2001. The creek flows north into Pike Lake with a relatively high flow in spring.

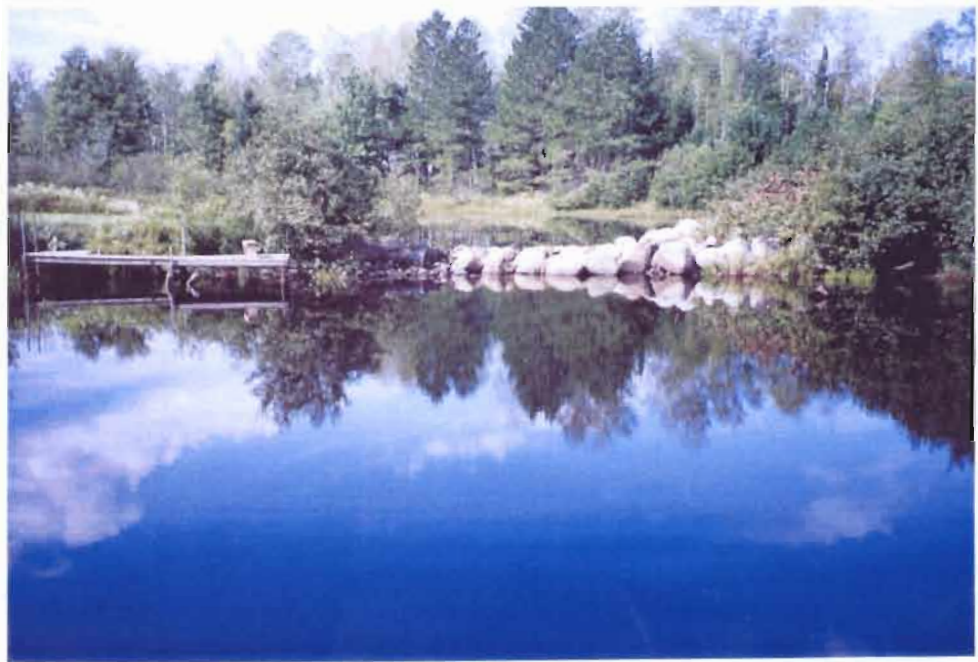
Figure 9. Fould's Creek - September 2001. In the fall, the flow in Foulds Creek is low. The average flow annual flow is estimated at 14 cubic feet per second.

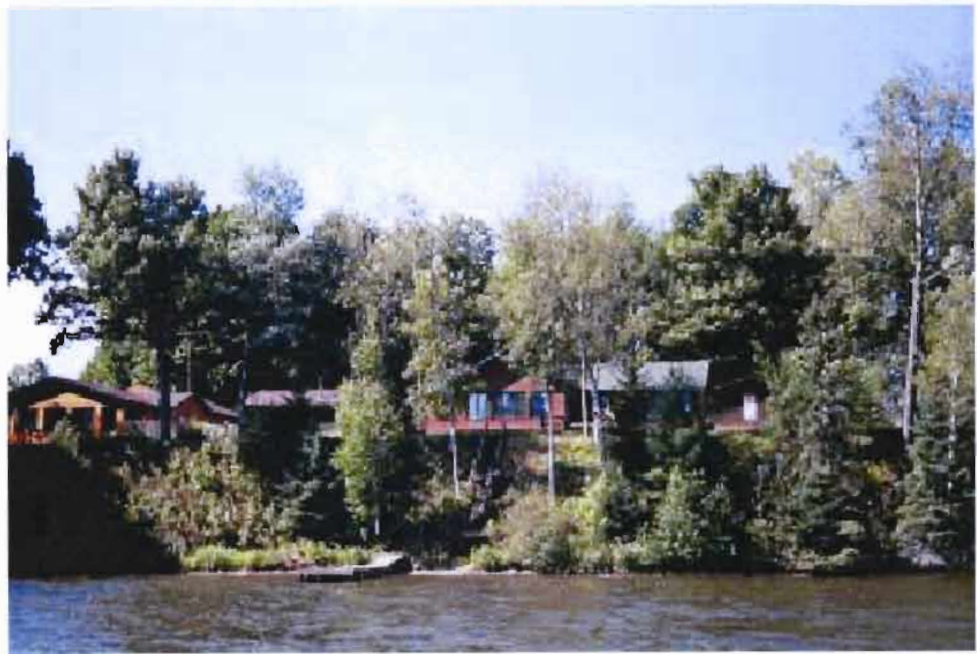
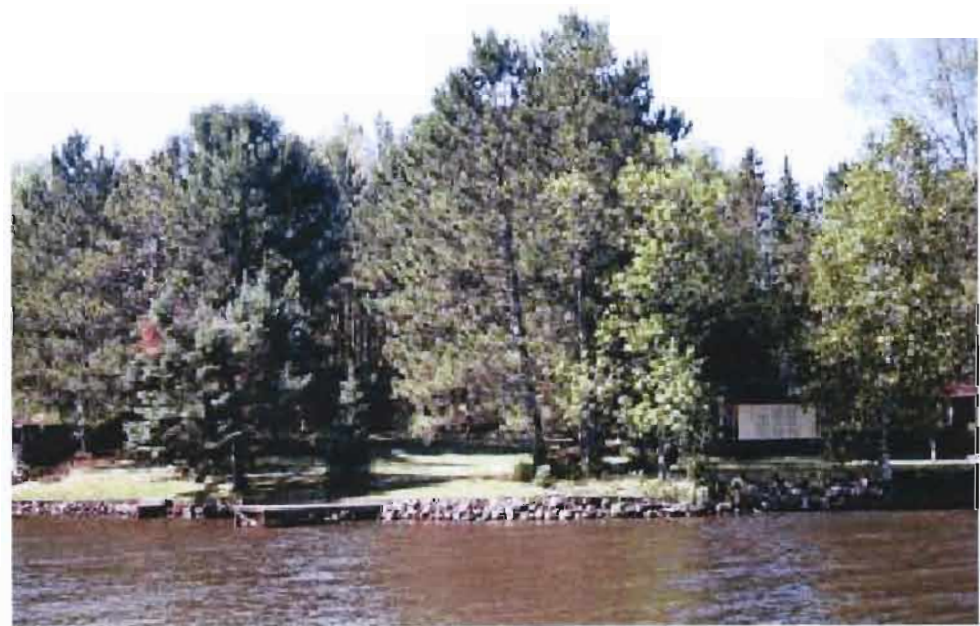
Figure 12. [top] This parcel would rate as having a shoreline with a buffer greater than 50% of the lot width and an understory with greater than 50% natural cover.

[bottom] This parcel would not qualify as having a natural shoreline buffer greater than 50% of the lot width. Also understory in the upland area would be rated as having less than 50% natural cover.

For each photograph we looked at the shoreline and the upland condition. Examples of shoreland conditions are shown in Figure 13. Our criteria for natural conditions were the presence of 50% native vegetation in the understory and at least 50% natural vegetation along the shoreline in a strip at least 15 feet deep. We evaluated shorelands at the 75% natural level as well.

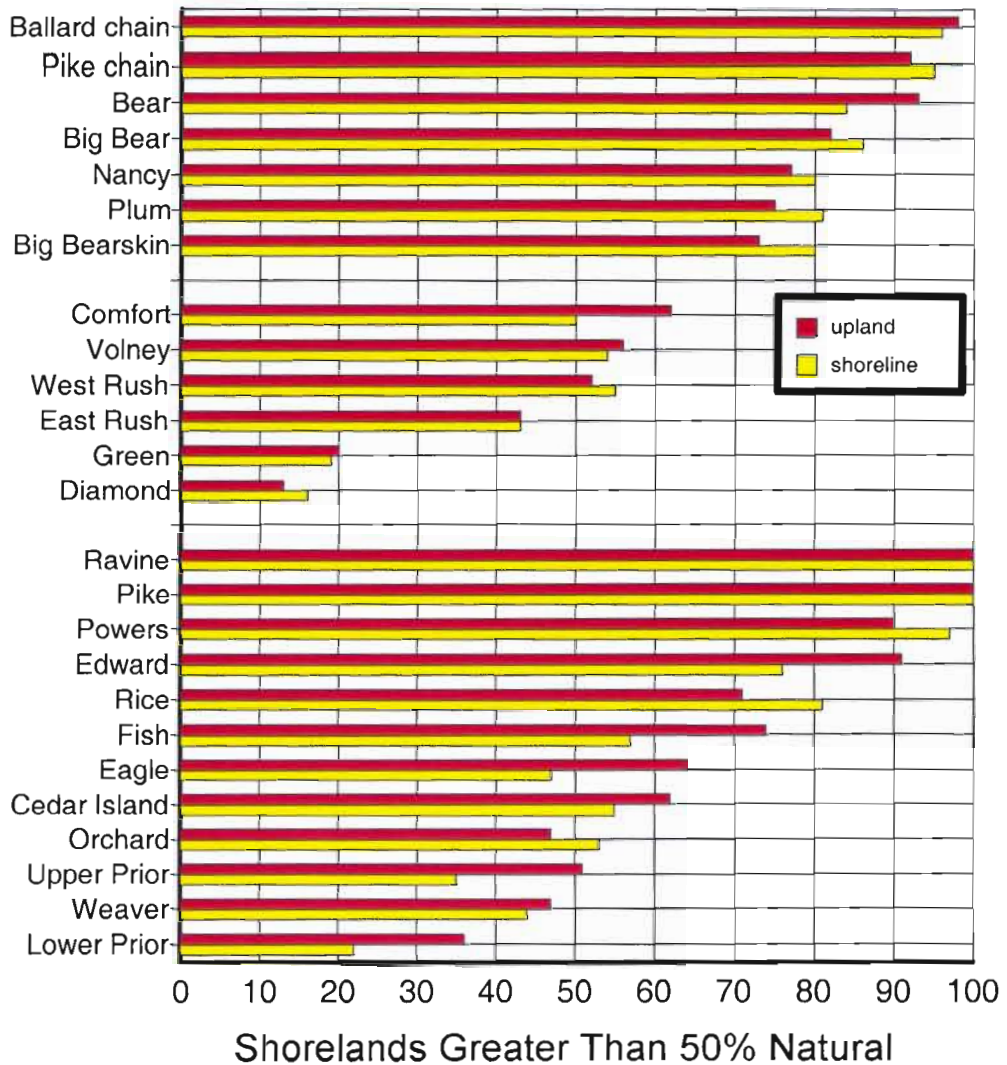
Figure 13. A summary of shoreland inventory results for lakes using an evaluation based on shoreland photographs. For each lake the percentage of shoreline and upland conditions with greater than 50% natural conditions is shown. The first tier of lakes are located in northern Wisconsin. The lower tier of lakes are in the Twin City Metropolitan area and are considered urban lakes. Although several lakes are “urban” lakes most of the shoreland is owned by the city and there is a high percentage of natural conditions. The middle tier of lakes are about an hour’s drive from the Twin Cities, and are not considered to be urban lakes, they are “country” lakes.

A summary of the inventory results is shown in Table 7. Based on our subjective criteria over 95% of the parcels in the Round, Amik and Turner, Pike Lakes shoreland area meet the natural rankings for shorelines and upland areas. This is good for a lake in northern Wisconsin. However in the next 10 years there could be pressure to reduce natural conditions. Proactive volunteer native landscaping should maintain existing conditions and improve other parcels.

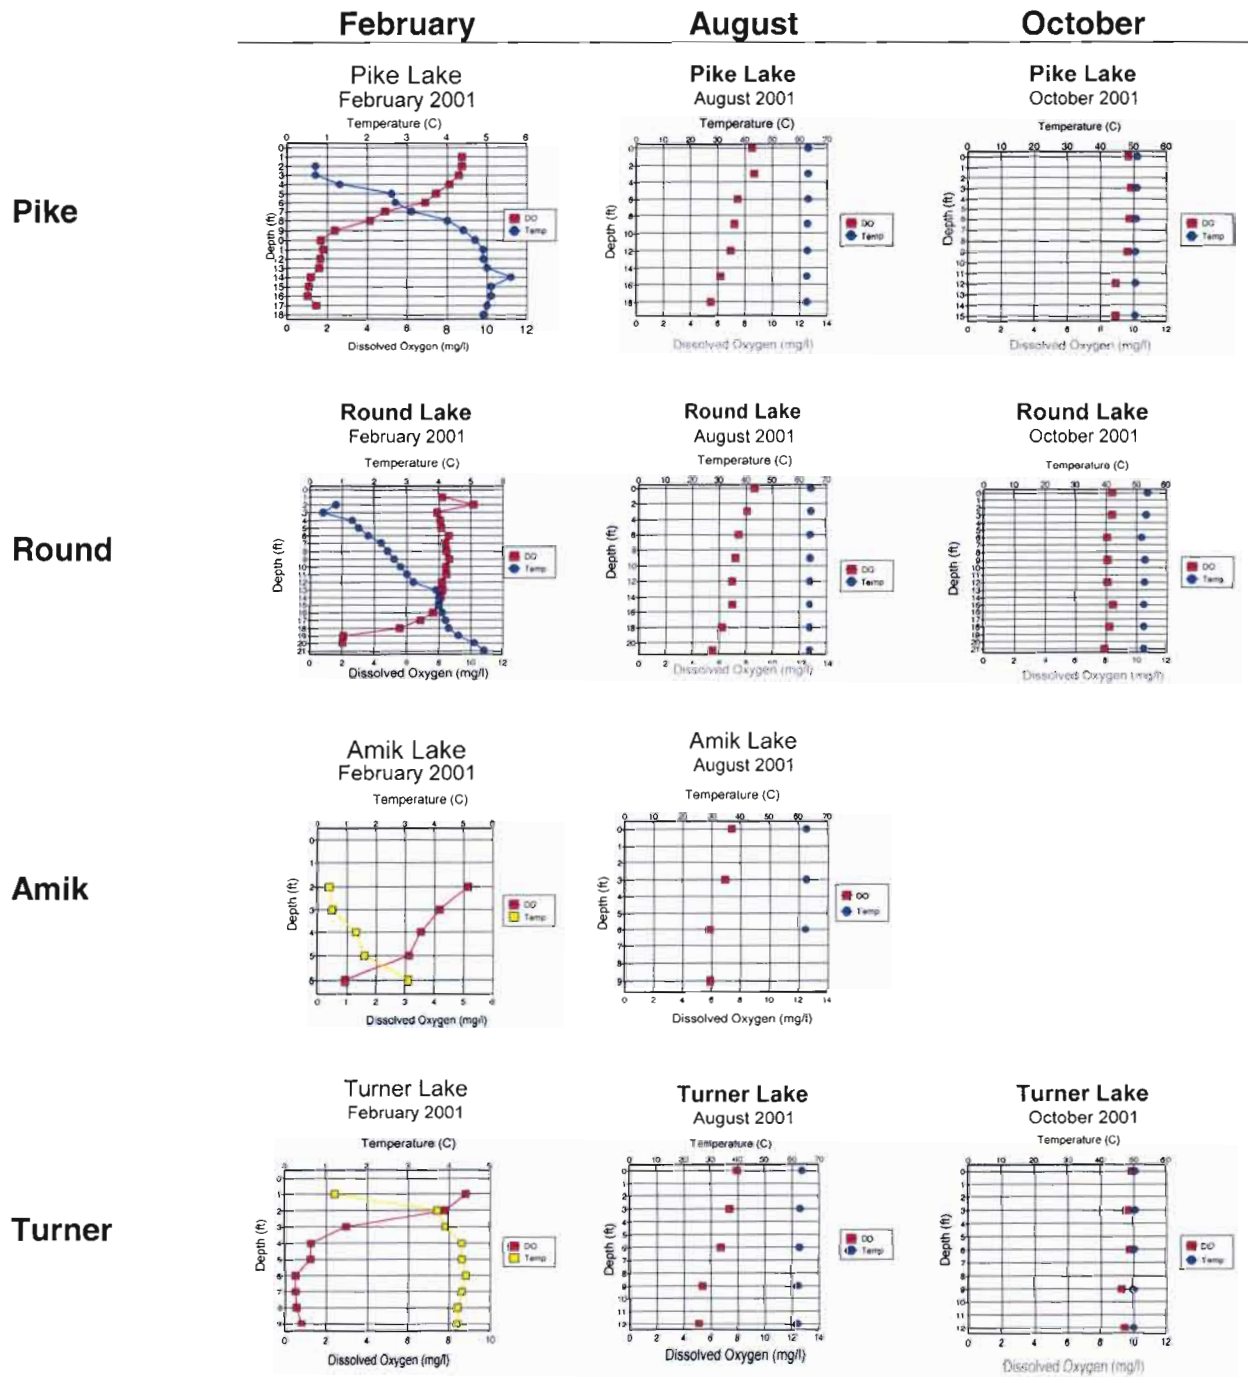
Figure 16. Dissolved oxygen/temperature profiles for Pike, Round, and Amik and Turner Lakes.

Winter oxygen levels can be low in the bottom water of all four lakes, however oxygen is present in the upper water column. In summer, the lakes are well mixed and oxygen is present throughout the summer.

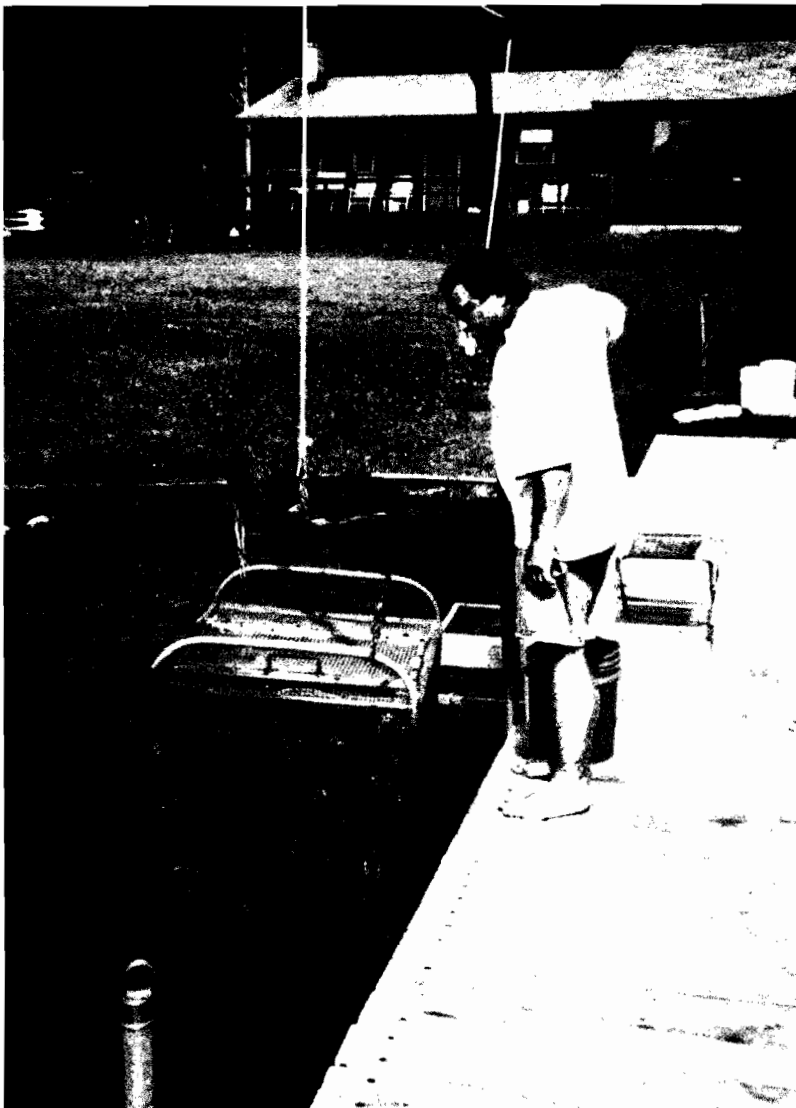
Figure 29. [top] Big Bearskin crayfish traps are ready to go into the lake. Pike Lake Chain volunteers could make and install traps as well. [bottom] Roger Soletski, Big Bearskin Lake, checks the crayfish holding cage at Big Bearskin. The larger crayfish can be sold.
