WHITNALL PARK

MILWAUKEE

EQUIPMENT RECORDING SONAR MAPPED MAY 1970

Source: Wisconsin Department of Natural Resources 608-266-2621
Whitnall Park Lake – Milwaukee County, Wisconsin DNR Lake Map
Date – May 1970 - Historical Lake Map - Not for Navigation
A Public Document - Please Identify the Source when using it.

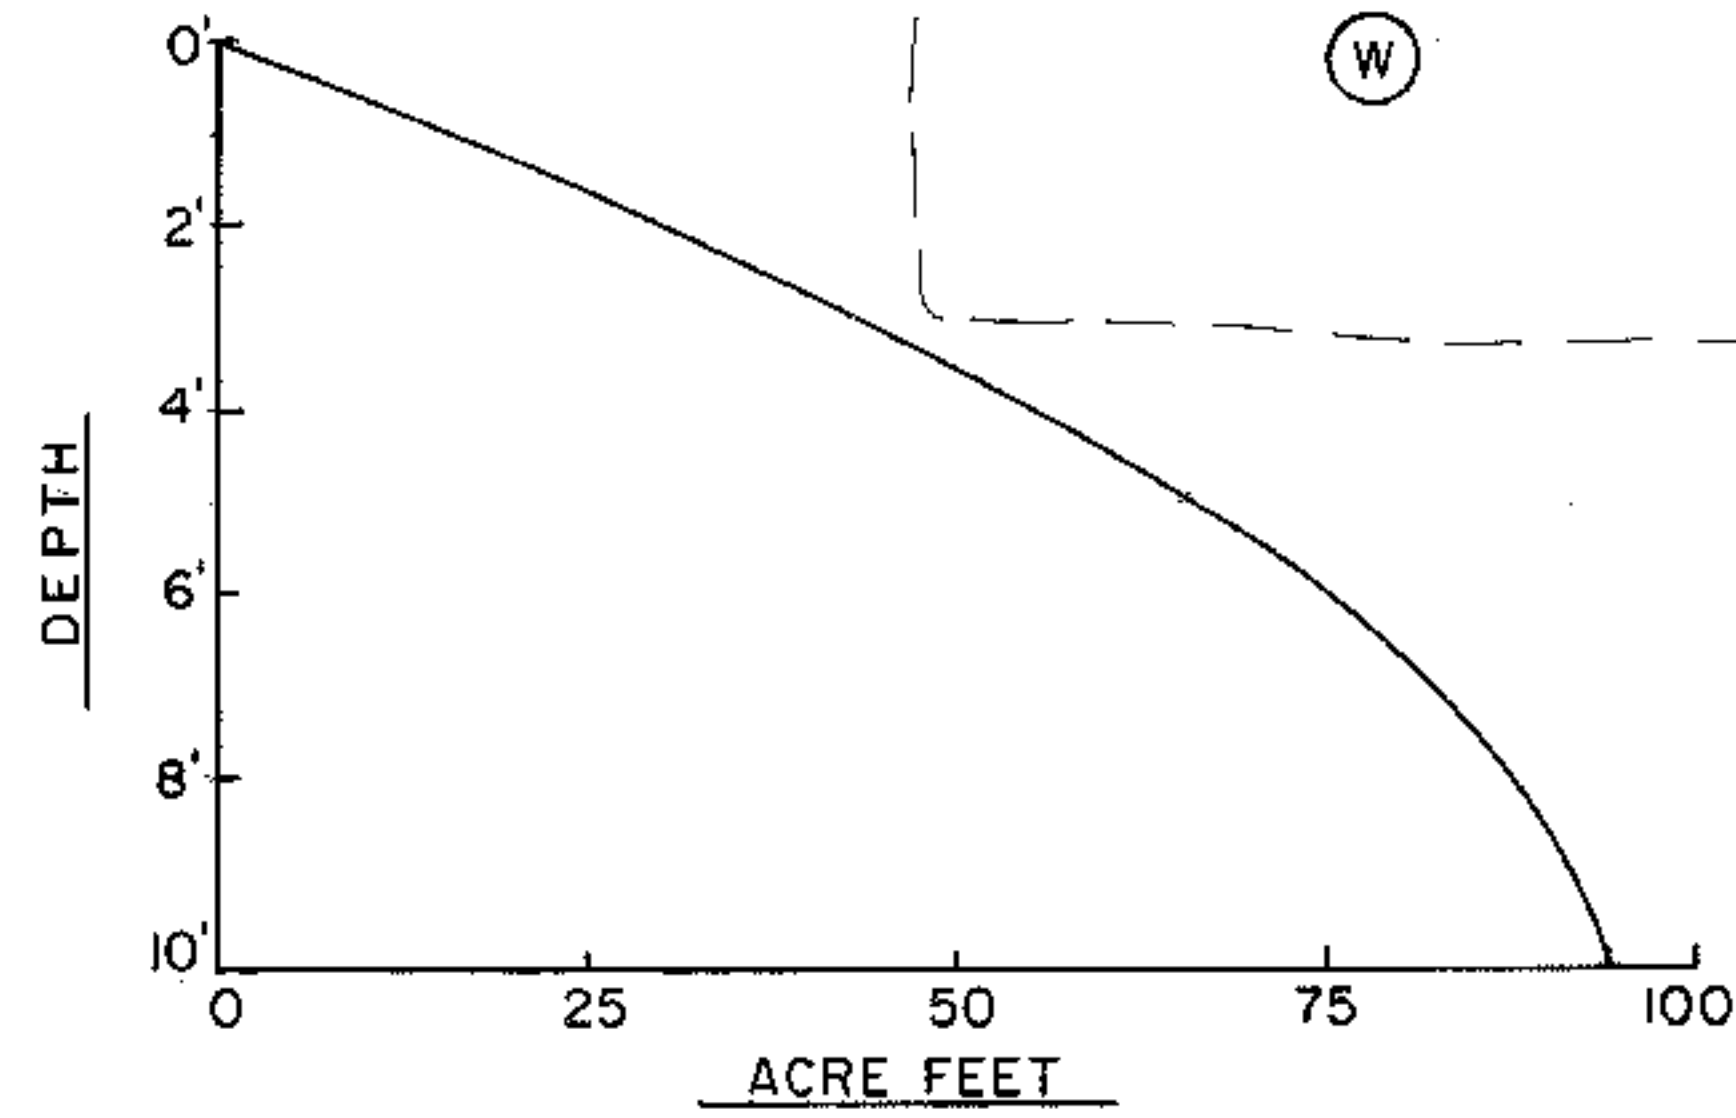
Department of Natural Resources Bench Mark.
Top of east edge of concrete spillway.
Assumed Elevation 100.00'
Water Elevation 99.75' (May 1970)

WATER AREA 15.3 ACRES
 UNDER 3 FT. 13 %
 OVER 20 FT. 0 %
 MAX. DEPTH 10 FEET.
 TOTAL ALK. 272 P.P.M.
 VOLUME 94.2 ACRE FT.
 SHORELINE 1.22 MILES
 0.84 MILES OF SHORELINE
 EXCLUDING ISLANDS
