EQUIPMENT RECORDING SONAR MAPPED JUNE 1968
MO. YR.

Source: Wisconsin Department of Natural Resources 608-266-2621
Spruce Lake – Fond du Lac County, Wisconsin DNR Lake Map
Date – Jun 1968 - Historical Lake Map - Not for Navigation
A Public Document - Please Identify the Source when using it.

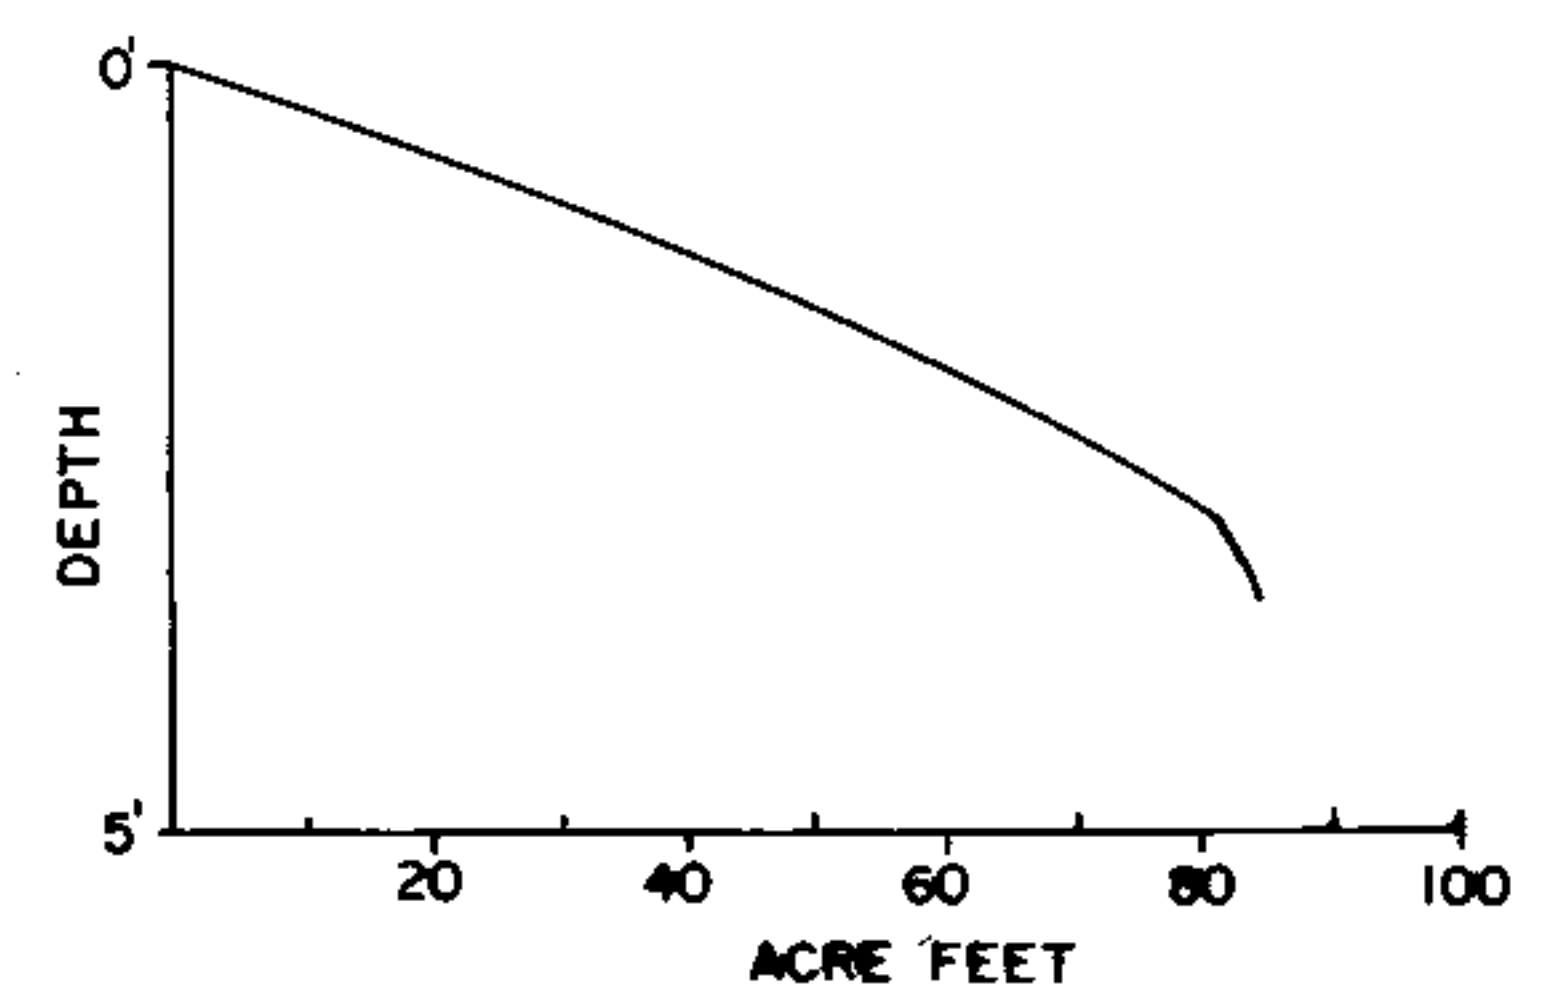
Bench Mark 3, Spikes in 5" Tamarack Tree
nearest to Lake on trail south end of Lake
Assumed Elev. 100.00'
Water Elev. 98.30'

WATER ELEV. 98.30'

AREA 33.7 ACRES
UNDER 3FT. 37.8 %
OVER 20FT. 0 %
VOLUME 87.1 ACRE FT.
TOTAL ALK. 100 P.P.M.
SHORELINE 0.86 MILES
MAX. DEPTH 3.5 FEET
