EQUIPMENT RECORDING SONAR MAPPED MAY 1970  
MONTH YEAR

Source: Wisconsin Department of Natural Resources 608-266-2621  
Brown Deer Park Pond – Milwaukee County, Wisconsin DNR Lake Map  
Date – May 1970 - Historical Lake Map - Not for Navigation  
A Public Document - Please Identify the Source when using it.

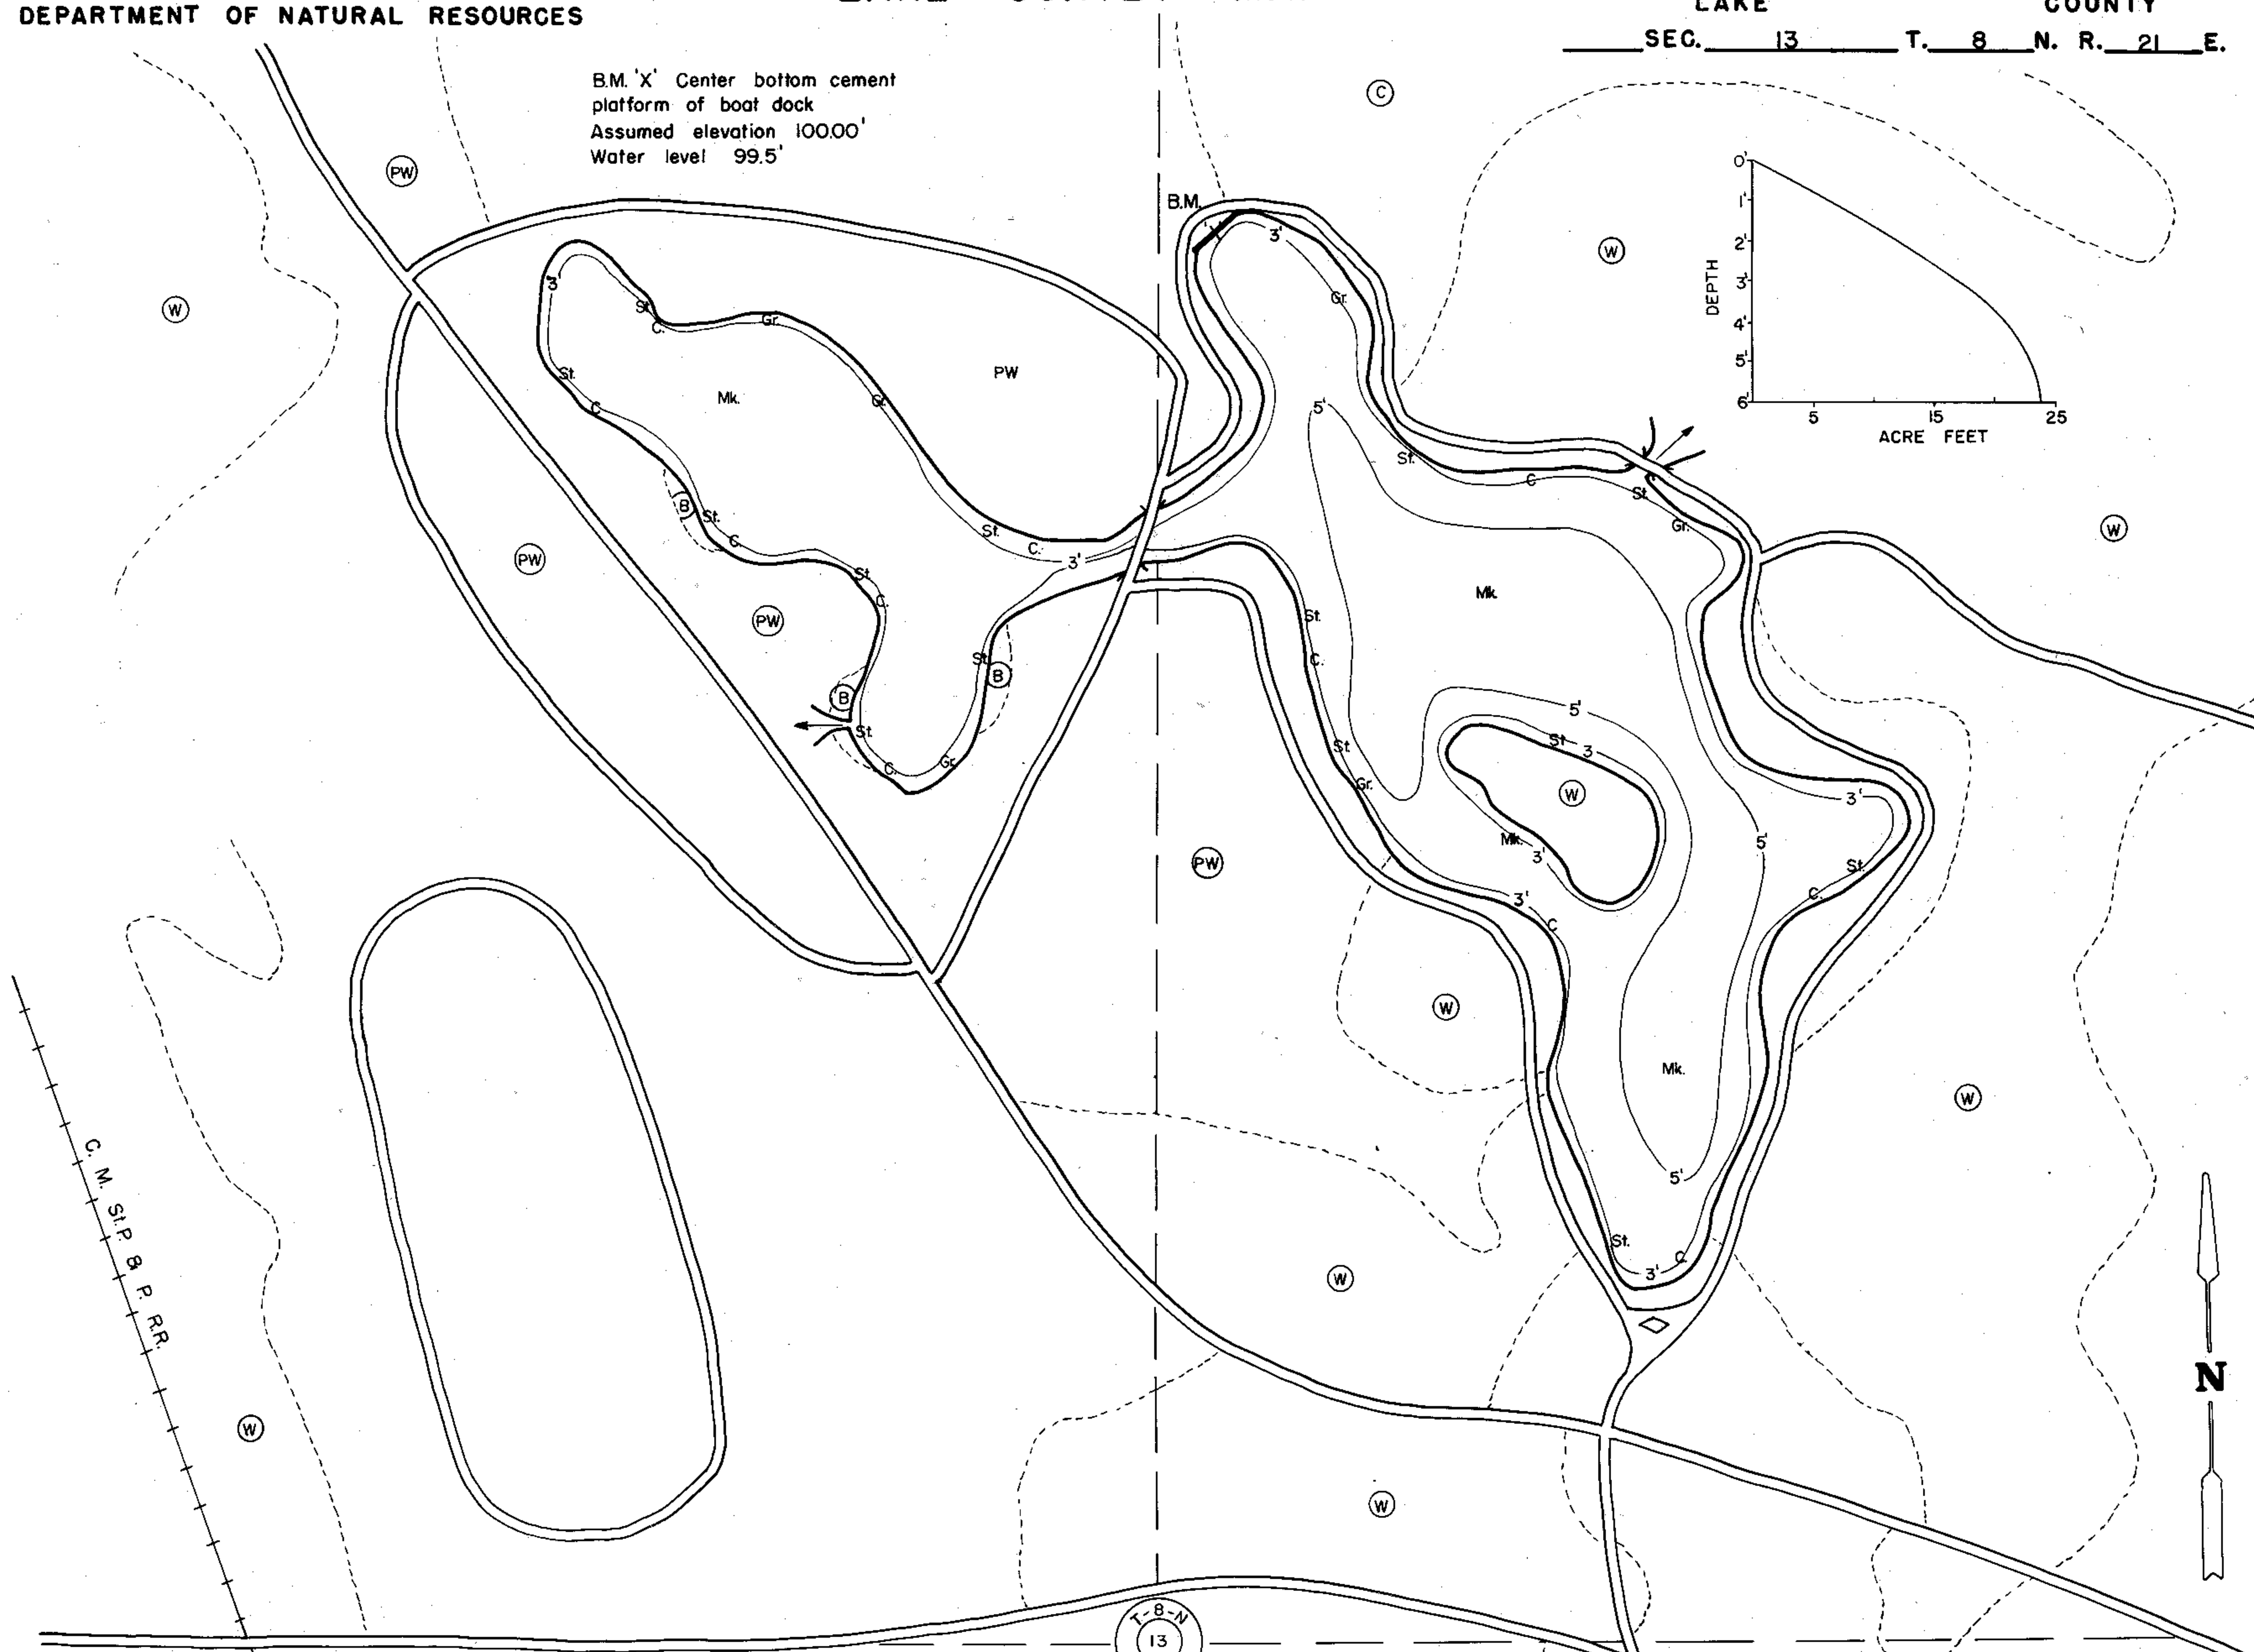
B.M. 'X' Center bottom cement platform of boat dock  
Assumed elevation 100.00'  
Water level 99.5'

WATER AREA 6.0 ACRES  
UNDER 3 FT. 16.7 %  
OVER 20 FT. 0 %  
MAX. DEPTH 6 FEET.  
TOTAL ALK. 200 P.P.M.  
VOLUME 23.9 ACRE FT.  
SHORELINE 0.87 MILES
