EQUIPMENT RECORDING SONAR MAPPED APRIL 1968  
MO. YR.

Source: Wisconsin Department of Natural Resources 608-266-2621  
Tilly Lake – Washington County, Wisconsin DNR Lake Map  
Date – Apr 1968 - Historical Lake Map - Not for Navigation  
A Public Document - Please Identify the Source when using it.

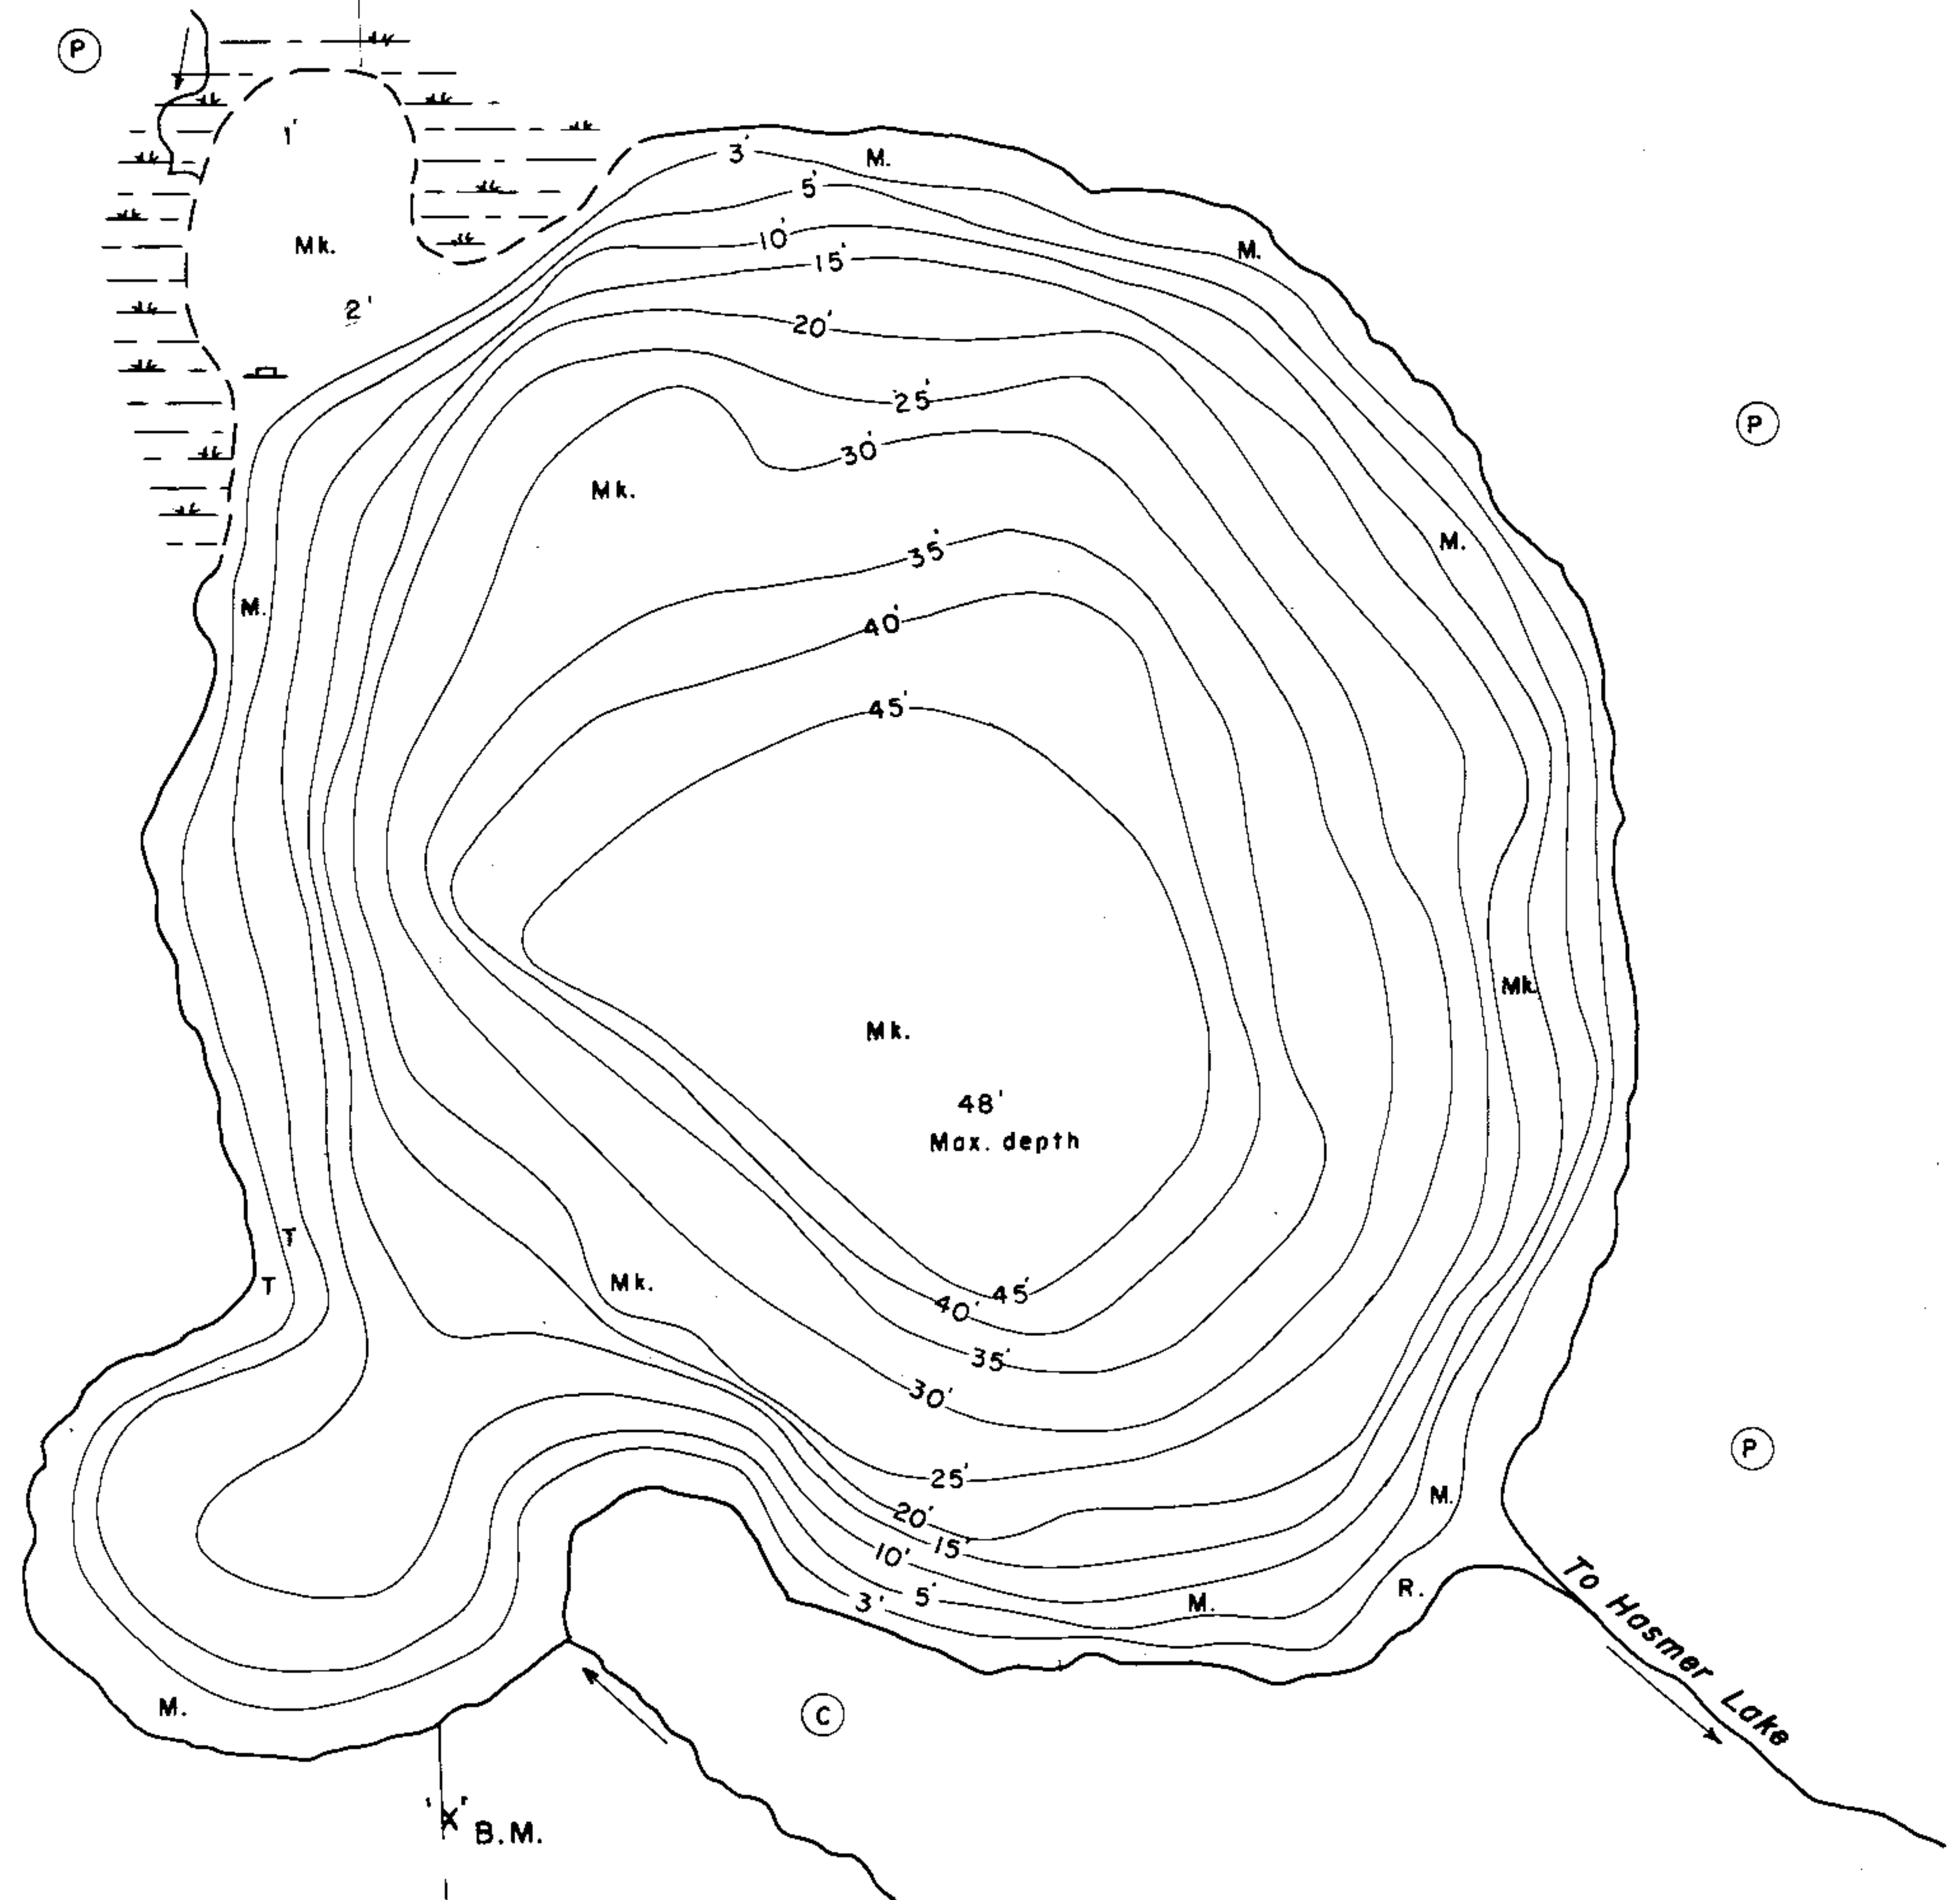
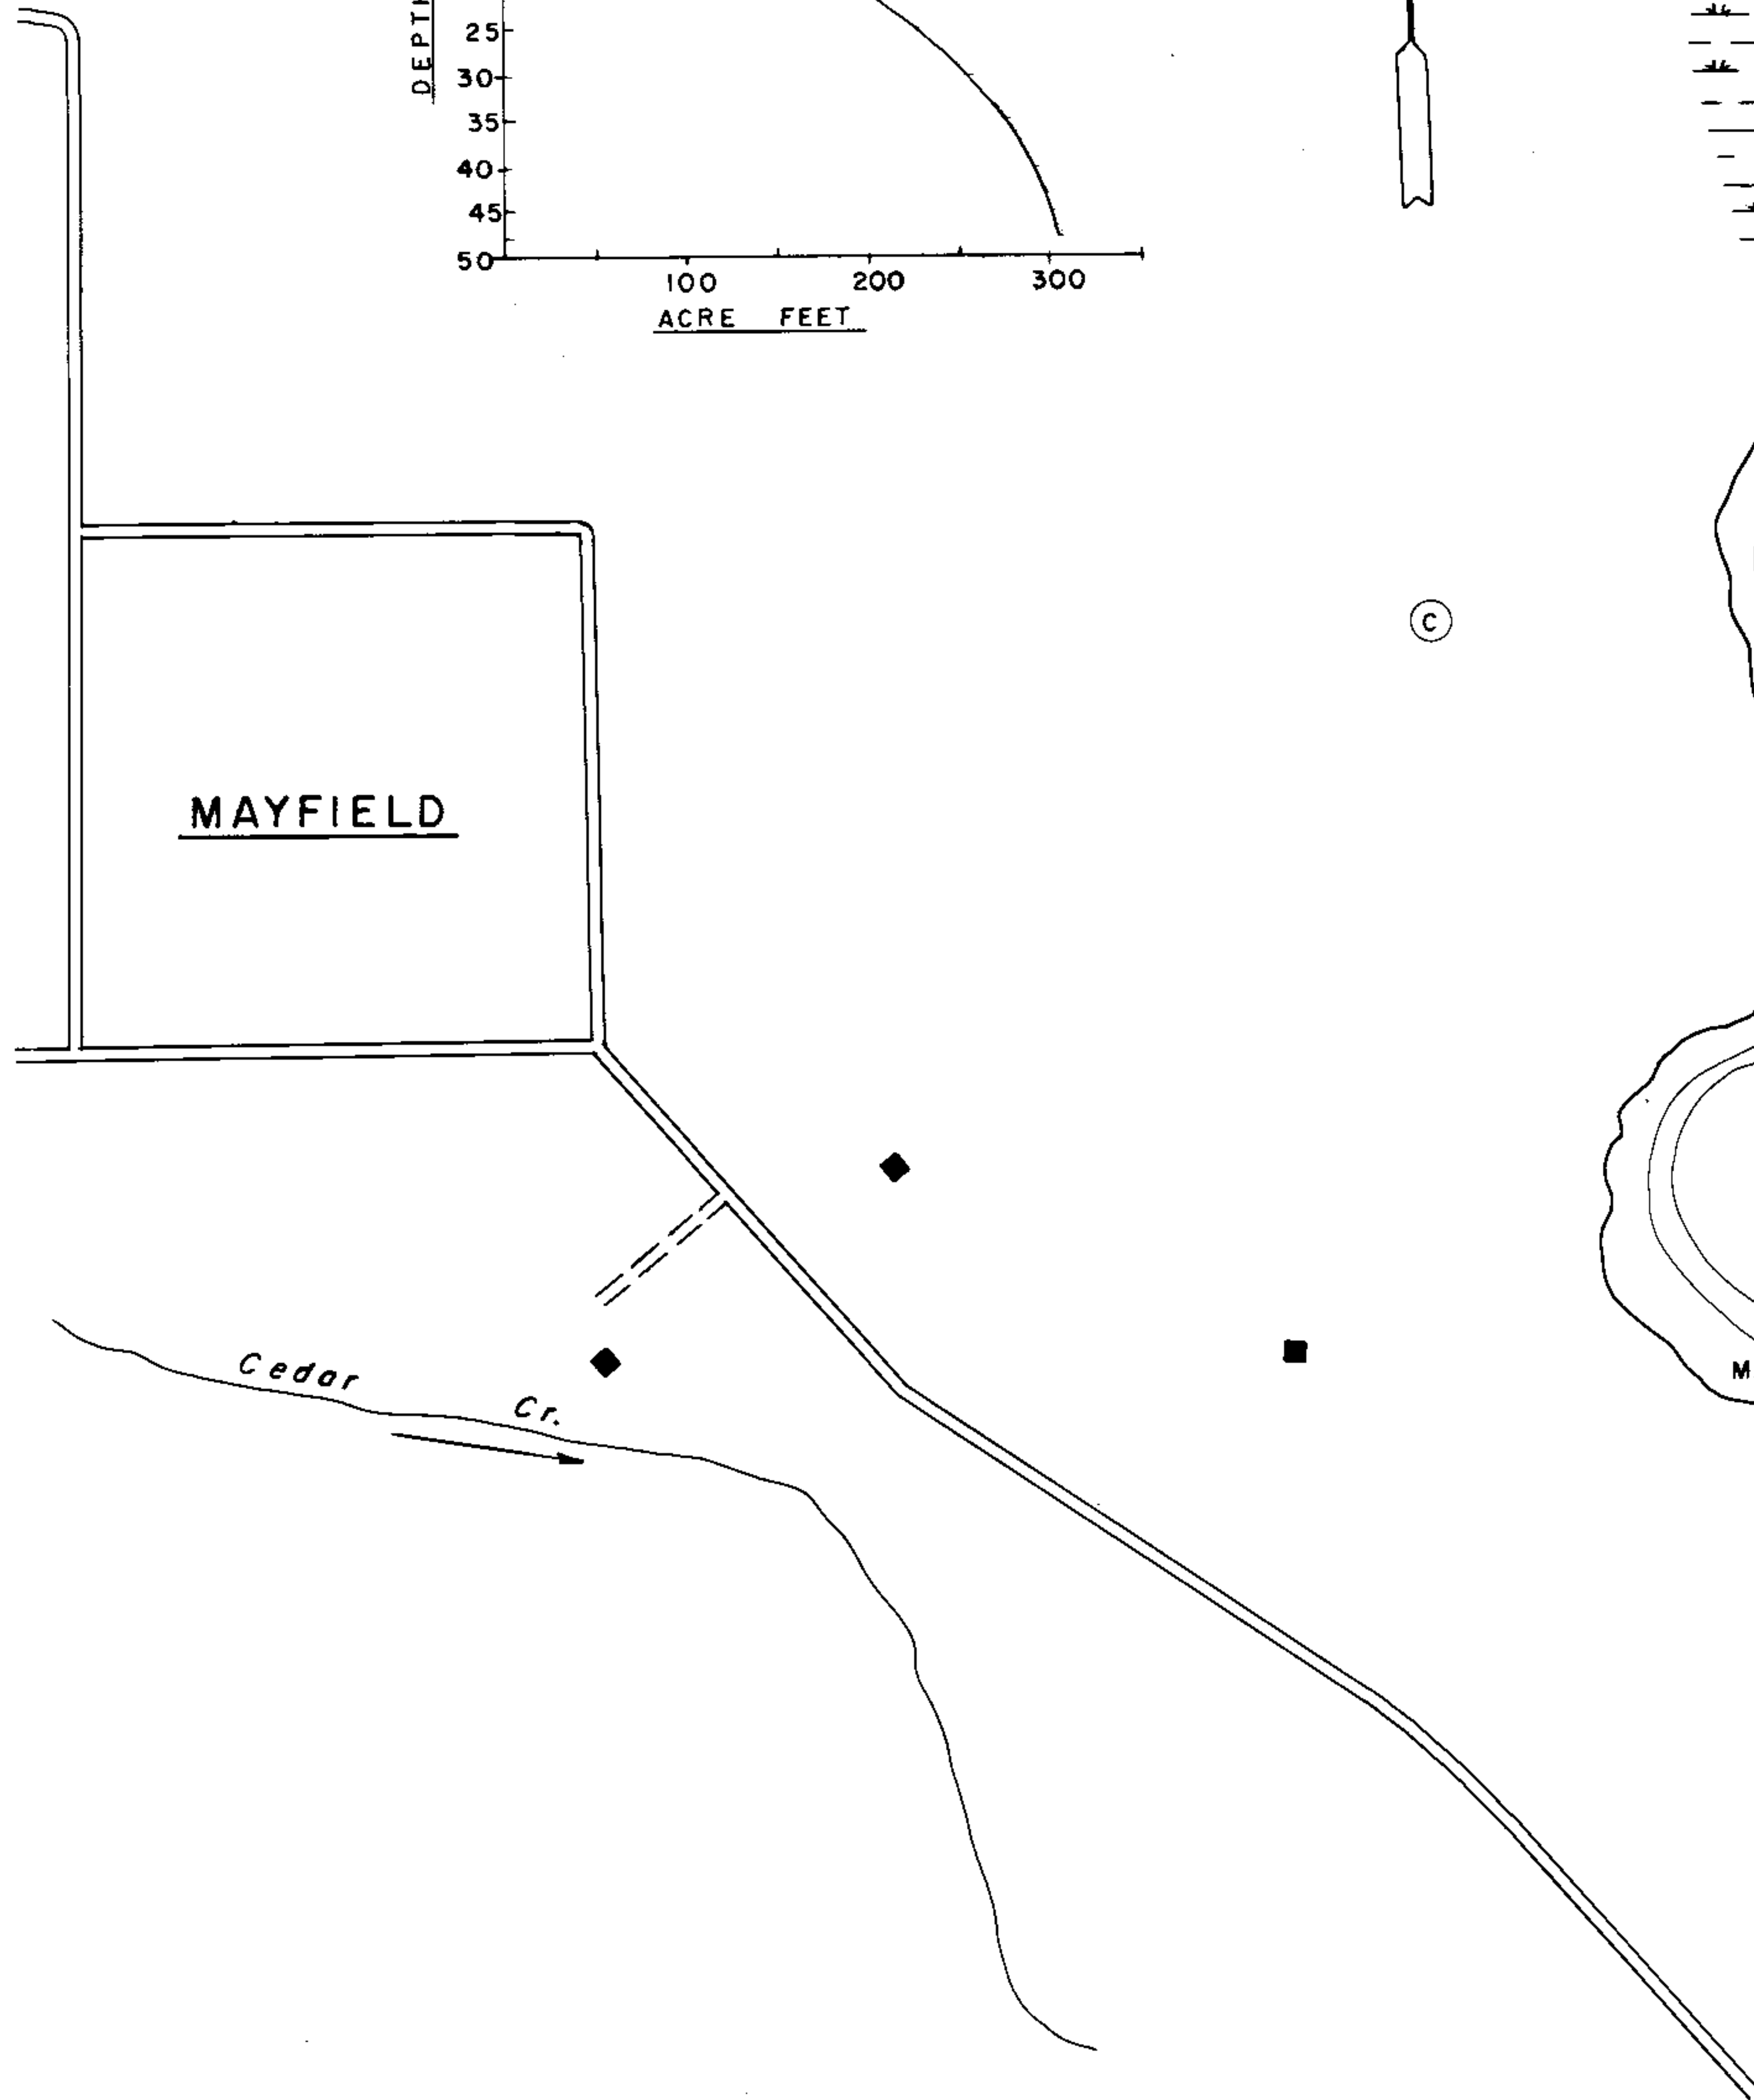
B.M. 1 1/2" Orange pipe on south end of lake on fence line  
Assumed Elev. 100.00'  
Water Elev. 97.7'

WATER ELEV. 97.7'

AREA 13.0 ACRES  
UNDER 3FT. 1 %  
OVER 20FT. 53 %  
VOLUME 304.7 ACRE FT.  
TOTAL ALK. 215 P.P.M.  
SHORELINE .7 MILES  
MAX. DEPTH 48 FEET
