EQUIPMENT RECORDING SONAR MAPPED MAY 1967
MO. YR.
WATER ELEV. 96.8

Source: Wisconsin Department of Natural Resources 608-266-2621
Ennis Lake – Marquette County, Wisconsin DNR Lake Map
Date – May 1967 - Historical Lake Map - Not for Navigation
A Public Document - Please Identify the Source when using it.

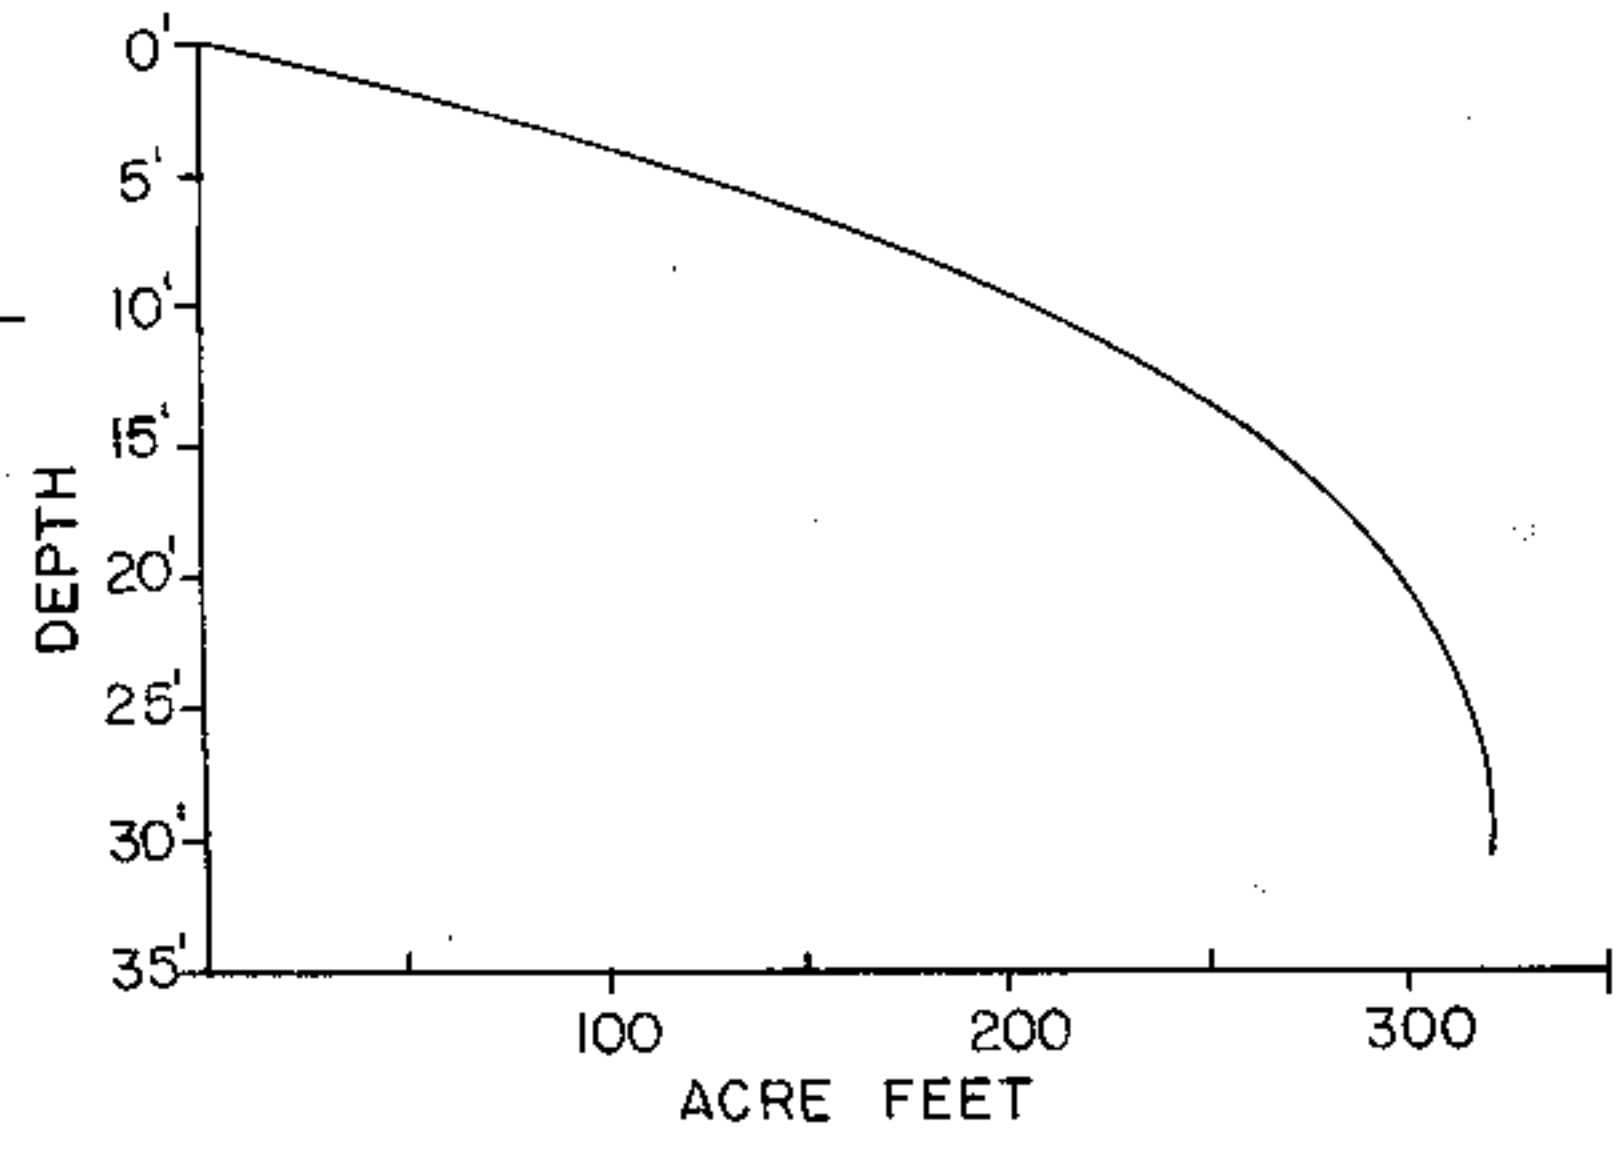
B.M. 'X' 1 1/2" Orange painted steel post
on W. end of lake, S. side of access
Assumed elev. 100.0
Water elev. 96.8

AREA 25.3 ACRES
UNDER 3 FT. 11.5 %
OVER 20 FT. 17.8 %
VOLUME 323.5 ACRE FT.
TOTAL ALK. 192 P.P.M.
SHORELINE 1.0 MILES
MAX. DEPTH 31 FEET
