EQUIPMENT RECORDING SONAR MAPPED MAY 1966  
 MO. YR.

Source: Wisconsin Department of Natural Resources 608-266-2621  
Gurholt Lake – Waupaca County, Wisconsin DNR Lake Map  
Date – May 1966 - Historical Lake Map - Not for Navigation  
A Public Document - Please Identify the Source when using it.

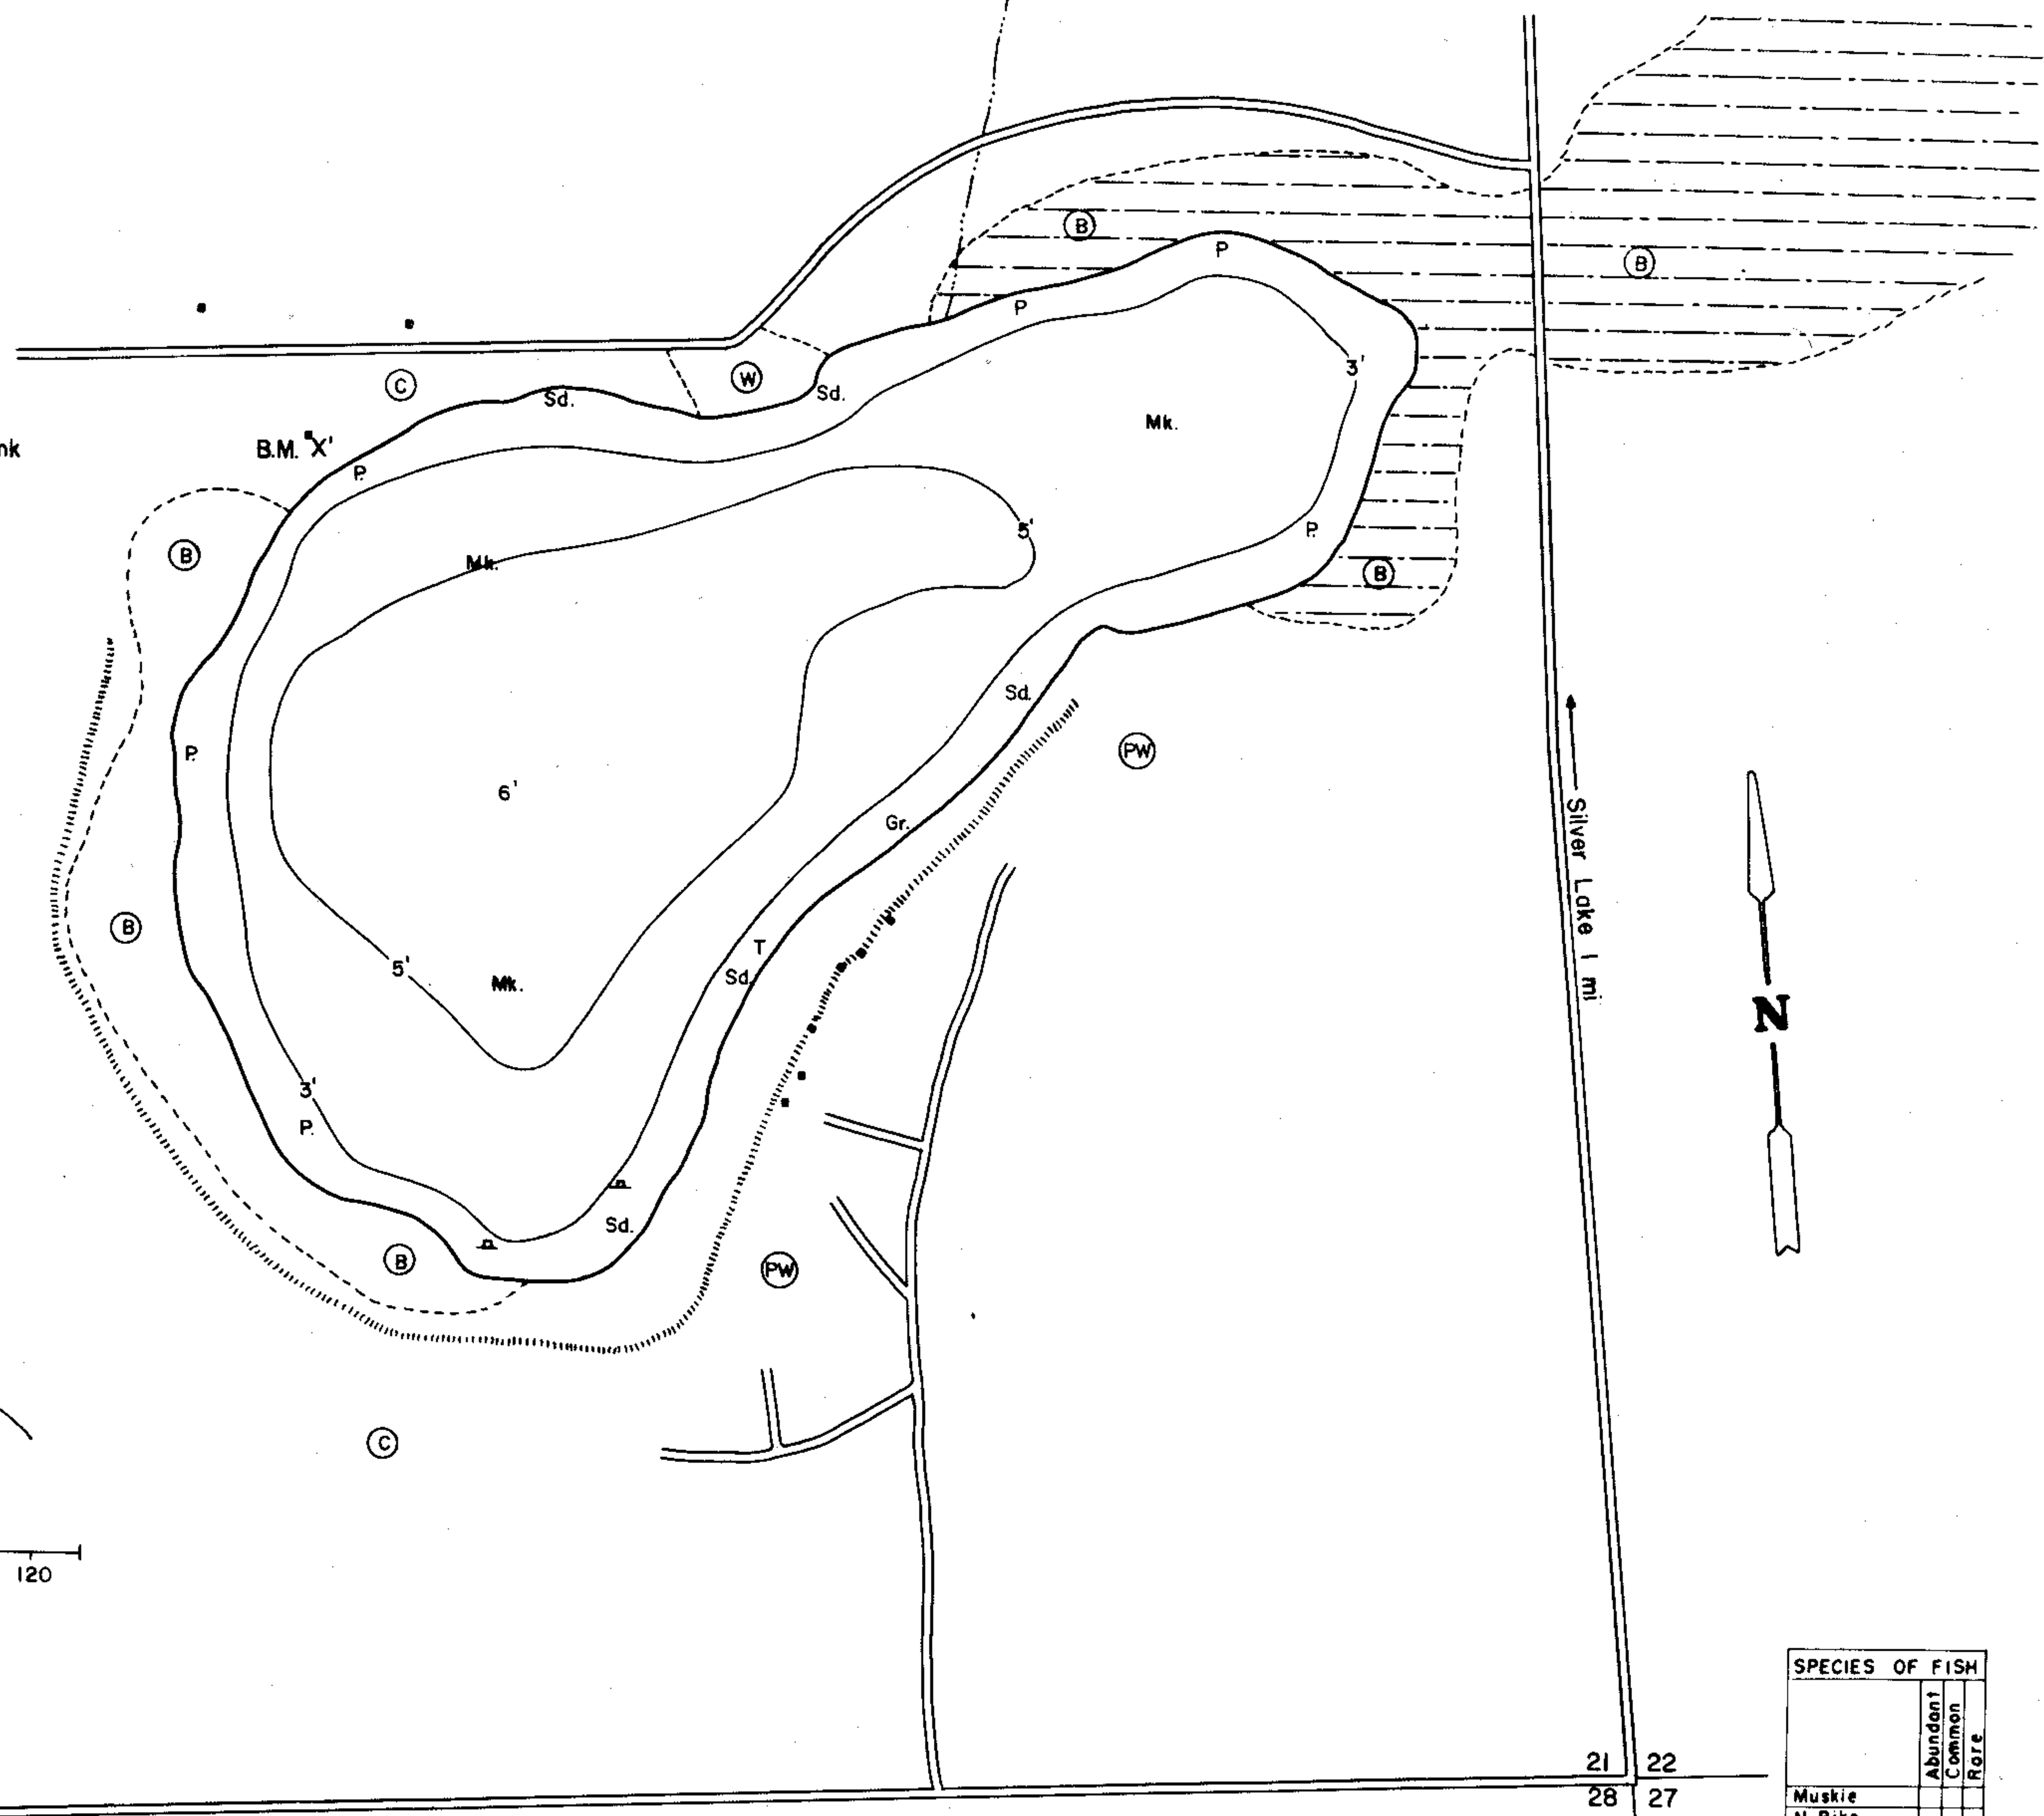
B.M. 'X' Square cut in top of stone stock tank  
 on S. side of barn on N. side of lake  
 Assumed elev. 100.0  
 Water elev. 91.0

WATER ELEV. 91.0

AREA 30.6 ACRES  
 UNDER 3FT. 23.4 %  
 OVER 20FT. 0 %  
 VOLUME 120.1 ACRE FT.  
 TOTAL ALK. 25 P.P.M.  
 SHORELINE .97 MILES  
 MAX. DEPTH 6 FEET
