EQUIPMENT ECHO SOUNDER MAPPED AUGUST 1964  
 MO. YR.  
 WATER ELEV. 93.00

Source: Wisconsin Department of Natural Resources 608-266-2621  
Round Lake – Waushara County, Wisconsin DNR Lake Map  
Date – Aug 1964 - Historical Lake Map - Not for Navigation  
A Public Document - Please Identify the Source when using it.

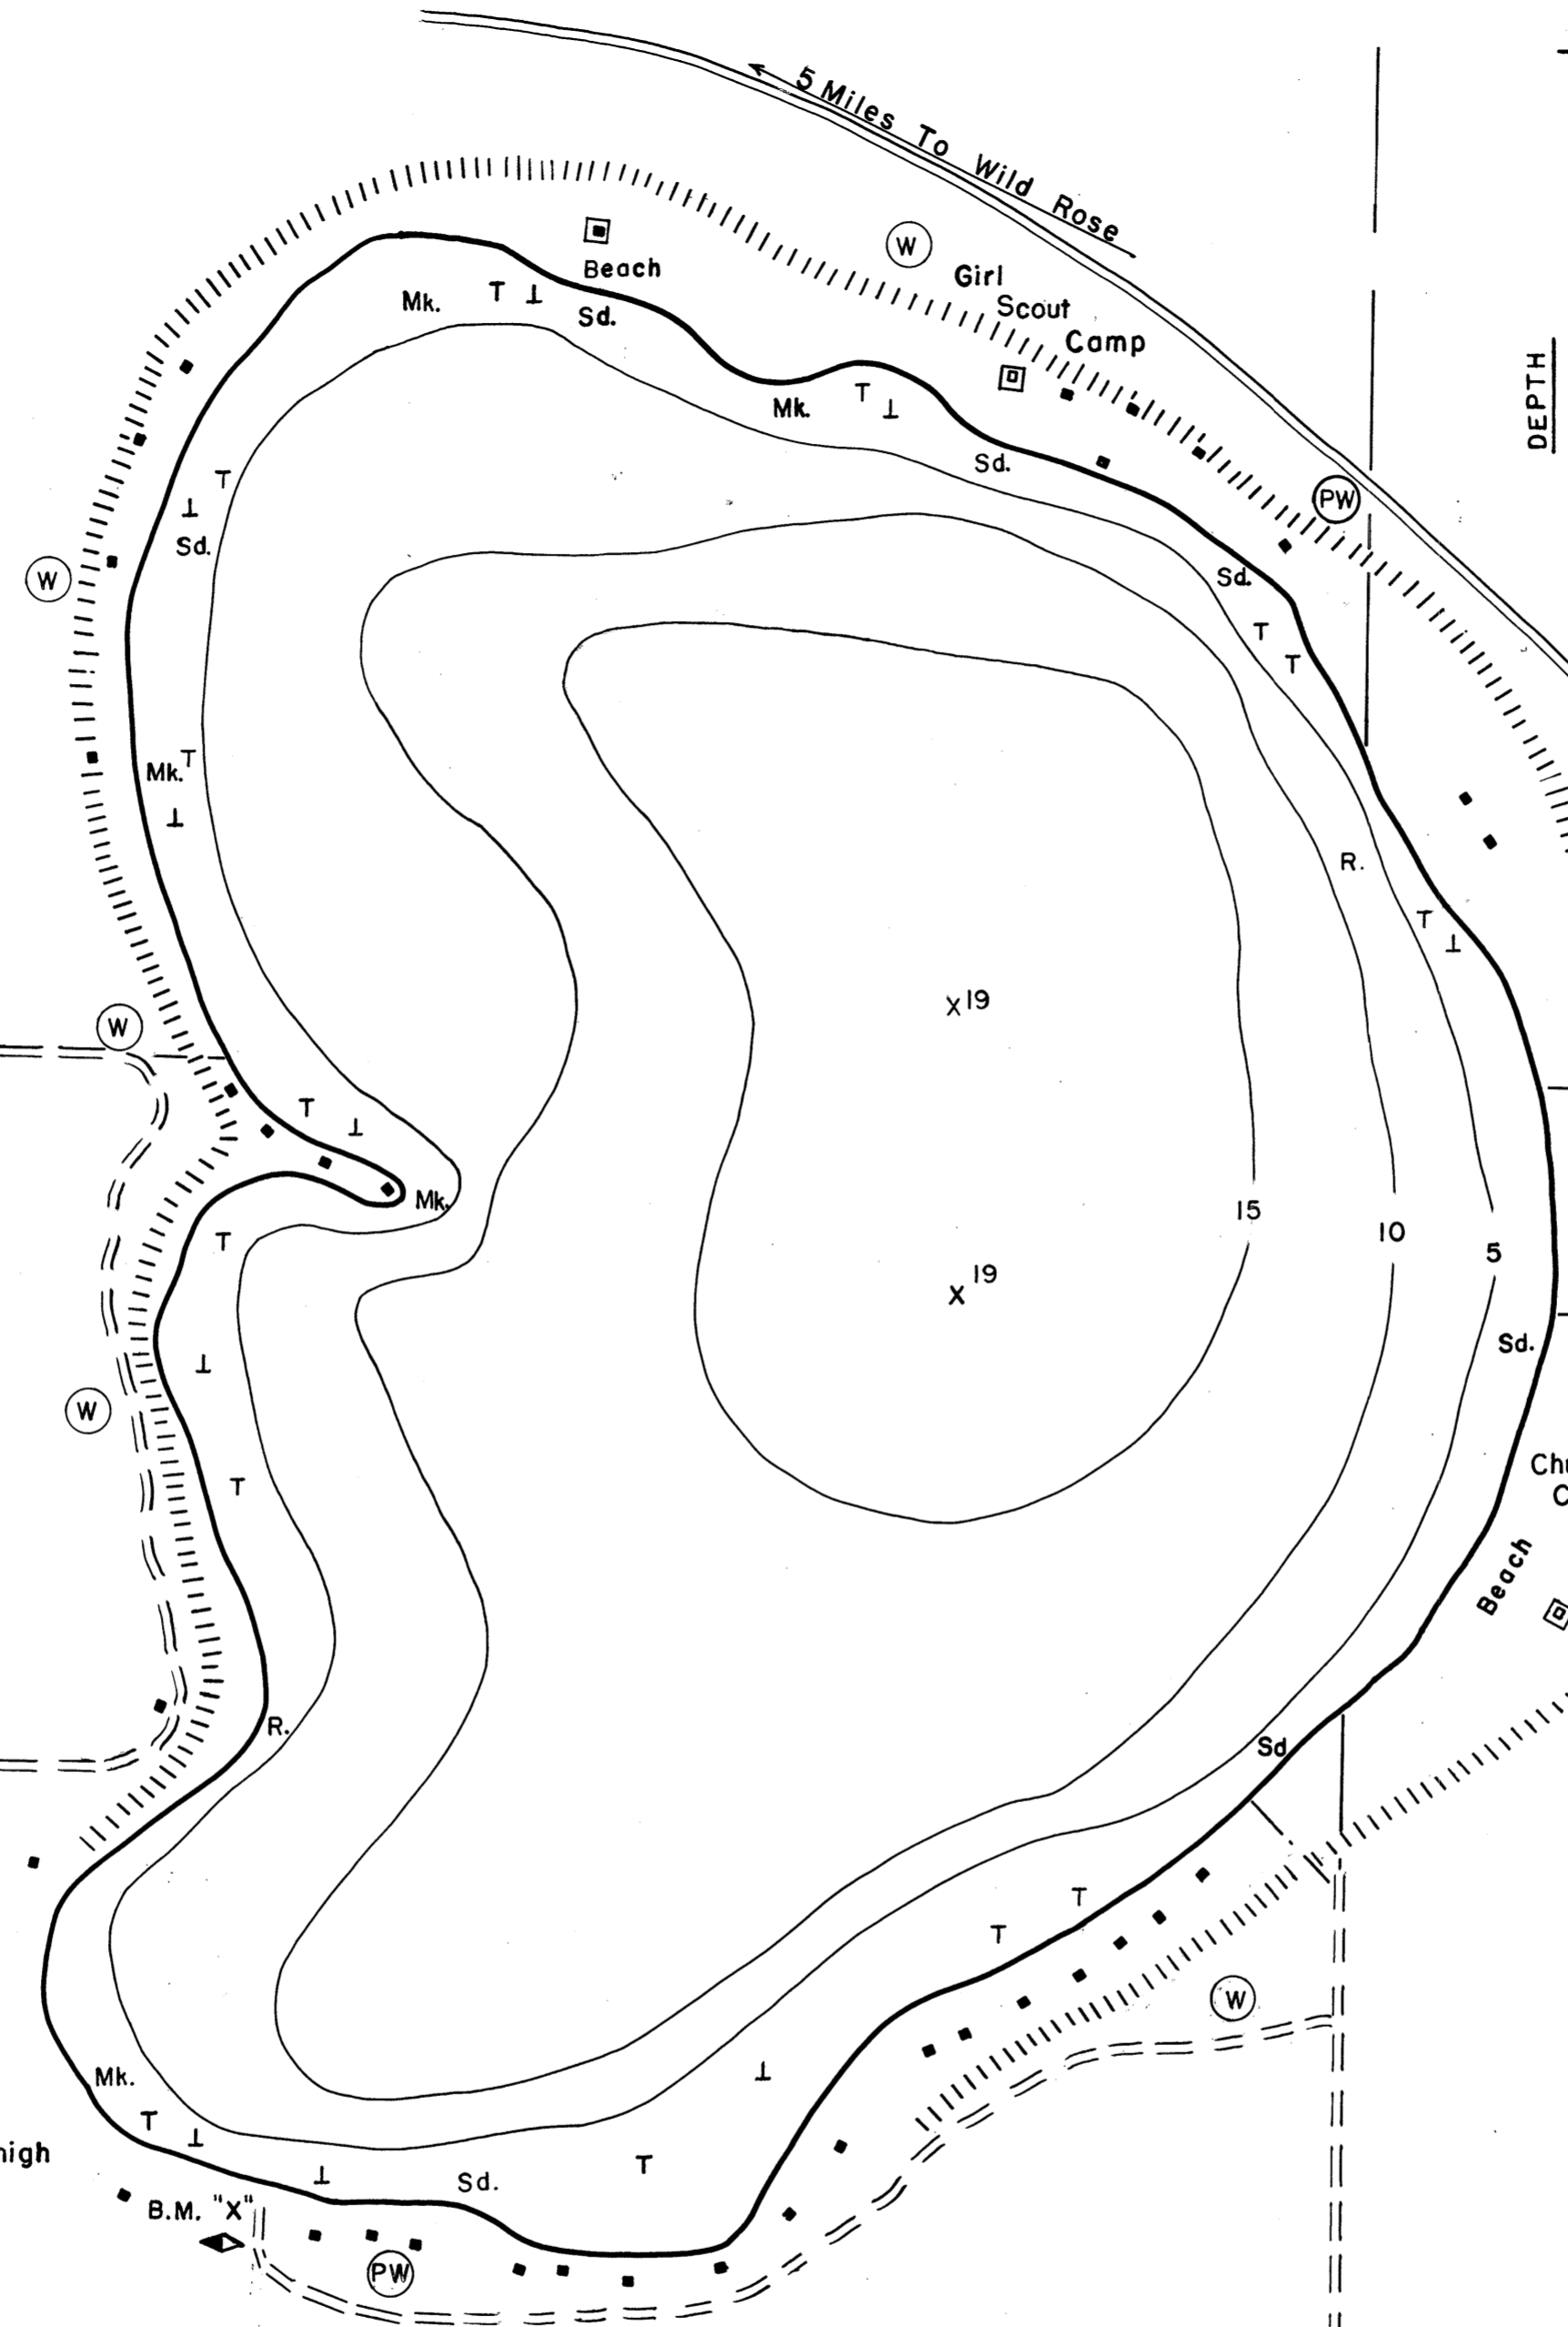
B.M. "X" Orange iron pipe at high water mark on West side of parking area.  
 Assumed Elev. 100.00  
 Water Elev. 93.00

AREA 63.4 ACRES  
 UNDER 3FT. 11 %  
 OVER 20FT. 0 %  
 VOLUME 629.5 ACRE FT.  
 TOTAL ALK. 68 P.P.M.  
 SHORELINE 1.3 MILES  
 MAX. DEPTH 19 FEET
