EQUIPMENT RECORDING SONAR MAPPED JULY 1970

Source: Wisconsin Department of Natural Resources 608-266-2621  
Wilson Lake – Shawano County, Wisconsin DNR Lake Map  
Date – Jul 1970 - Historical Lake Map - Not for Navigation  
A Public Document - Please Identify the Source when using it.

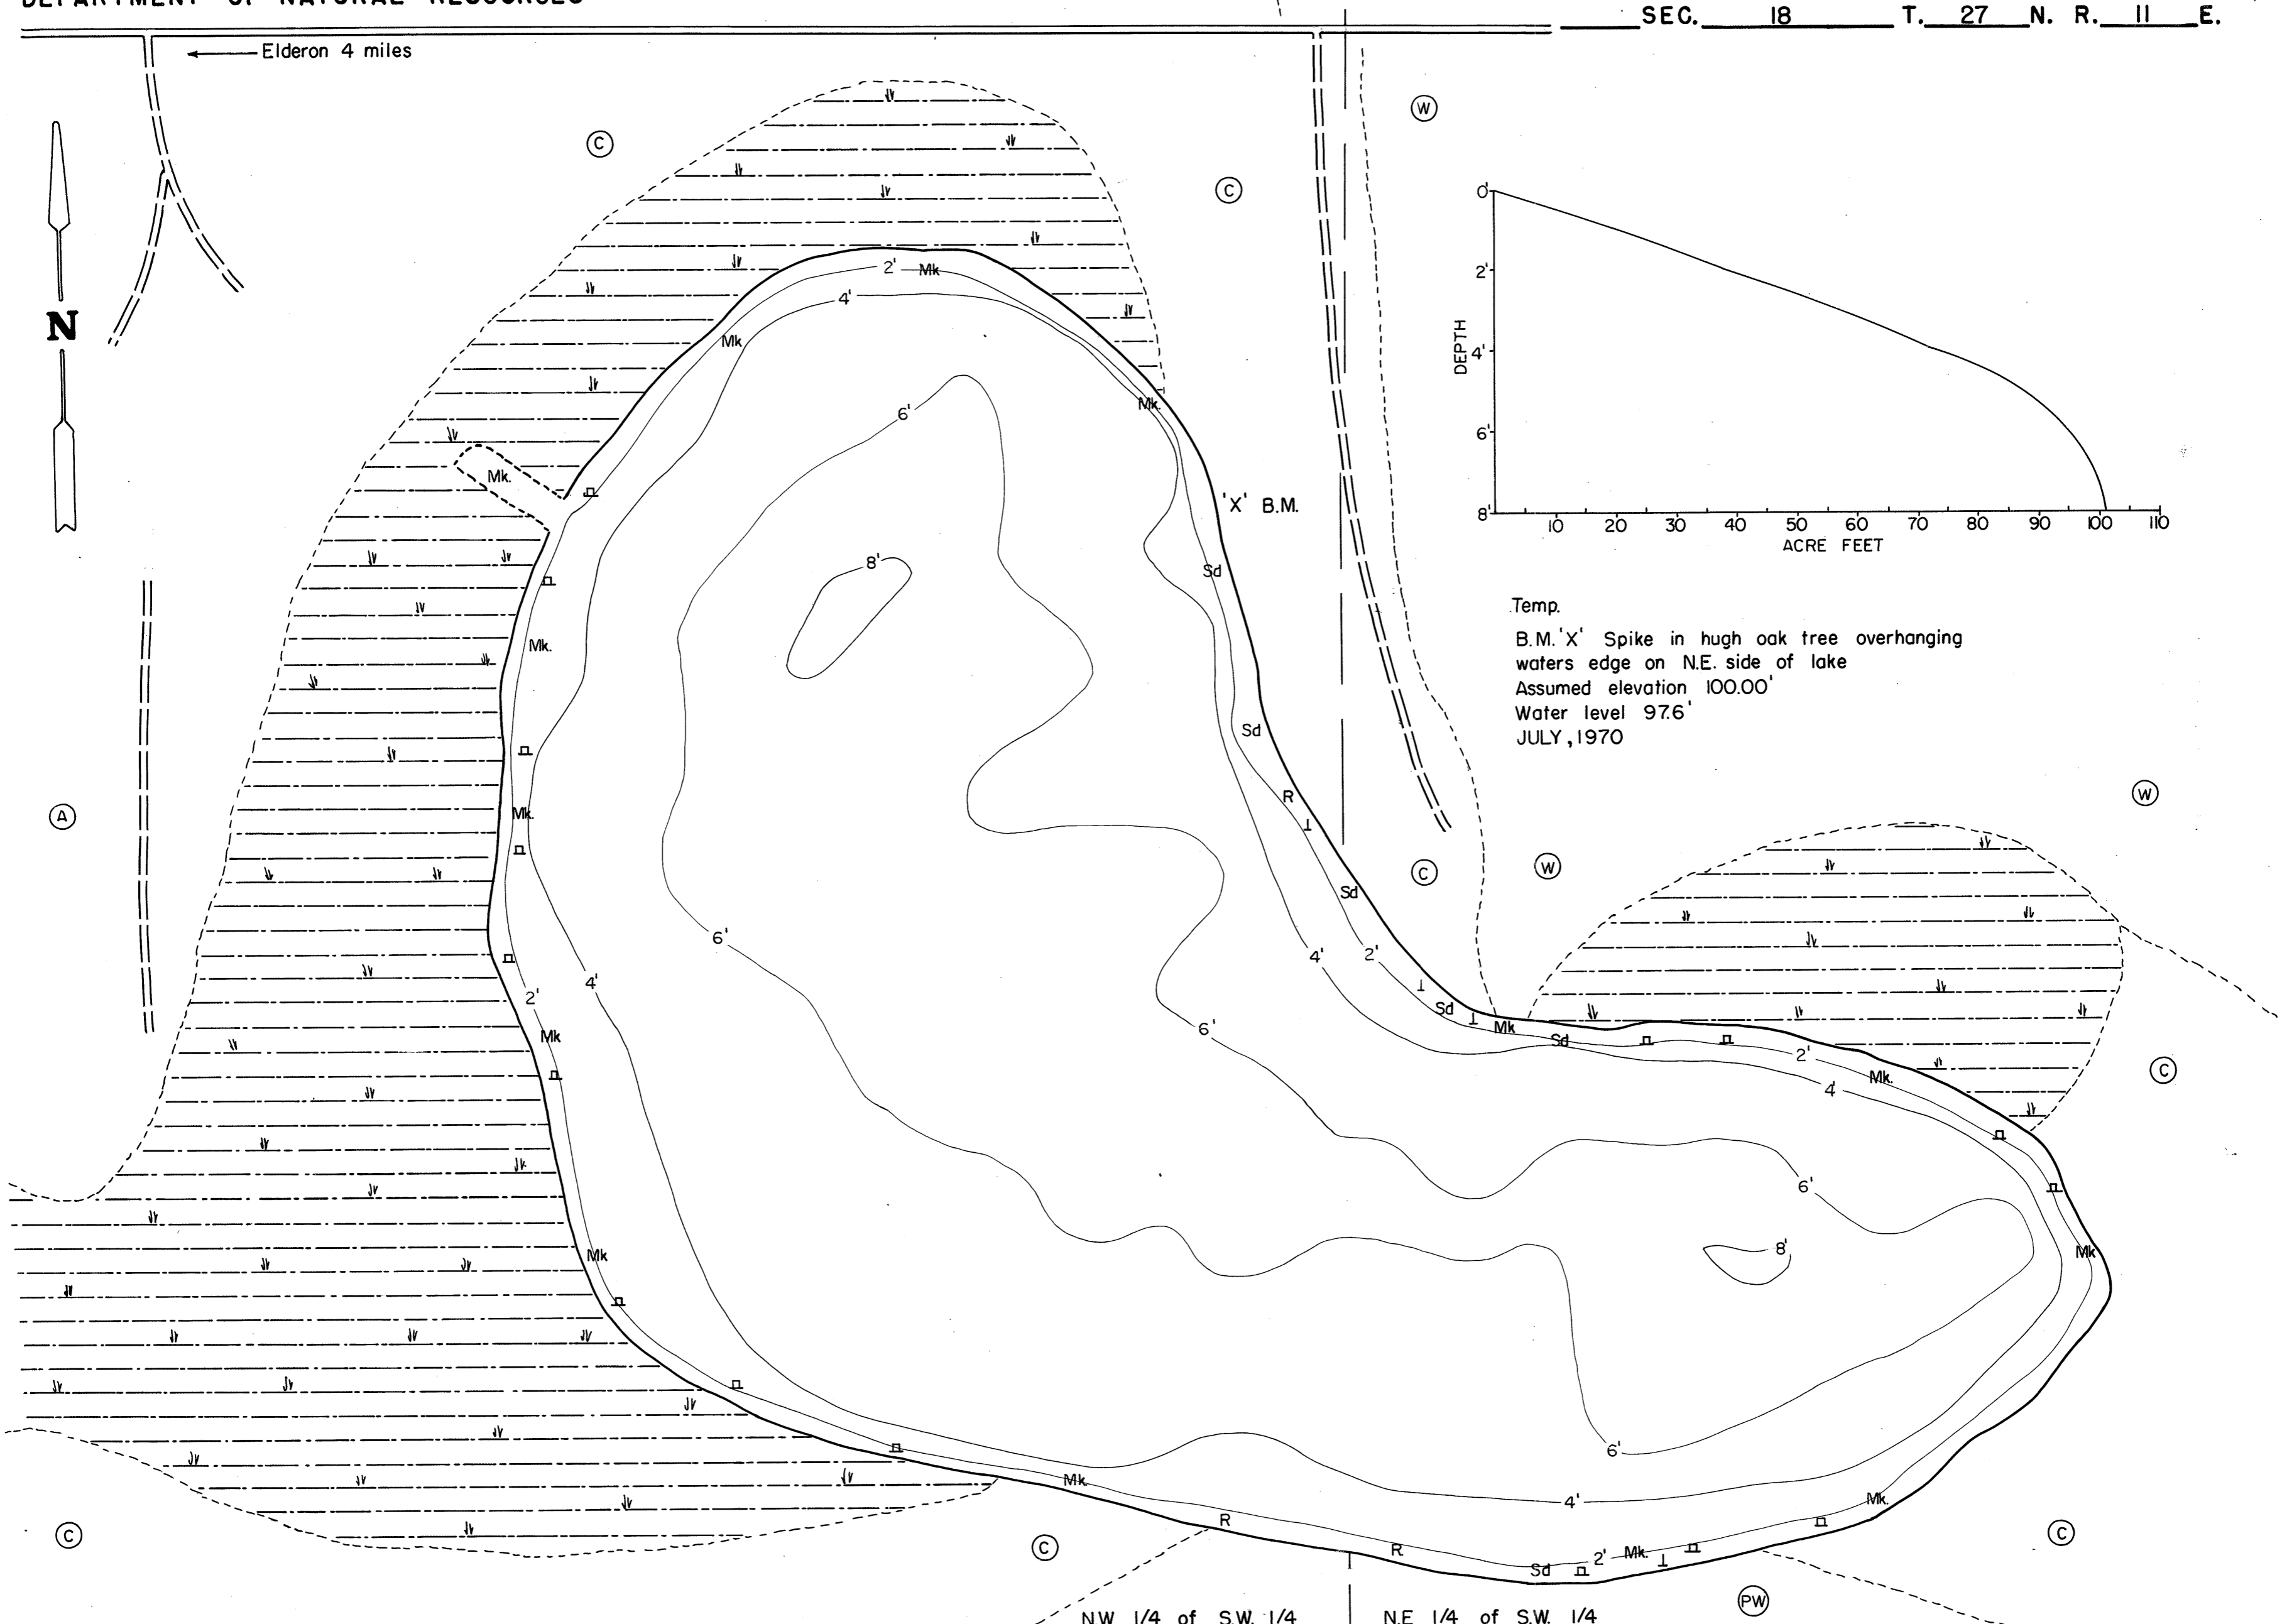
Temp.  
B.M. 'X' Spike in hugh oak tree overhanging  
waters edge on N.E. side of lake  
Assumed elevation 100.00'  
Water level 97.6'  
JULY, 1970

WATER AREA 19.6 ACRES  
UNDER 3 FT. 13.3 %  
OVER 20 FT. 0 %  
MAX. DEPTH 8 FEET.  
TOTAL ALK. 9 P.P.M.  
VOLUME 1011 ACRE FT.  
SHORELINE 0.77 MILES
