Source: Wisconsin Department of Natural Resources 608-266-2621  
Norwegian Lake – Waushara County, Wisconsin DNR Lake Map  
Date – Jul 1977 - Historical Lake Map - Not for Navigation  
A Public Document - Please Identify the Source when using it.

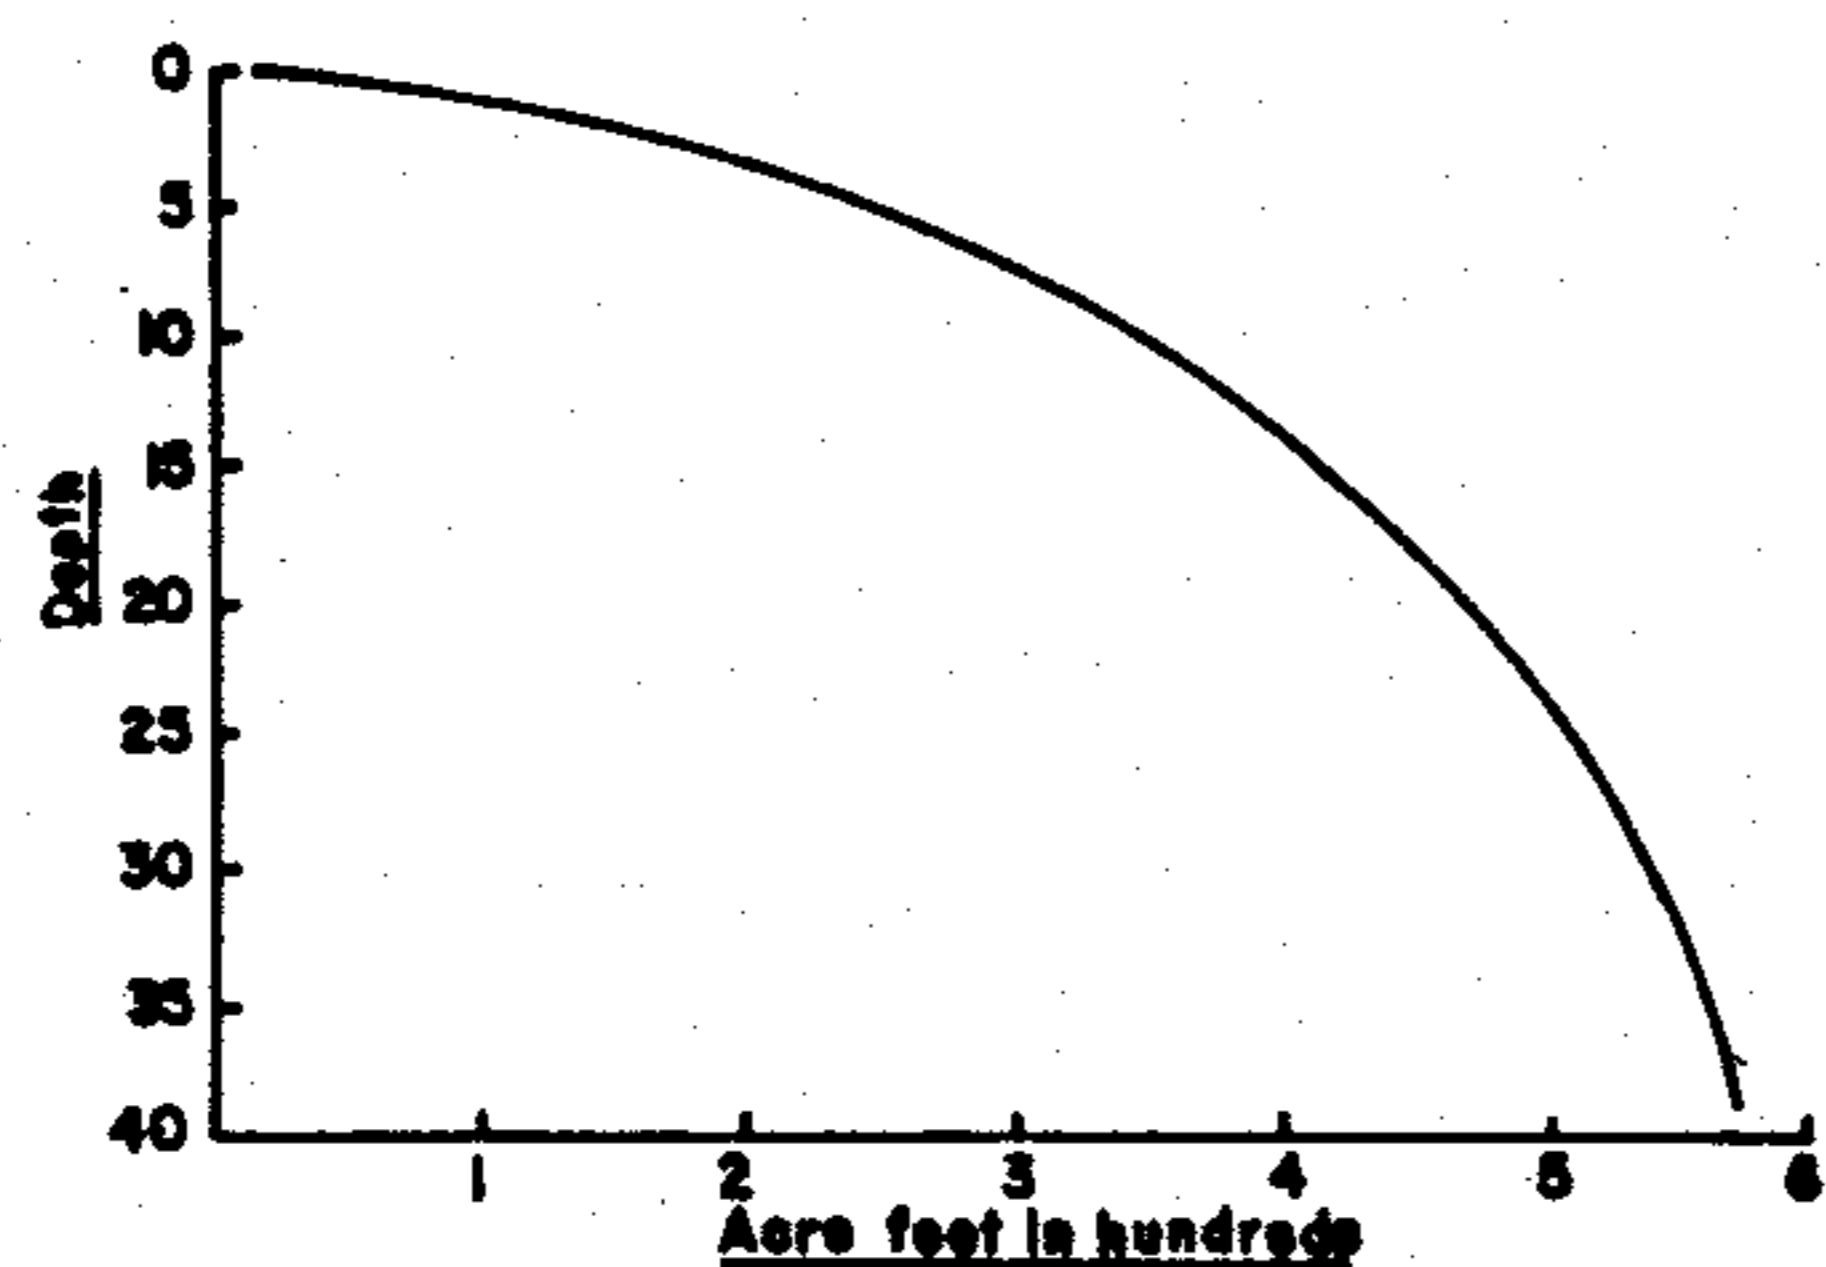
Bench mark (X) located top of wood fence post next to shoreline on south shore of lake, west of private boat landing.

Assume elevation 100.0'  
Water elevation 93.9'

EQUIPMENT RECORDING SONAR MAPPED JULY 1977  
MONTH YEAR  
LAKE BOTTOM SYMBOLS

WATER AREA 62.13 ACRES  
 UNDER 5 FT. 66 %  
 OVER 20 FT. 16 %  
 MAX. DEPTH 43 FEET.  
 TOTAL ALK. 120 P.P.M.  
 VOLUME 570.78 ACRE FT.  
 MAIN SHORELINE 2.9 MI.  
 ISLAND SHORELINE        MI.
