B O W L E R

Source: Wisconsin Department of Natural Resources 608-266-2621  
Bowler Pond – Shawano County, Wisconsin DNR Lake Map  
Date – Aug 1972 - Historical Lake Map - Not for Navigation  
A Public Document - Please Identify the Source when using it.

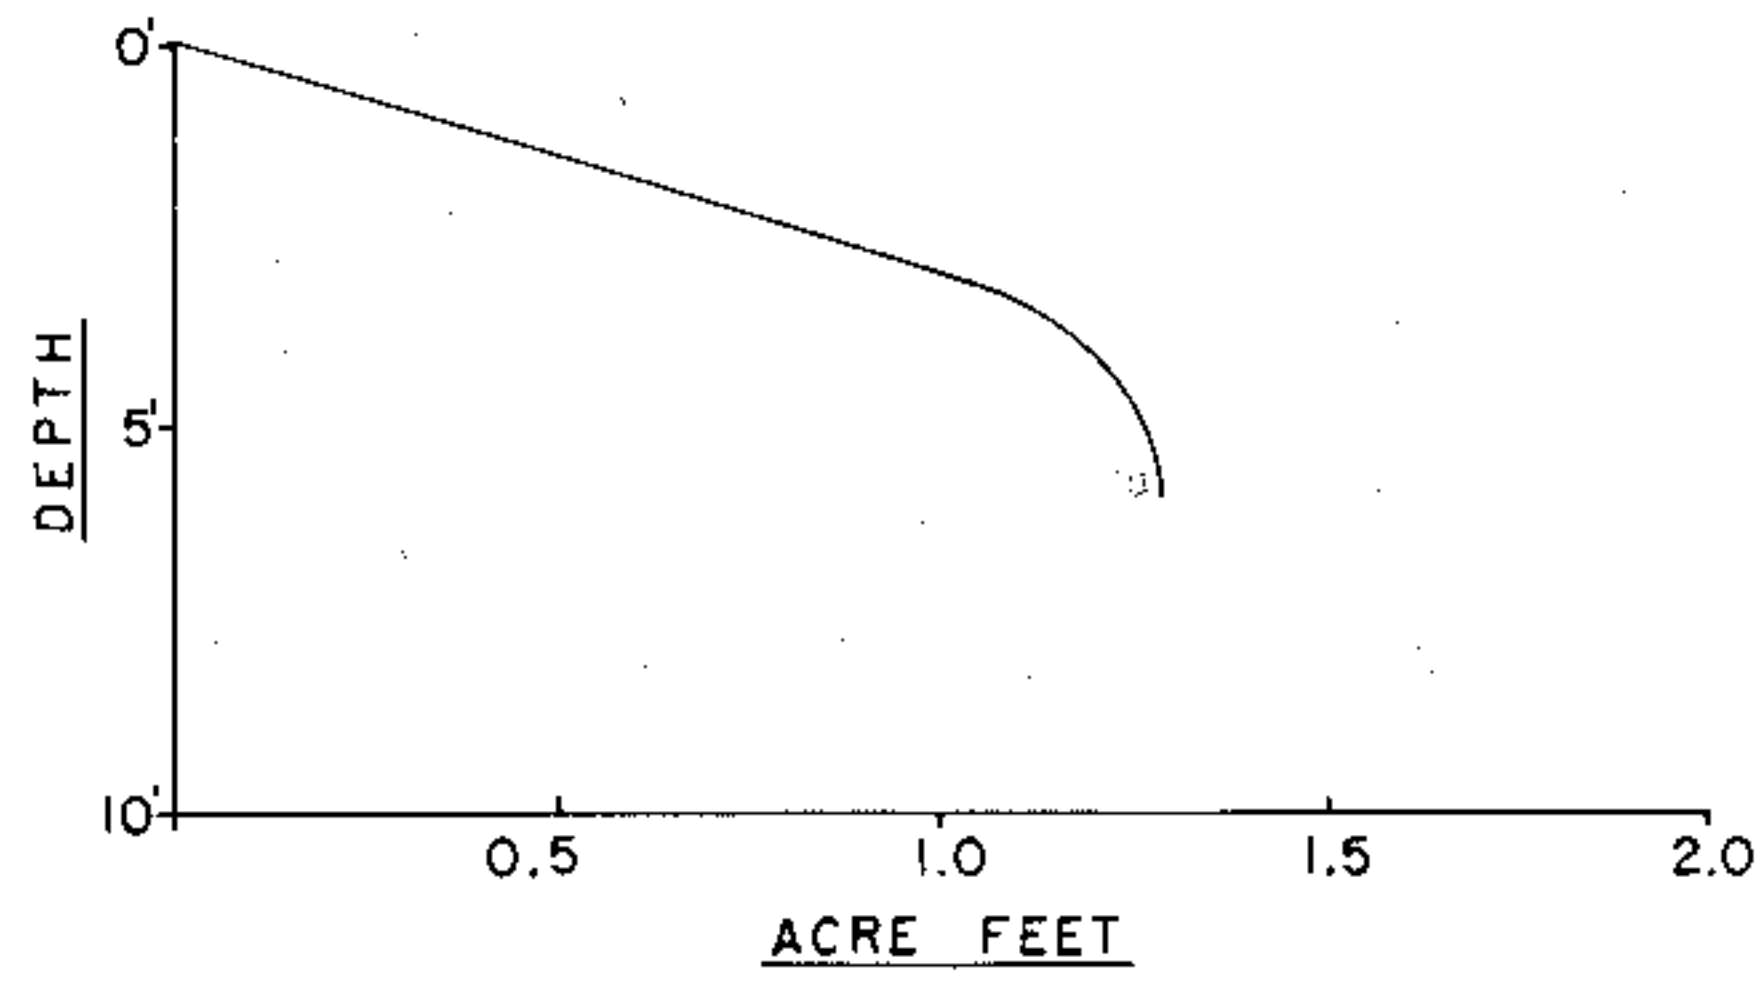
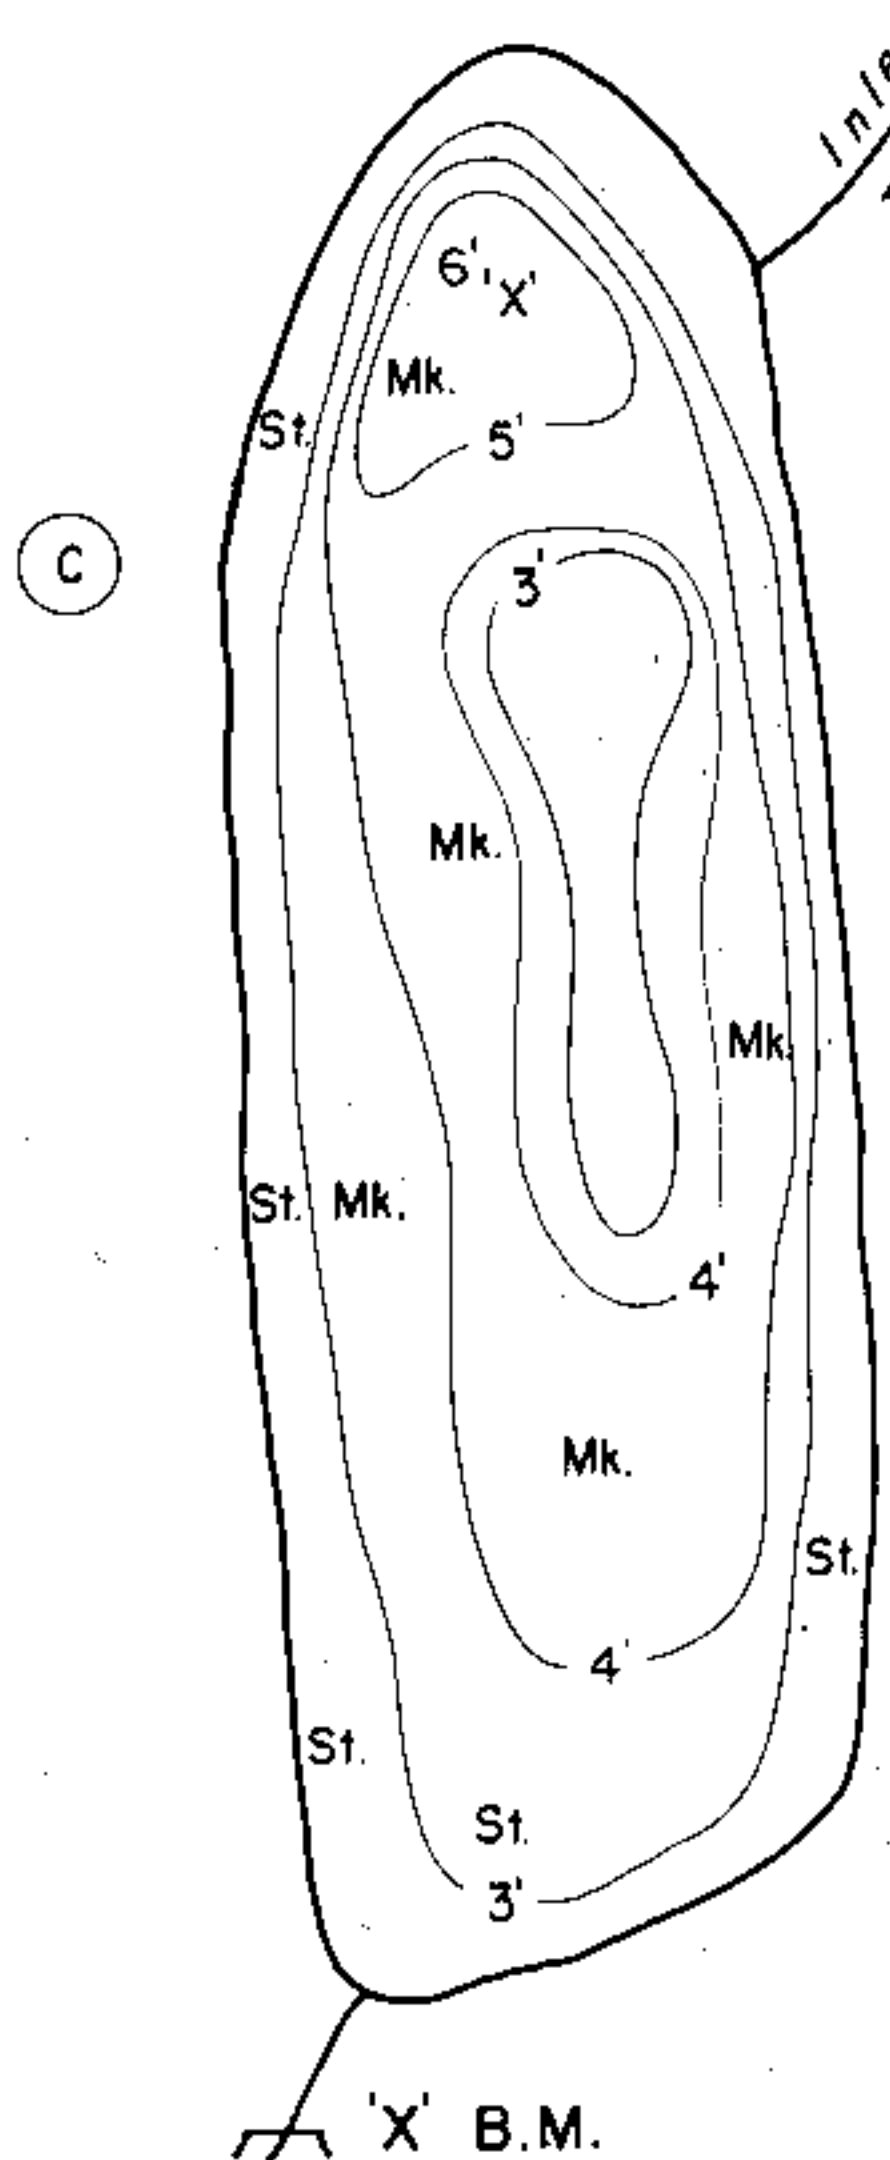
B.M. 'X' 2" Square "□" located on  
East wing of spillway on south end of pond.  
Assumed elevation = 100.00'  
Water level = 98.45'

WATER AREA 0.4 ACRES  
 UNDER 3 FT. 34 %  
 OVER 20 FT. 0 %  
 MAX. DEPTH 6 FEET.  
 TOTAL ALK. 154 P.P.M.  
 VOLUME 1.281 ACRE FT.  
 SHORELINE 0.114 MILES
