LAKE SURVEY MAP

Lower & Upper TIGERTON POND
LAKE

SHAWANO
COUNTY

SEC. 9, 16, 17 T. 26 N. R. 12 E.

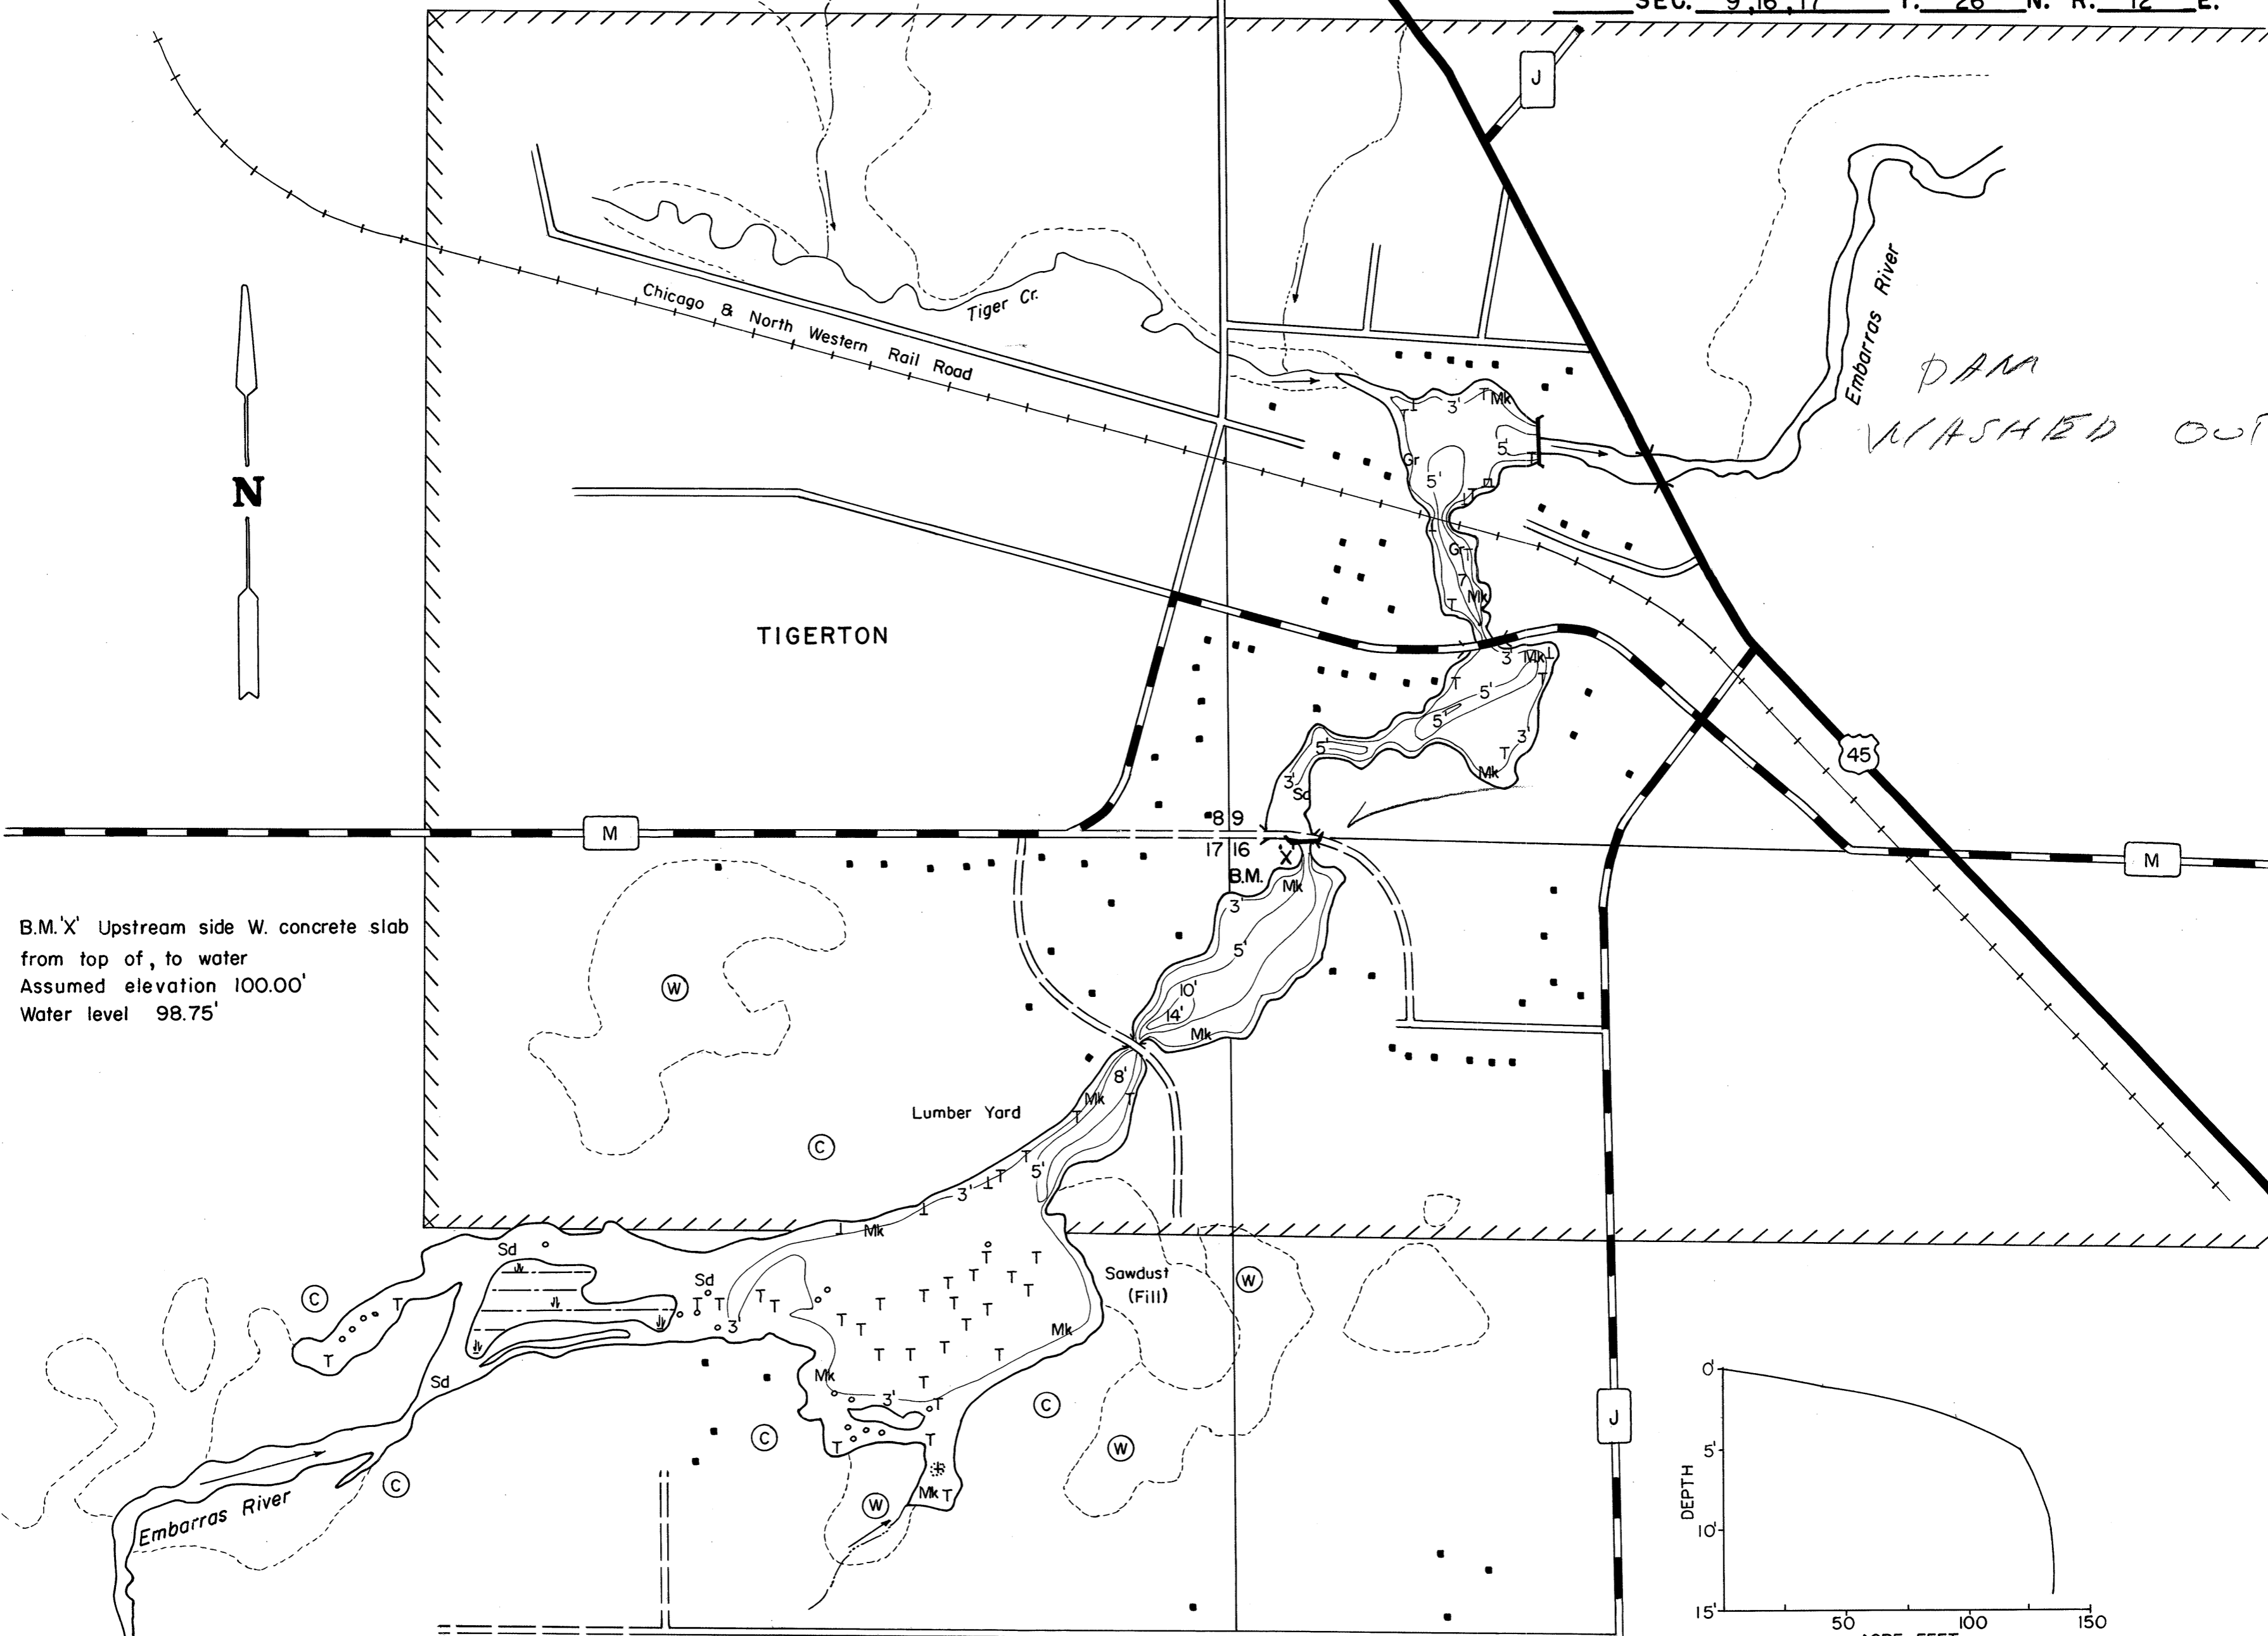
B.M. 'X' Upstream side W. concrete slab
from top of, to water
Assumed elevation 100.00'
Water level 98.75'

EQUIPMENT RECORDING SONAR MAPPED JULY 1969

WATER AREA 40.9 ACRES
 UNDER 3 FT. 43.3 %
 OVER 20 FT. 0 %
 MAX. DEPTH 14 FEET.
 TOTAL ALK. 180 P.P.M.
 VOLUME 134.8 ACRE FT.
 SHORELINE 3.04 MILES
