Source: Wisconsin Department of Natural Resources 608-266-2621
Berry Lake – Menominee County, Wisconsin DNR Lake Map
Date – Aug 1972 - Historical Lake Map - Not for Navigation
A Public Document - Please Identify the Source when using it.

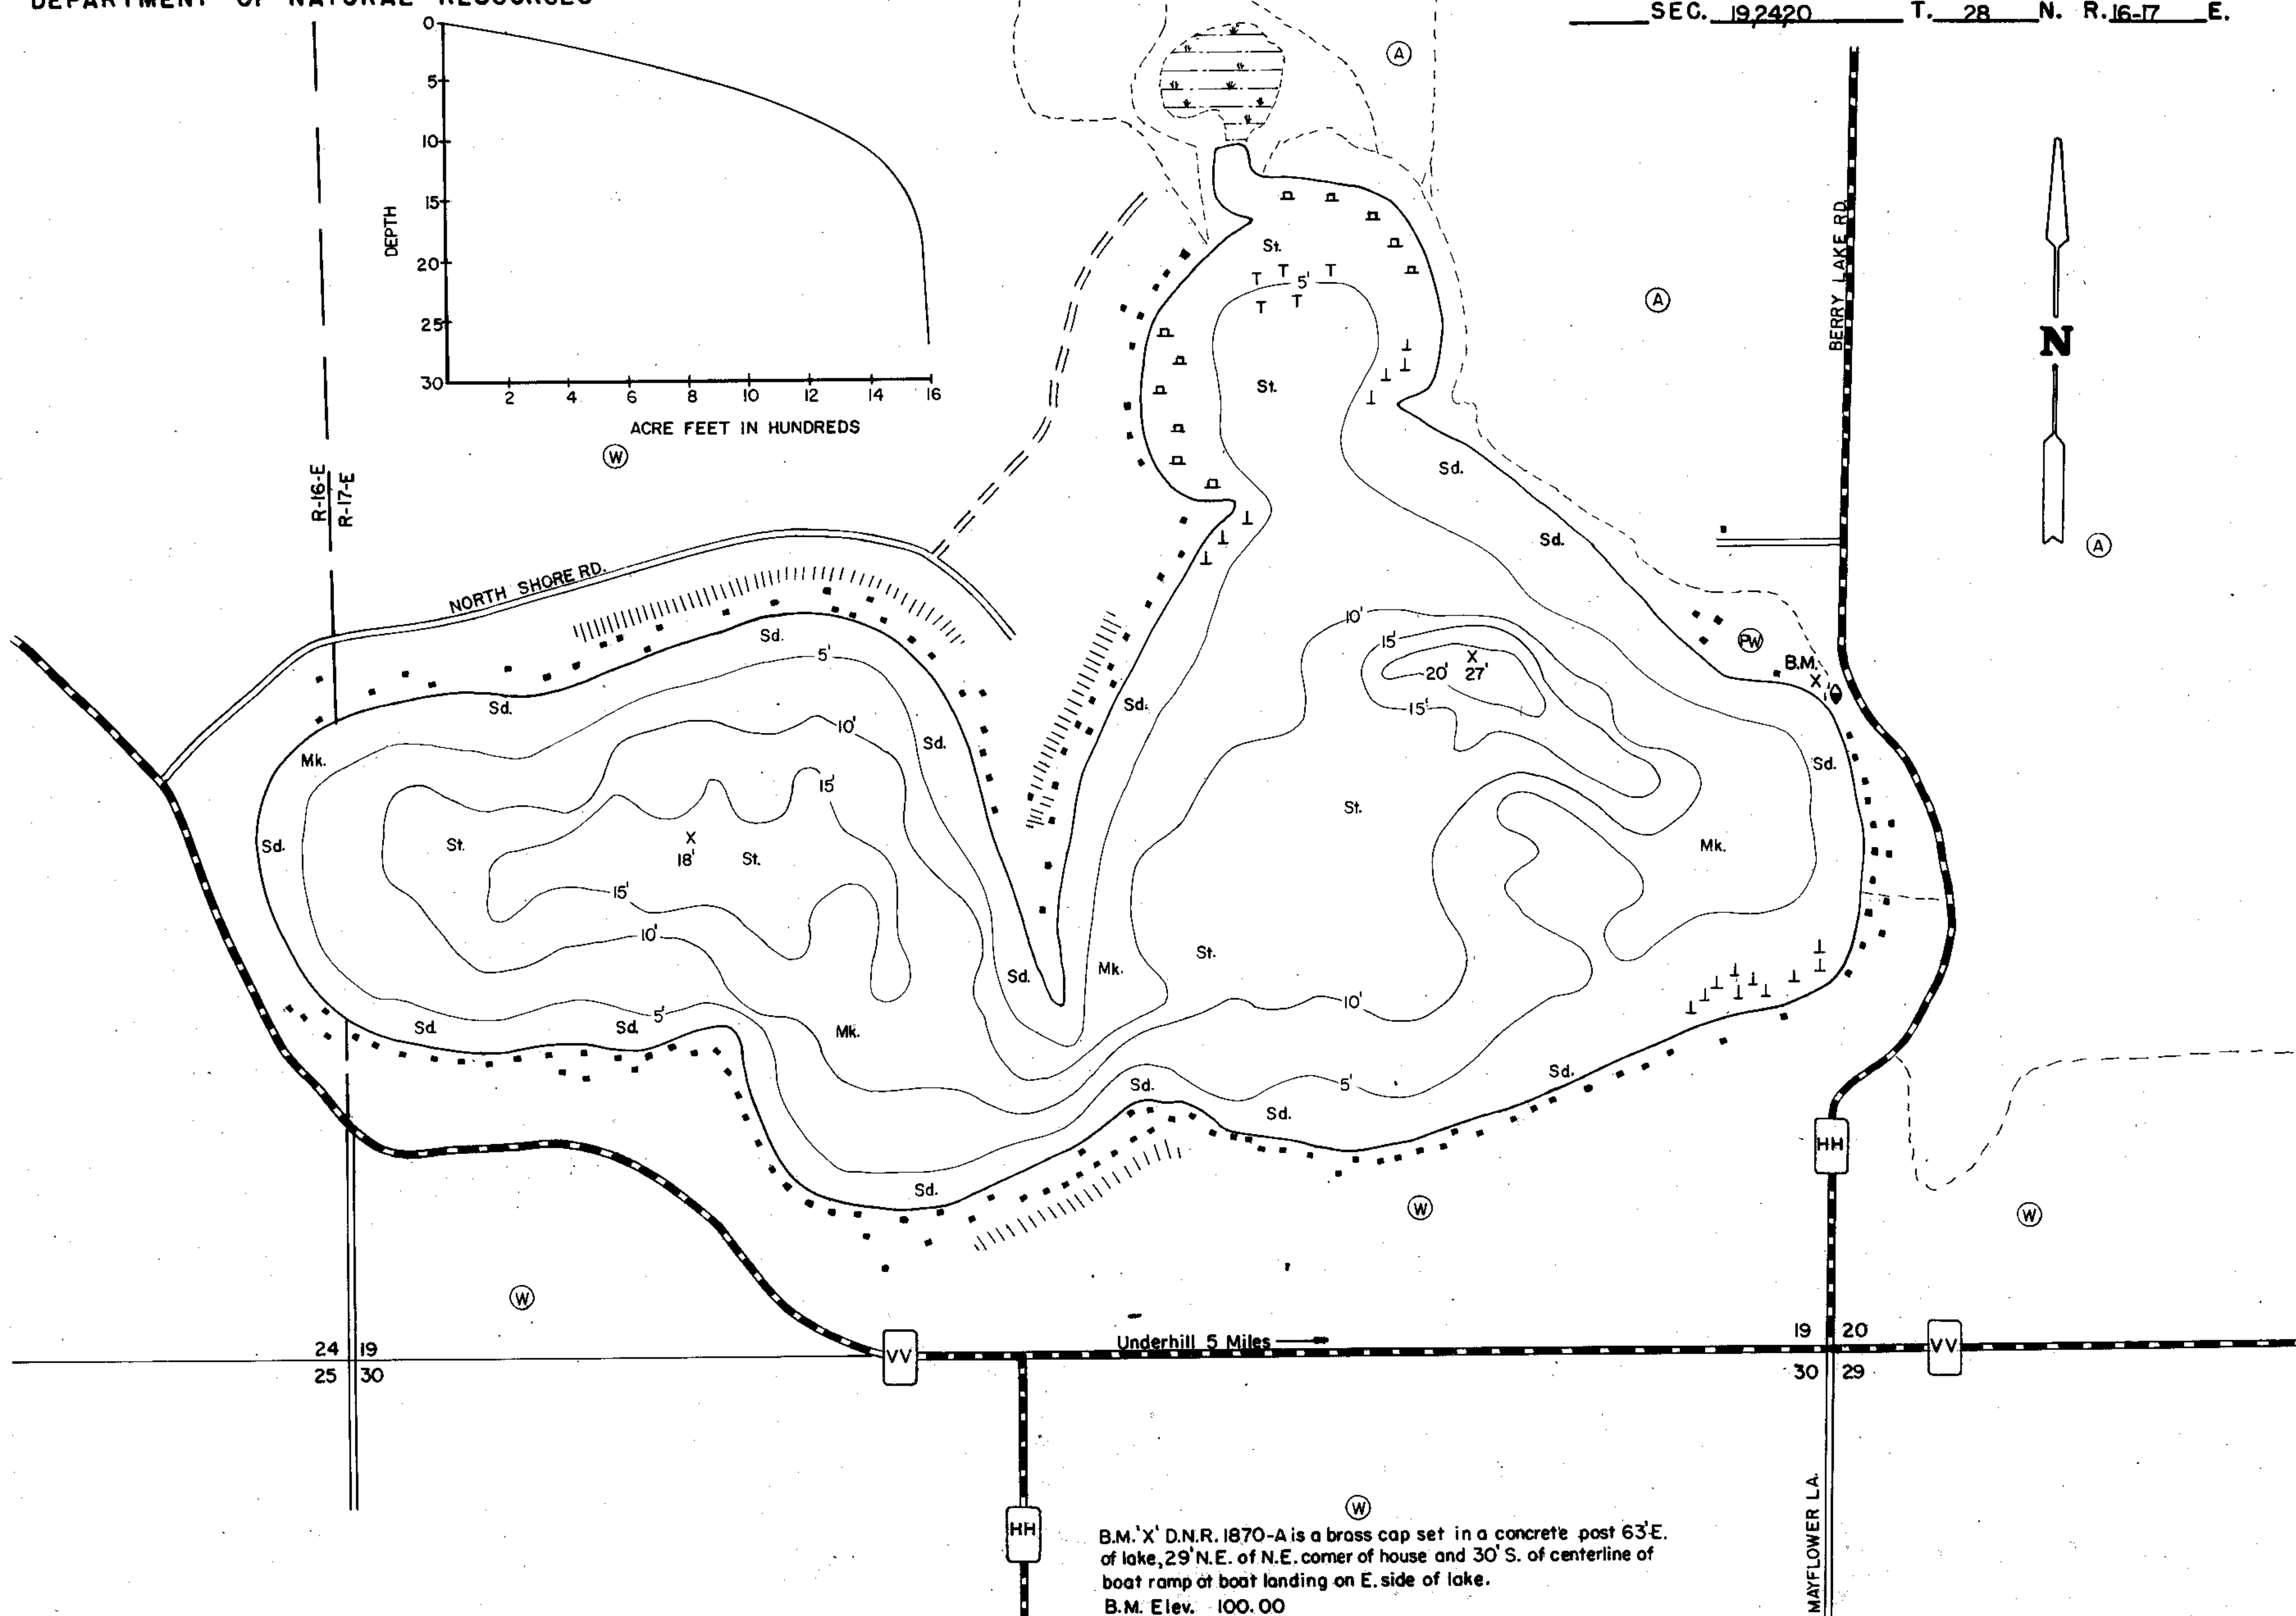
B.M. 'X' D.N.R. 1870-A is a brass cap set in a concrete post 63' E. of lake, 29' N.E. of N.E. corner of house and 30' S. of centerline of boat ramp at boat landing on E. side of lake.
B.M. Elev. 100.00
Water Elev. 94.71
As of 8-28-73

EQUIPMENT		RECORDING SONAR	MAPPED	AUGUST	1972
TOPOGRAPHIC SYMBOLS		LAKE BOTTOM SYMBOLS			
(B) Brush		Steep slope	P. Peat	B Boulders	
(PW) Partially wooded		Indefinite shoreline	Mk. Muck	Stumps & Snags	
(W) Wooded		Marsh	C. Clay	Rock danger to navigation	
(C) Cleared		Spring	M. Marl	T Submergent vegetation	
(P) Pastured		Intermittent stream	Sd. Sand	Emergent vegetation	
(A) Agricultural		Permanent inlet	St. Silt	Floating vegetation	
B.M. Bench Mark		Permanent outlet	Gr. Gravel	Brush shelters	
■ Dwelling		Dam	R. Rubble		
□ Resort		D.N.R. State owned land	Br. Bedrock		
□ Camp

WATER AREA 200.5 ACRES
 UNDER 3 FT. 12 %
 OVER 20 FT. 75 %
 MAX. DEPTH 27 FEET.
 TOTAL ALK. 77 P.P.M.
 VOLUME 1592.9 ACRE FT.
 SHORELINE 3.33 MILES
