Source: Wisconsin Department of Natural Resources 608-266-2621  
Grand Rapids Flowage – Marinette County, Wisconsin DNR Lake Map  
Date – August 1974 - Historical Lake Map - Not for Navigation  
A Public Document - Please Identify the Source when using it.

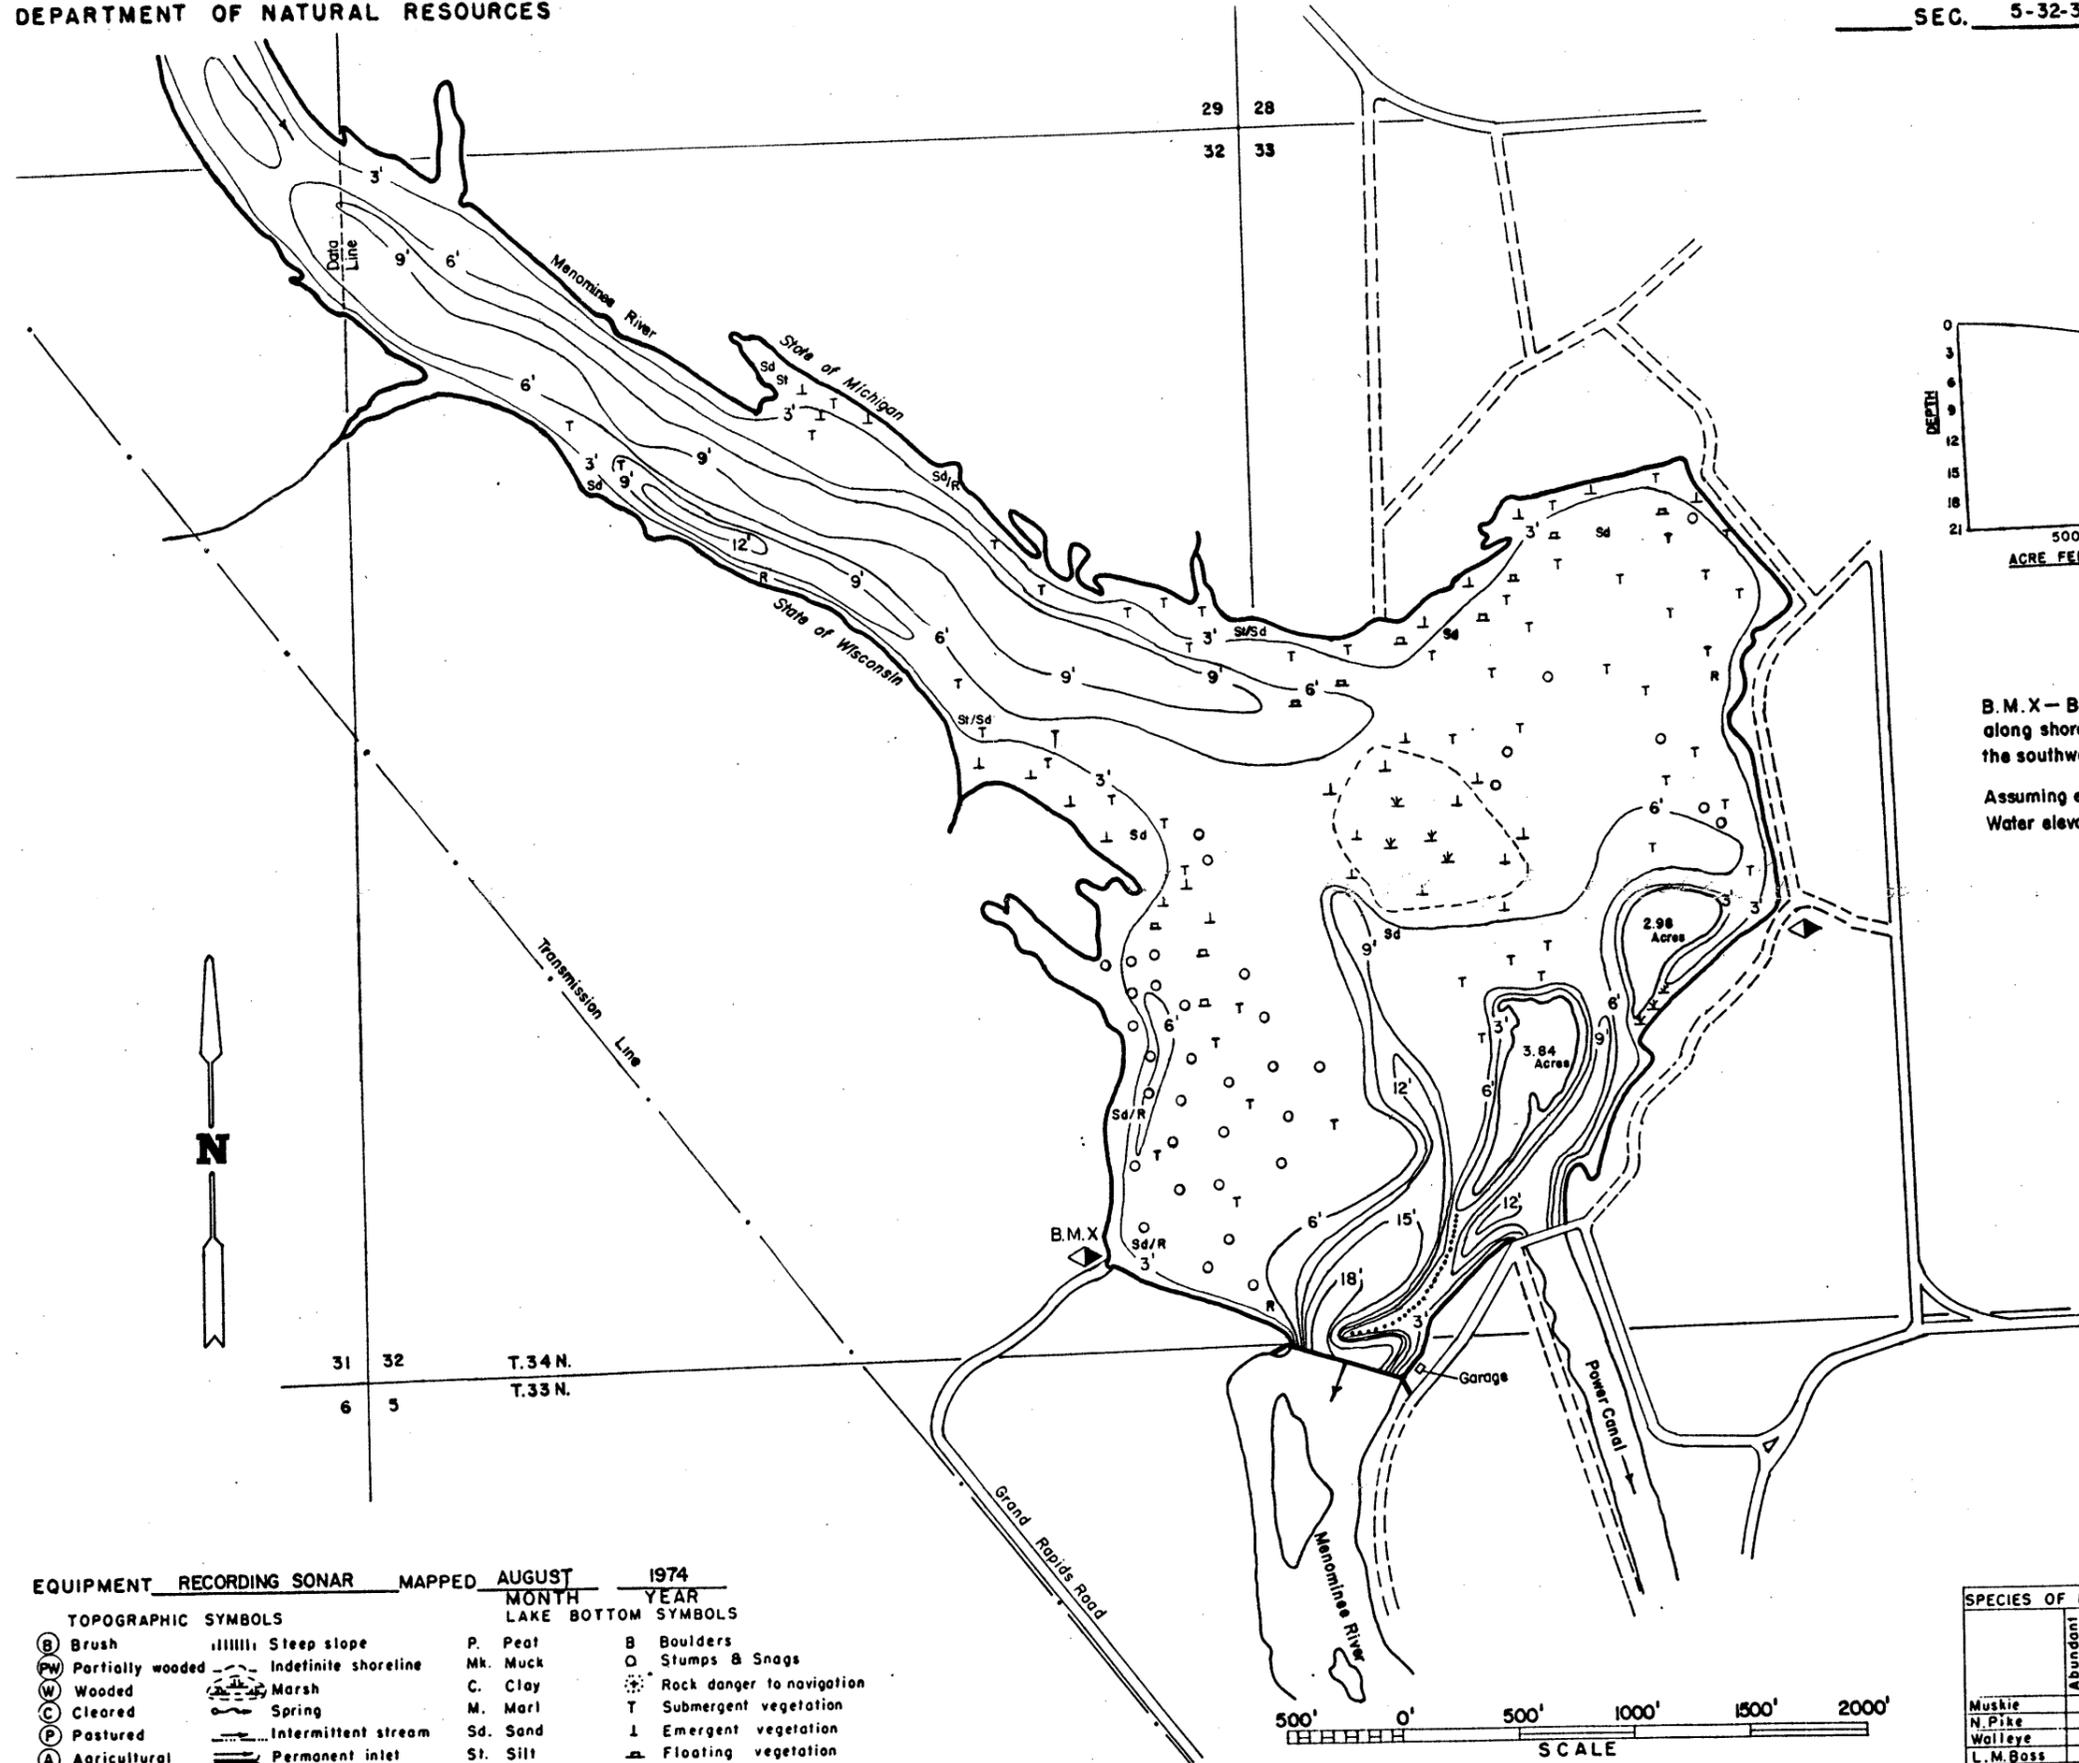
B.M. X - Benchmark located on top of post along shoreline on north side of access on the southwest corner of the flowage.

Assuming elevation at 100.0'  
Water elevation 97.3' - (8-24-74)

WATER AREA 258.9 ACRES  
 UNDER 3 FT. 16 %  
 OVER 20 FT. 0 %  
 MAX. DEPTH 21 FEET.  
 TOTAL ALK. 91 P.P.M.  
 VOLUME 142.54 ACRE FT.  
 MAIN SHORELINE 5.6 MI.  
 ISLAND SHORELINE .76 MI.
