WATER AREA 109.00 ACRES
 UNDER 3 FT. 3.11 %
 OVER 20 FT. 13.5 %
 MAX. DEPTH 22 FEET.
 TOTAL ALK. 15 P.P.M.
 VOLUME 1624.87 ACRE FT.
 MAIN SHORELINE 1.63 MI.
 ISLAND SHORELINE 0 MI.

Source: Wisconsin Department of Natural Resources 608-266-2621
Crystal Lake - Lincoln County, Wisconsin DNR Lake Map
Date – Jul. 1974 - Historical Lake Map - Not for Navigation
A Public Document - Please Identify the Source when using it.

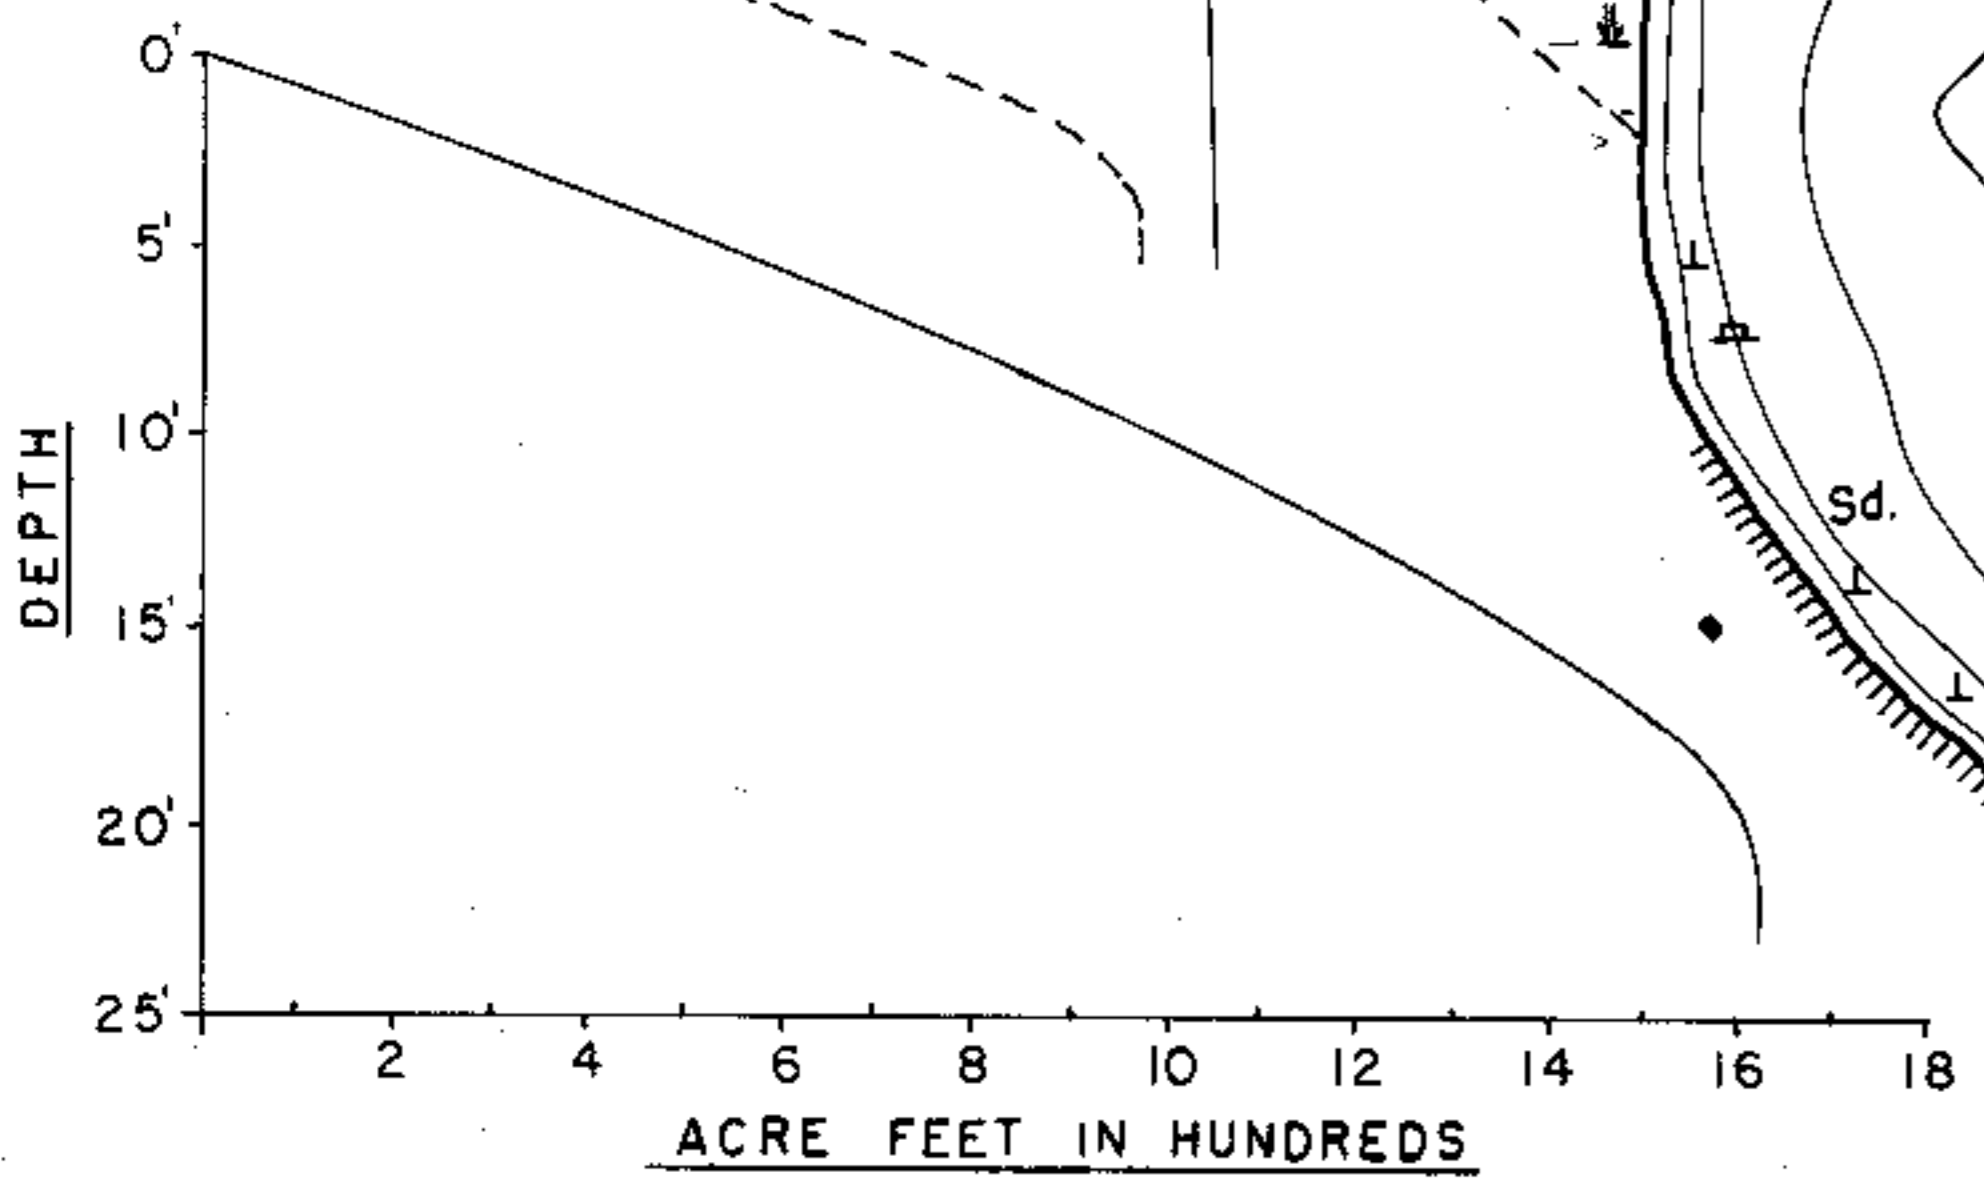
EQUIPMENT RECORDING SONAR MAPPED JULY 1974
MONTH YEAR
