EQUIPMENT RECORDING SONAR MAPPED JULY 1969

Source: Wisconsin Department of Natural Resources 608-266-2621
Indian Lake – Langlade and Oneida Counties, Wisconsin DNR Lake Map
Date Jul 1969 - Historical Lake Map - Not for Navigation
A Public Document - Please Identify the Source when using it.

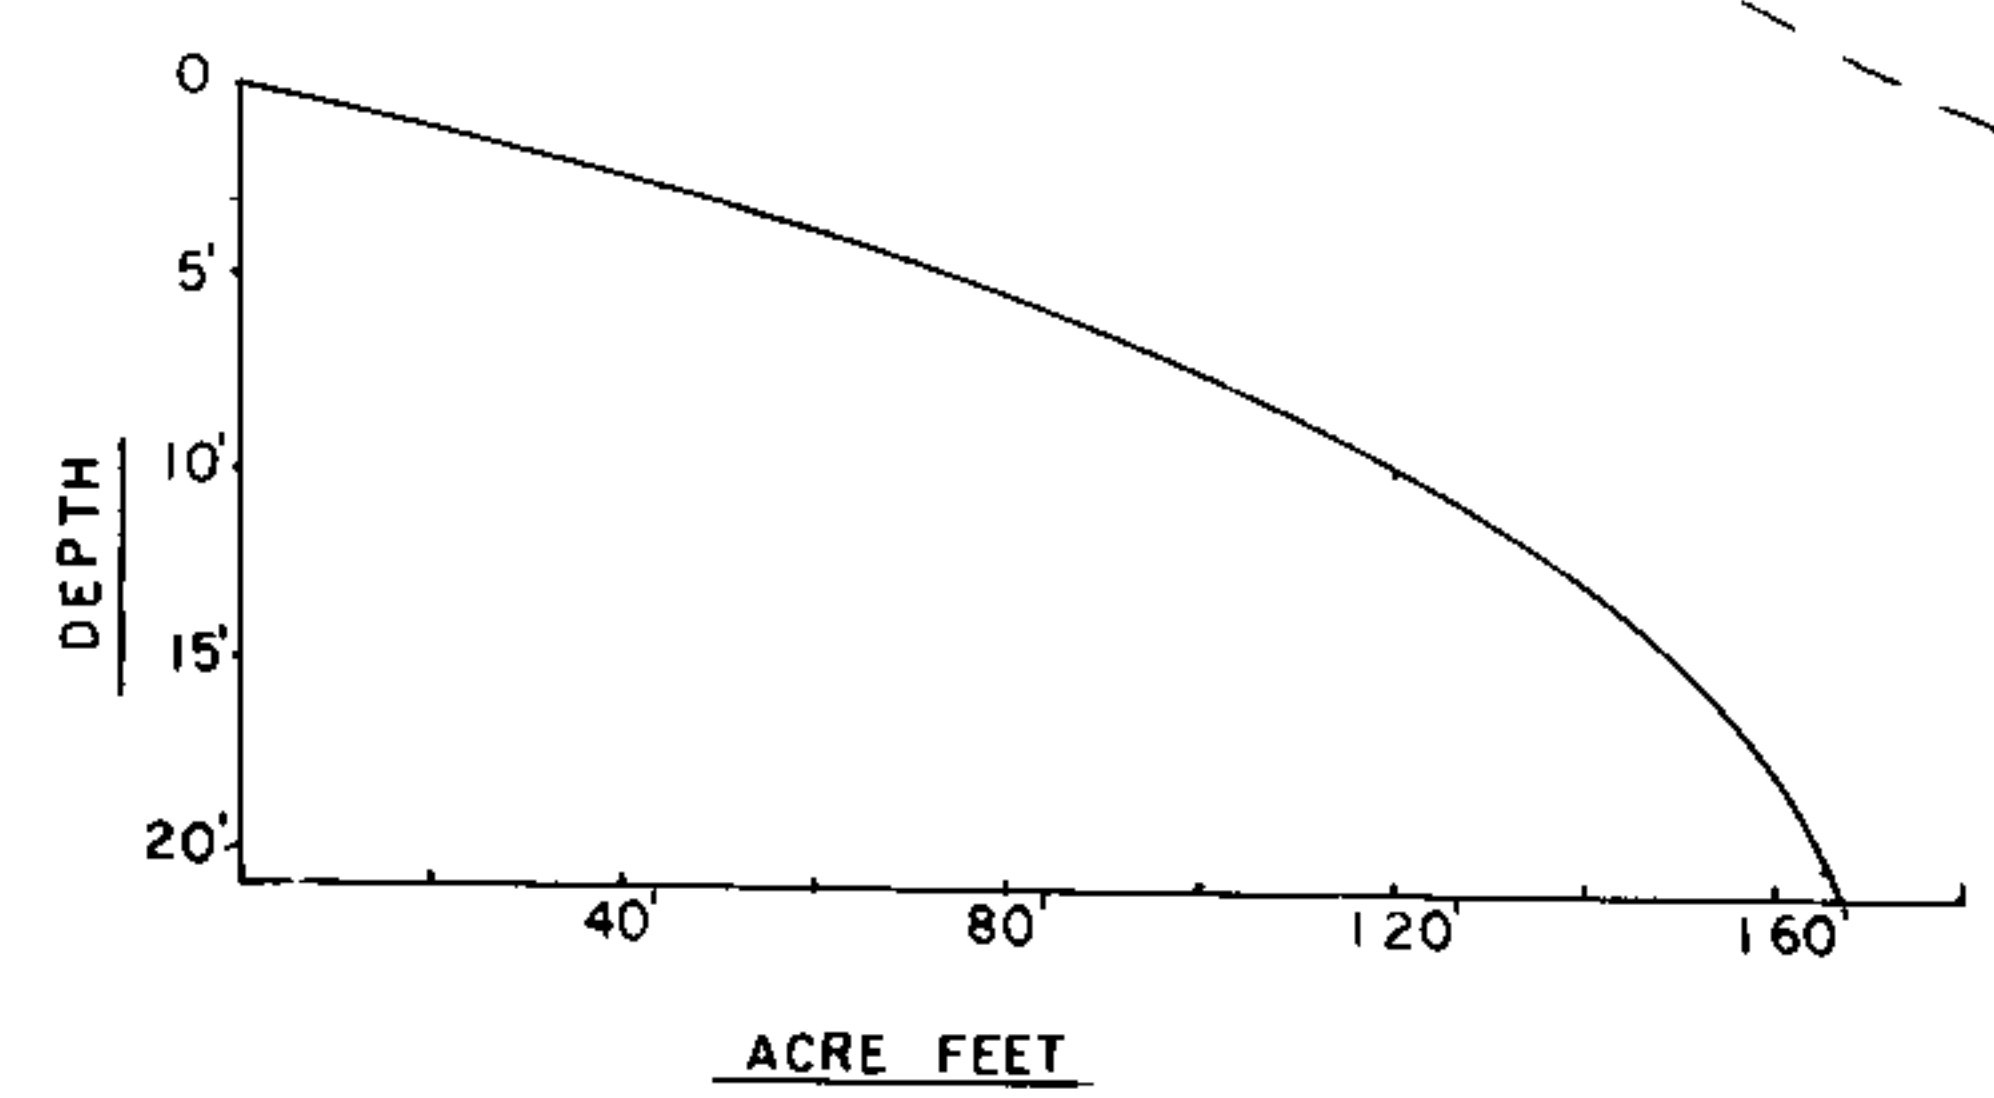
Temporary
B.M. - Top of lakeside at culvert by intermittent
outlet at S.E. corner of lake
Elevation = 100.00'
Water elevation = 97.10' taken July 1969

WATER AREA 15.2 ACRES
UNDER 3 FT. 11.7 %
OVER 20 FT. 0 %
MAX. DEPTH 21 FEET.
TOTAL ALK. 8 P.P.M.
VOLUME 165.46 ACRE FT.
SHORELINE .73 MILES
