Source: Wisconsin Department of Natural Resources 608-266-2621
Stormy Lake - Vilas County, Wisconsin DNR Lake Map
Date – Jul 1966 - Historical Lake Map - Not for Navigation
A Public Document - Please Identify the Source when using it.

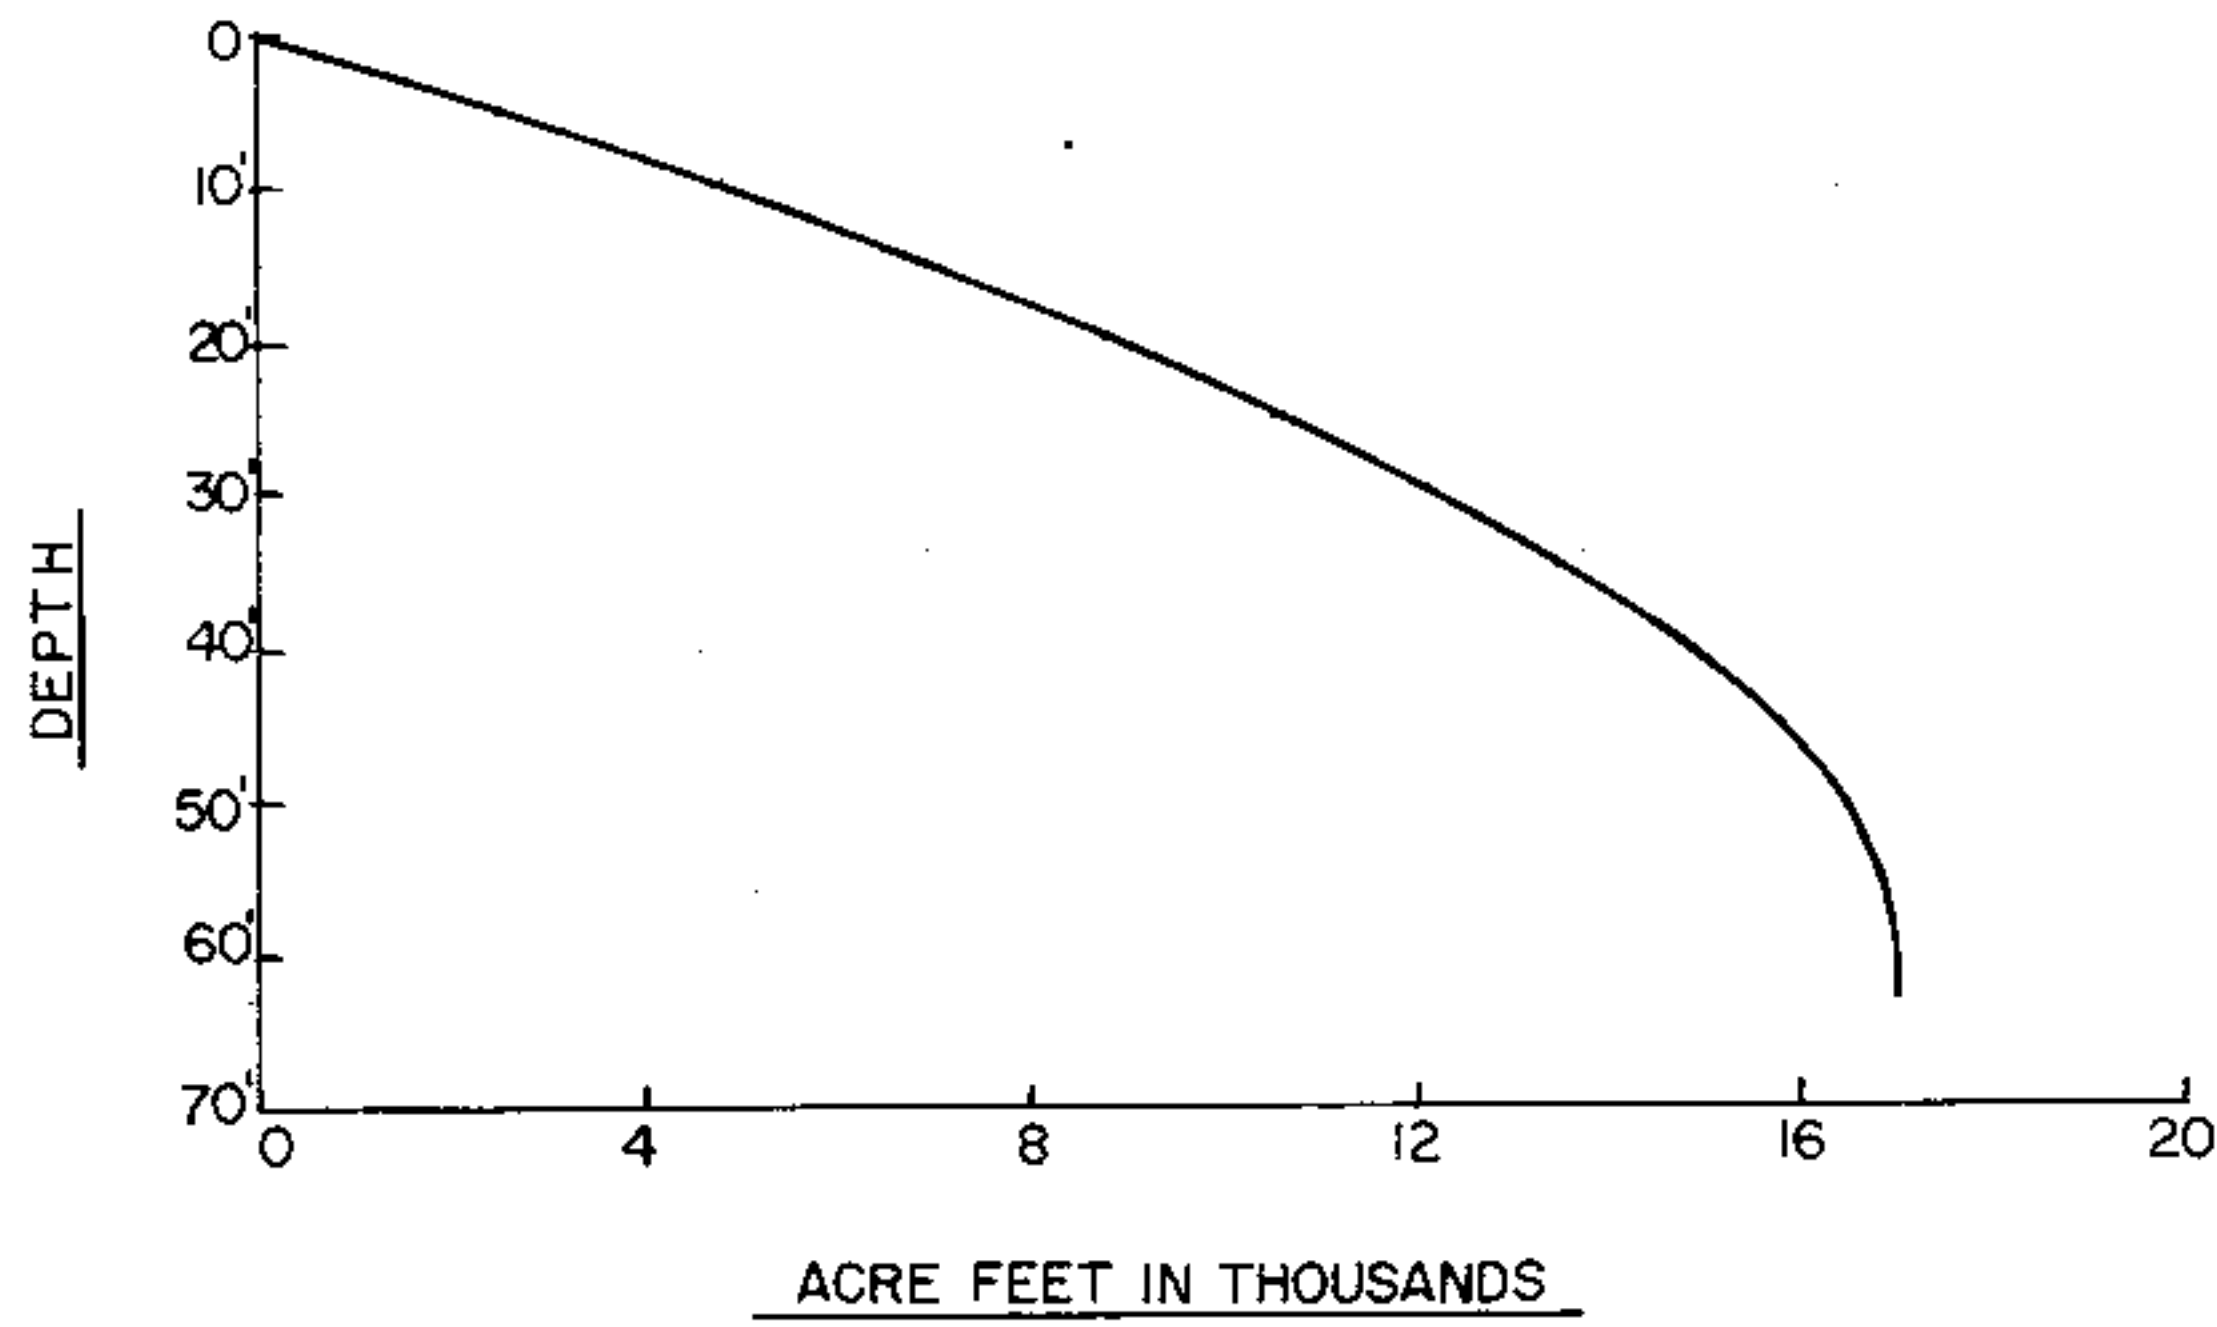
B.M. 'X' Top of northernmost of three cement foundation structures of boathouse on east-central point of lake. Assumed elevation 100.00' Water elevation 96.74'

WATER ELEV. 96.74'

AREA 521.9 ACRES
UNDER 3 FT. 45%
OVER 20 FT. 69%
VOLUME 16,974.5 ACRE FT.
TOTAL ALK. 17 P.P.M.
SHORELINE 5.13 MILES
MAX. DEPTH 63 FEET
