EQUIPMENT RECORDING SONAR MAPPED SEPT 1973
MONTH YEAR
LAKE BOTTOM SYMBOLS

Source: Wisconsin Department of Natural Resources 608-266-2621
Copper Lake - Lincoln County, Wisconsin DNR Lake Map
Date – Sep 1973 - Historical Lake Map - Not for Navigation
A Public Document - Please Identify the Source when using it.

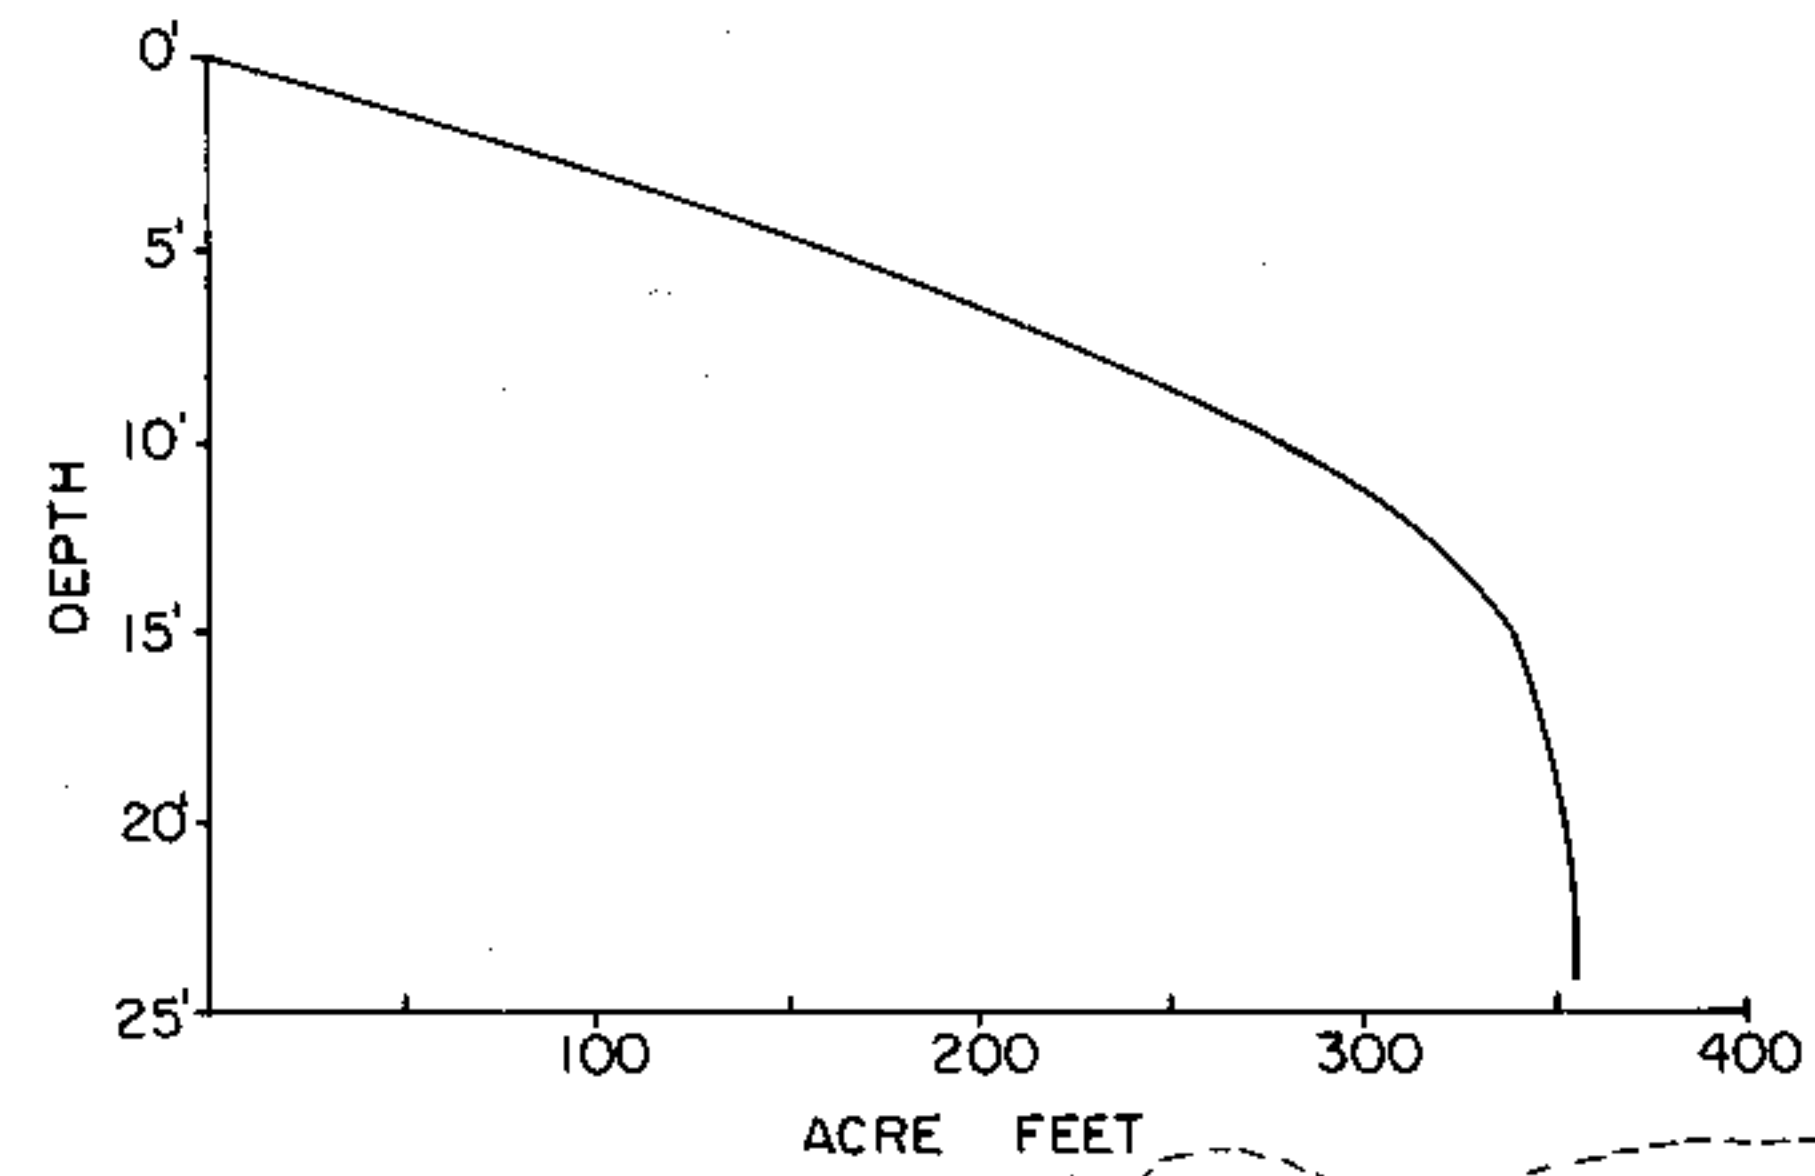
WATER AREA 34.2 ACRES
UNDER 3 FT. 7 %
OVER 20 FT. 2 %
MAX. DEPTH 24 FEET.
TOTAL ALK. 7 P.P.M.
VOLUME 353 ACRE FT.
MAIN SHORELINE 1.16 MI.
ISLAND SHORELINE 0.11 MI.
