LAKE SURVEY MAP

CAROL LAKE ONEIDA COUNTY
SEC. 4, 5, 8, 9, 33 T.-39 - N. R. - 7 - E.

Source: Wisconsin Department of Natural Resources 608-266-2621
Carol Lake – Oneida County, Wisconsin - DNR Lake Map
Date – Jul 1977 - Historical Lake Map - Not for Navigation
A Public Document - Please Identify the Source when using it.

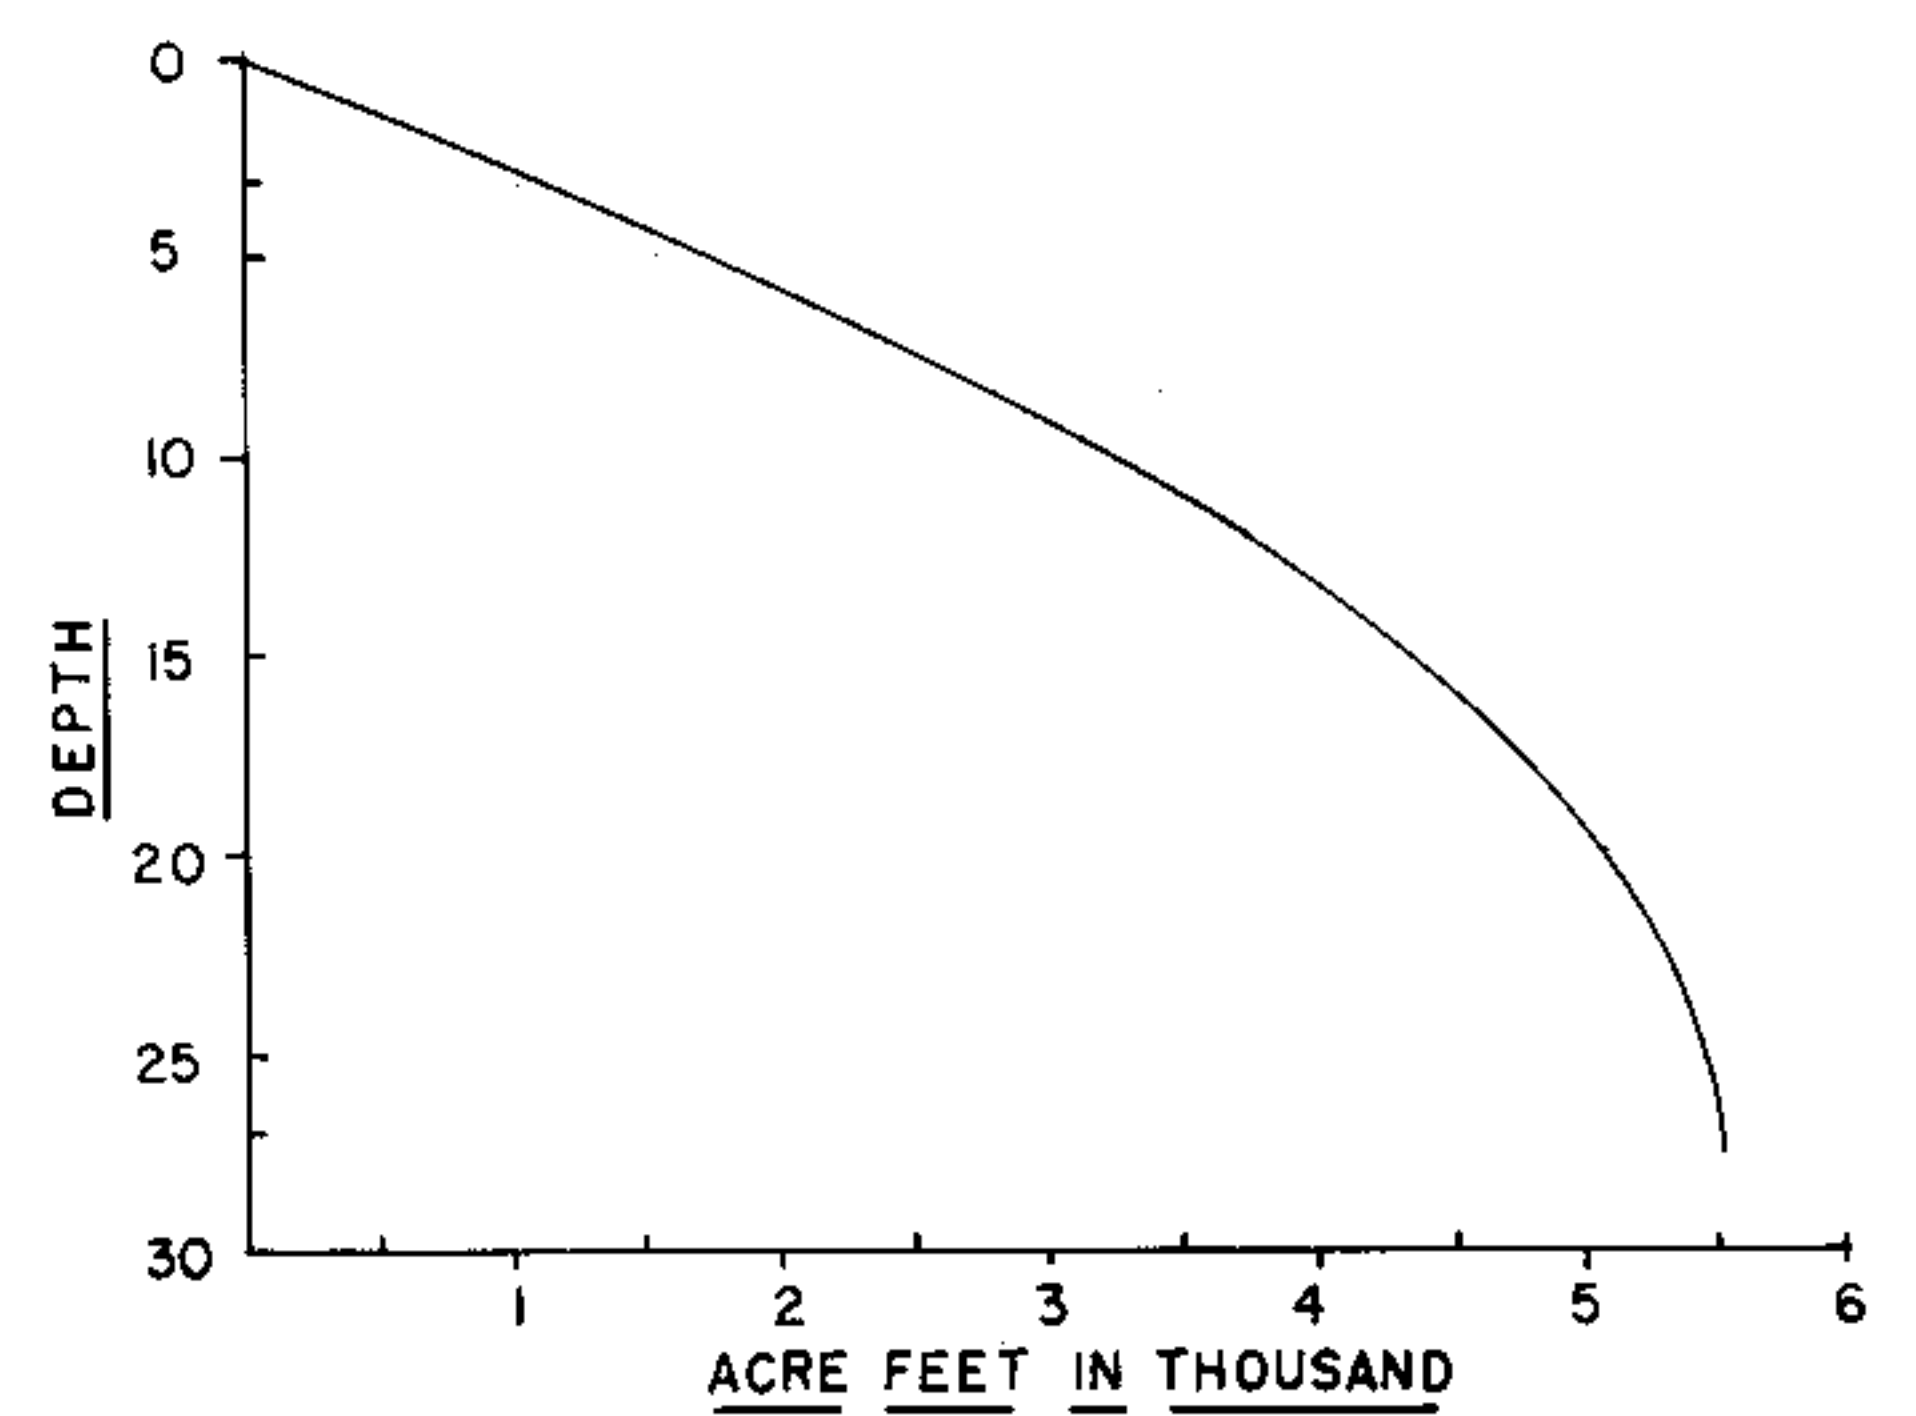
EQUIPMENT RECORDING SONAR MAPPED JULY 1977

WATER AREA 352.1 ACRES
 UNDER 3 FT. 5 %
 OVER 20 FT. 27 %
 MAX. DEPTH 27 FEET.
 TOTAL ALK. 57 P.P.M.
 VOLUME 5,509.6 ACRE FT.
 MAIN SHORELINE 5.2 MI.
 ISLAND SHORELINE .9 MI.
