EQUIPMENT RECORDING SONAR MAPPED JULY 1967
MONTH YEAR

Source: Wisconsin Department of Natural Resources 608-266-2621
Long Lake – Oneida County, Wisconsin DNR Lake Map
Date – Jul 1967 - Historical Lake Map - Not for Navigation
A Public Document - Please Identify the Source when using it.

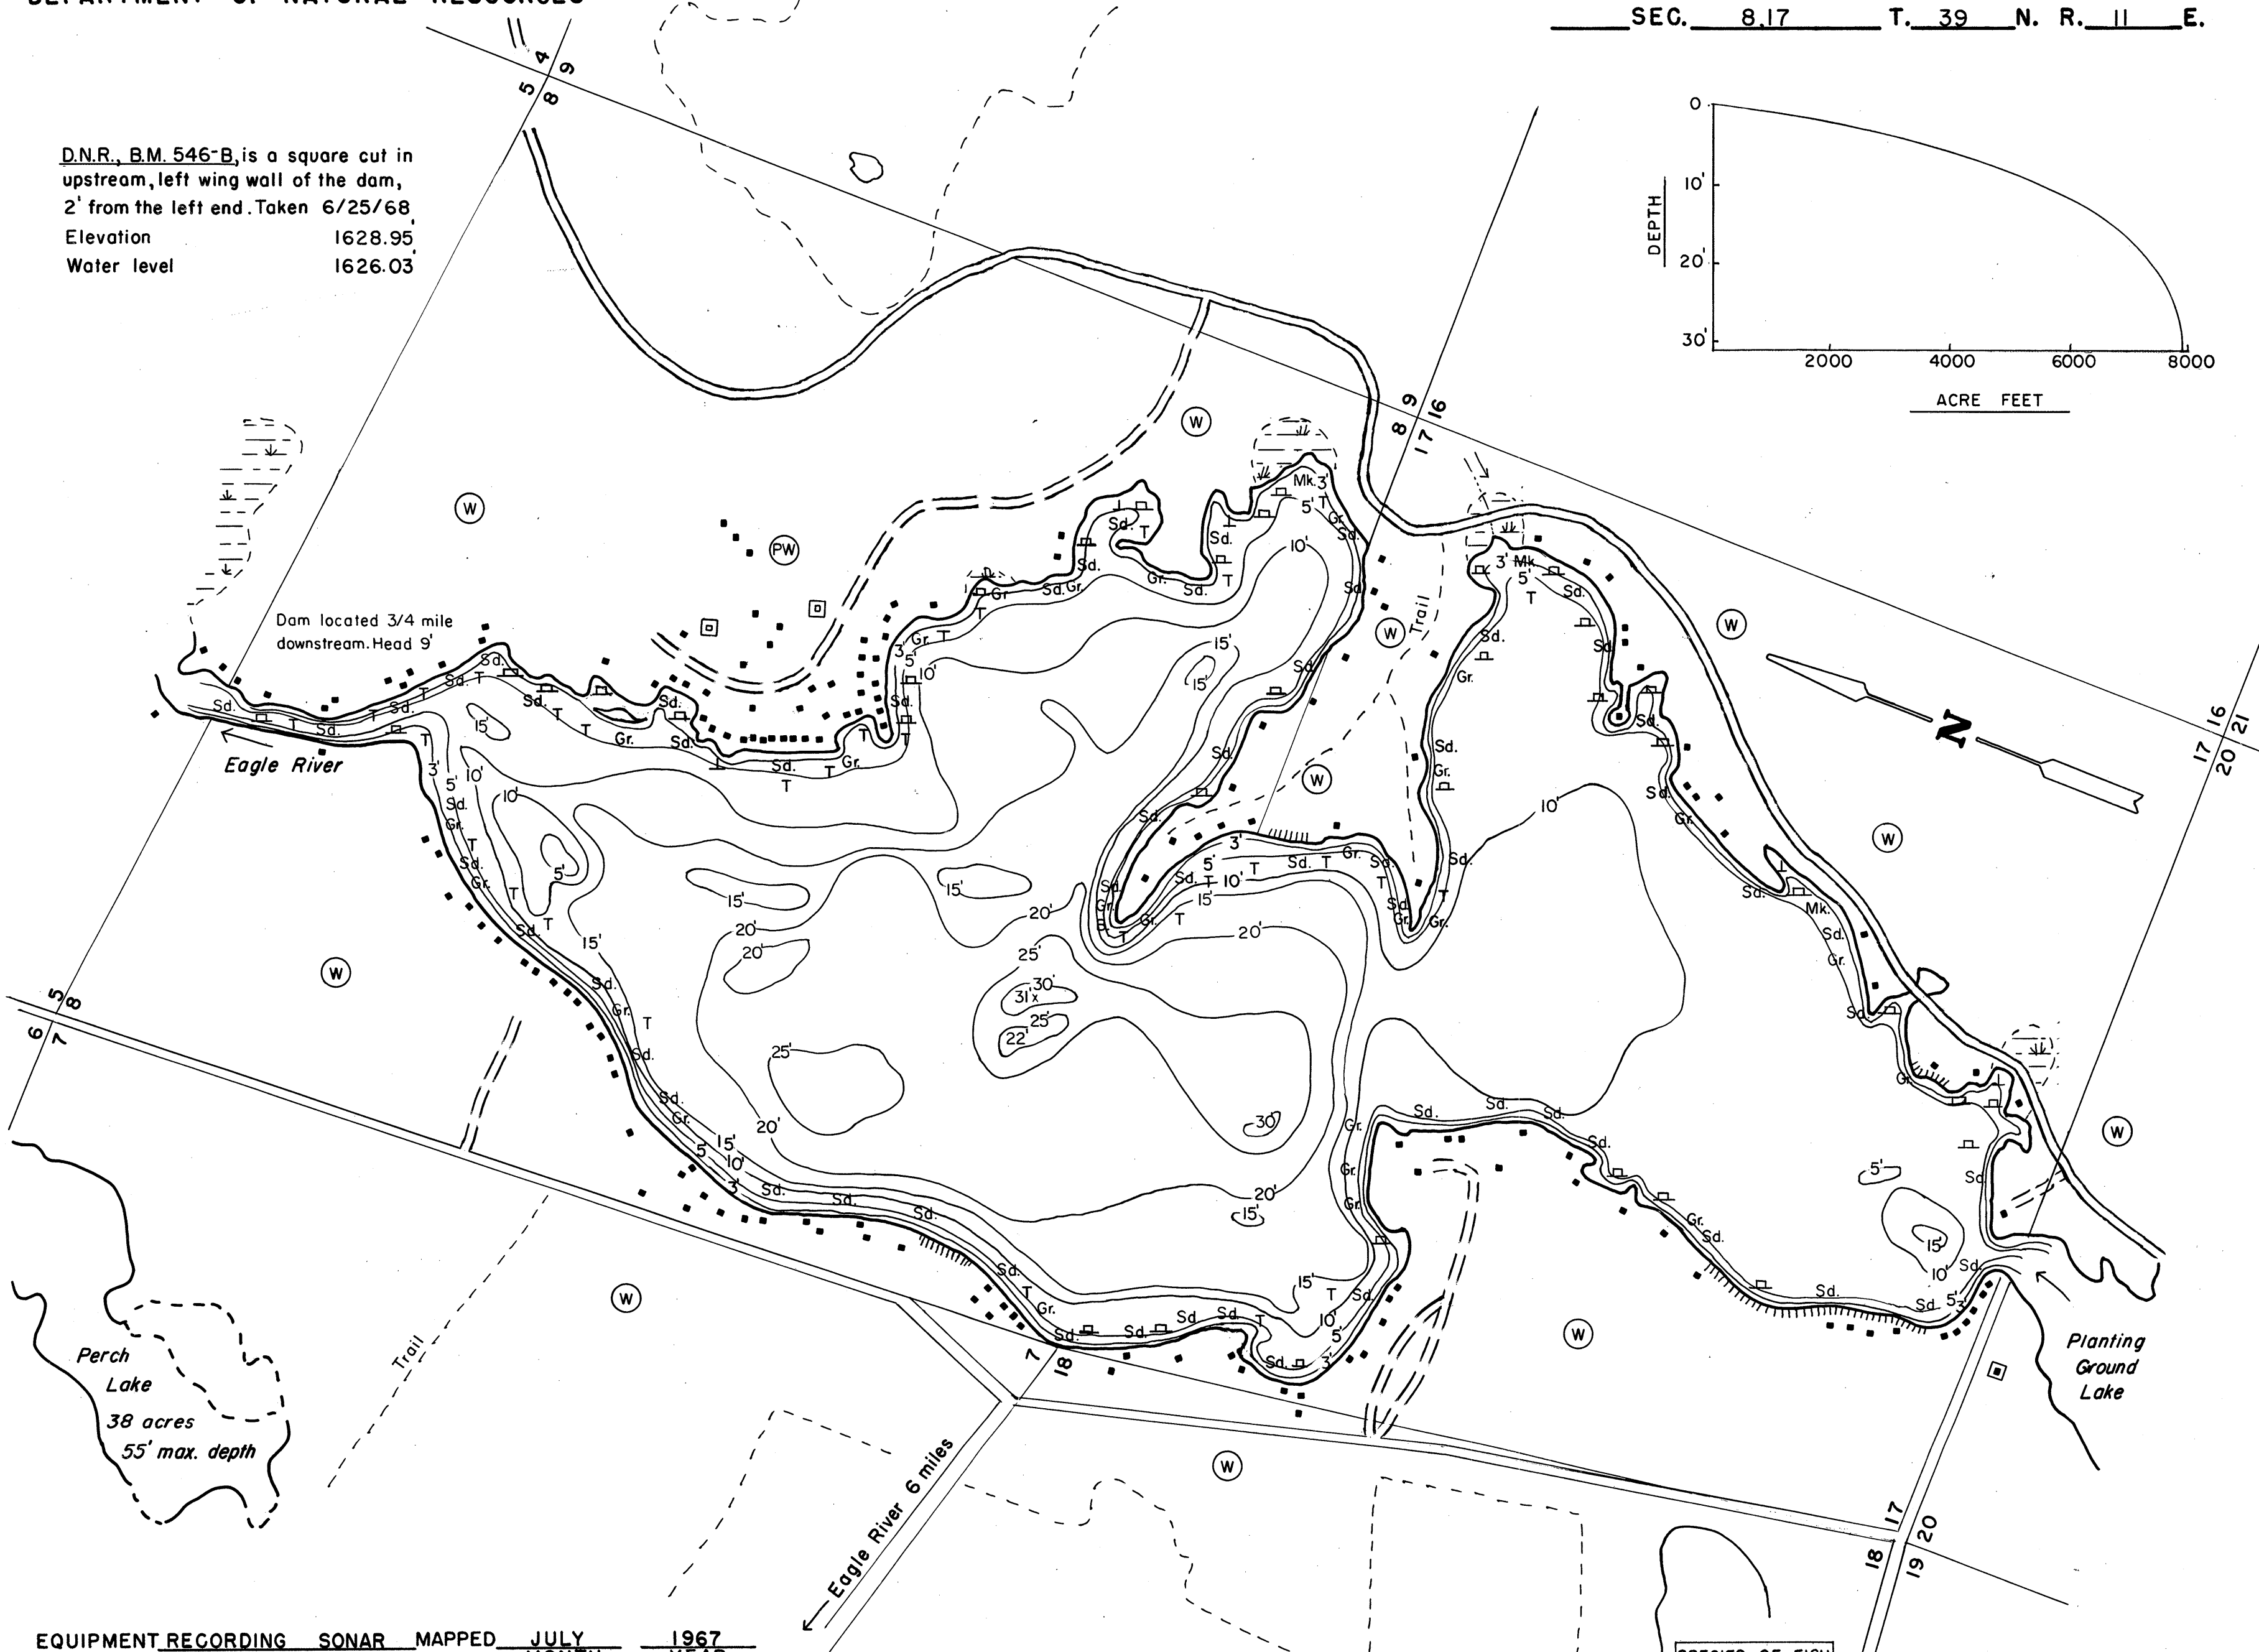
D.N.R., B.M. 546-B, is a square cut in upstream, left wing wall of the dam, 2' from the left end. Taken 6/25/68
Elevation 1628.95
Water level 1626.03

WATER AREA 620.10 ACRES
UNDER 3 FT. 5 %
OVER 20 FT. 20 %
MAX. DEPTH 31 FEET.
TOTAL ALK. 33 P.P.M.
VOLUME 7831.47 ACRE FT.
SHORELINE 7.45 MILES
