EQUIPMENT RECORDING SONAR MAPPED MAY 1968
MO. YR.

Source: Wisconsin Department of Natural Resources 608-266-2621
Cataract Lake – Monroe County, Wisconsin DNR Lake Map
Date – May 1968 - Historical Lake Map - Not for Navigation
A Public Document - Please Identify the Source when using it.

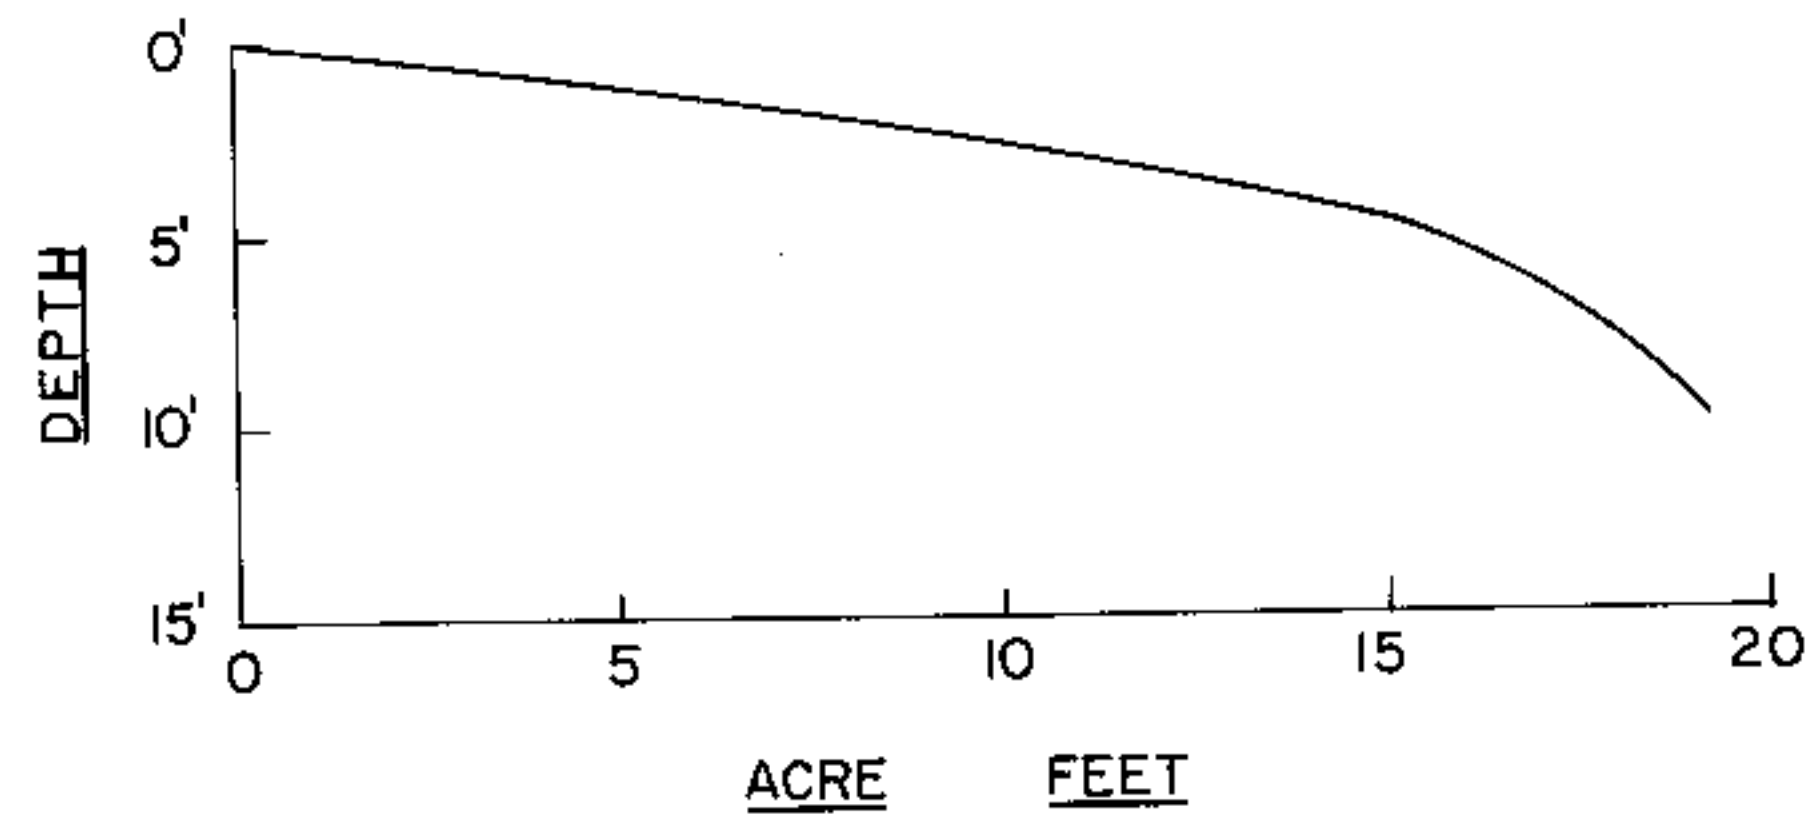
Department of Natural Resources
B.M. "X" top of concrete abutment directly at south
end of catwalk above dam.
Assumed elevation 100.00
Water elevation 97.50

WATER ELEV. 97.5'

AREA 4.58 ACRES
UNDER 3FT. 50.43 %
OVER 20FT. 0.0 %
VOLUME 19.2 ACRE FT.
TOTAL ALK. 22 P.P.M.
SHORELINE .74 MILES
MAX. DEPTH 12 FEET
