EQUIPMENT RANGE POLE MAPPED MAY 1969

Source: Wisconsin Department of Natural Resources 608-266-2621
Oakwood Lake – Jackson County, Wisconsin DNR Lake Map
Date – May 1969 - Historical Lake Map - Not for Navigation
A Public Document - Please Identify the Source when using it.

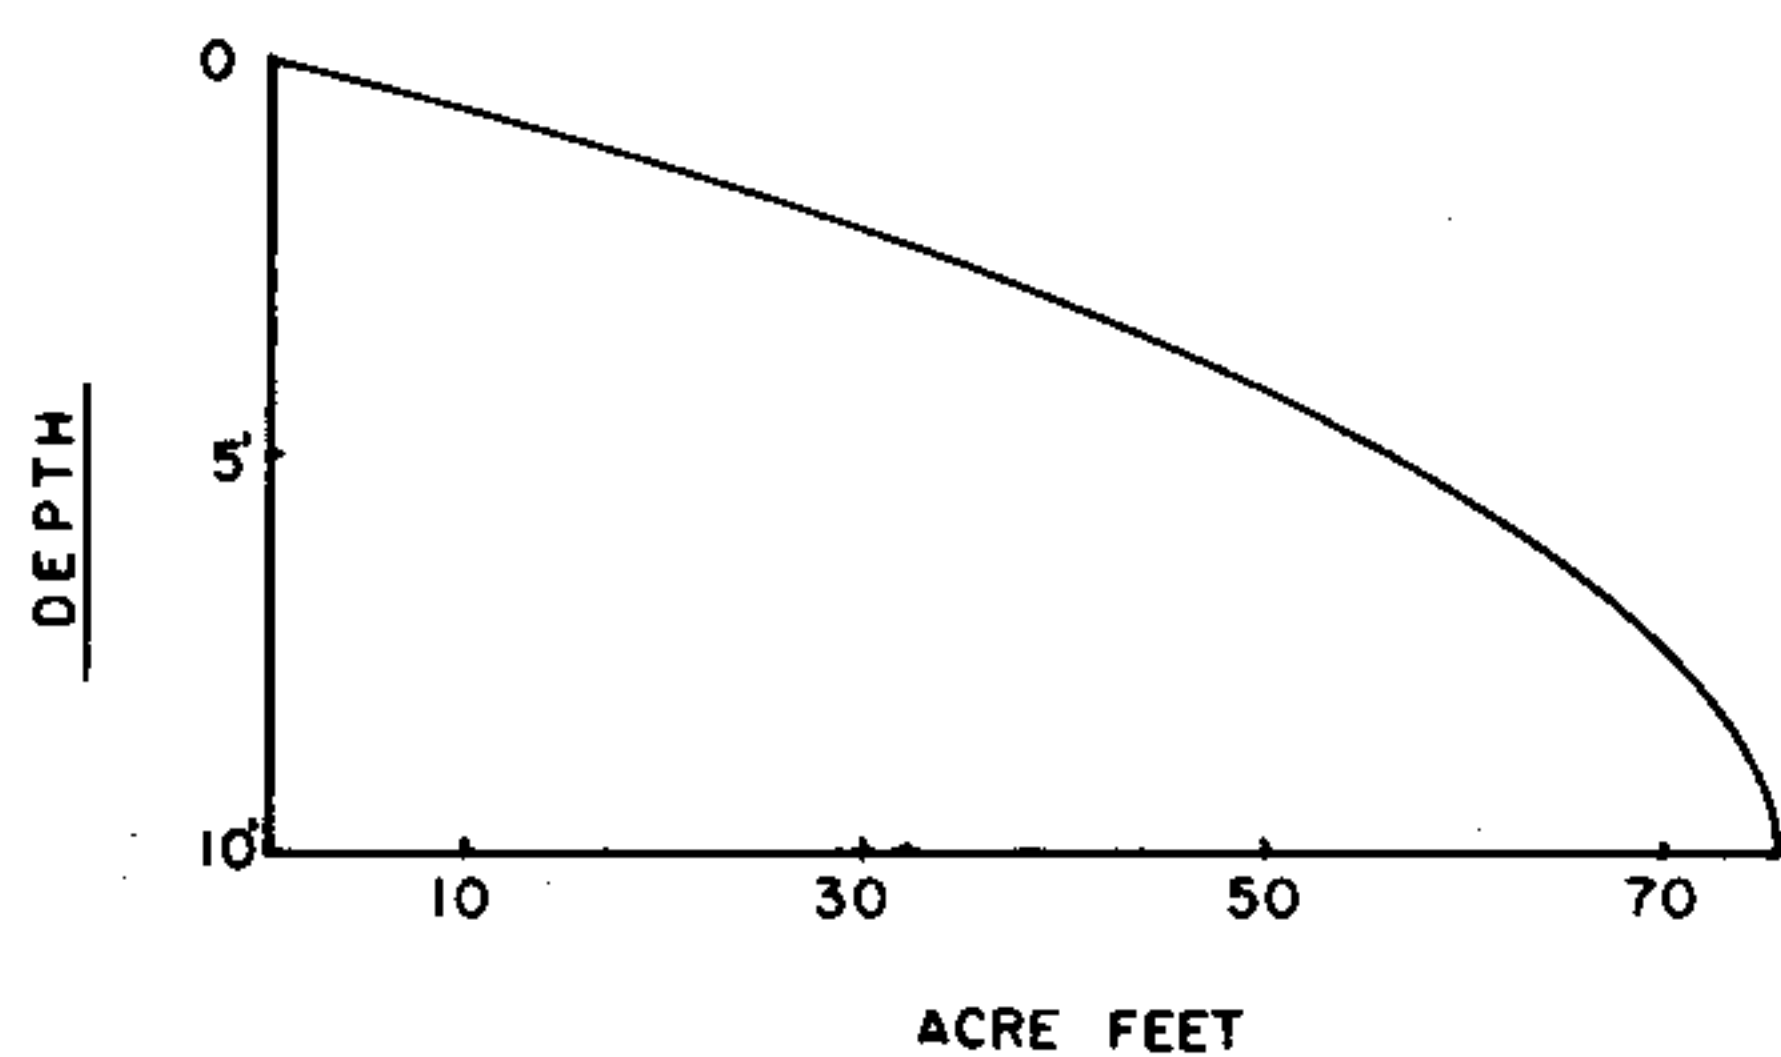
B.M. - located on top of concrete headwall at interior junction of old tumewall and new head wall at north side of dam.

Assumed elev. 100.00'
Water level 97.45'

WATER AREA 16.04 ACRES
 UNDER 3 FT. 35 %
 OVER 20 FT. 0 %
 MAX. DEPTH 13 FEET.
 TOTAL ALK. 23 P.P.M.
 VOLUME 75.55 ACRE FT.
 SHORELINE 1.74 MILES
