LAKE SURVEY MAP

CRYSTAL LAKE
VILAS COUNTY
SEC. 27, 28 T. 41 N. R. 7 E.

EQUIPMENT RECORDING SONAR MAPPED OCT 1971

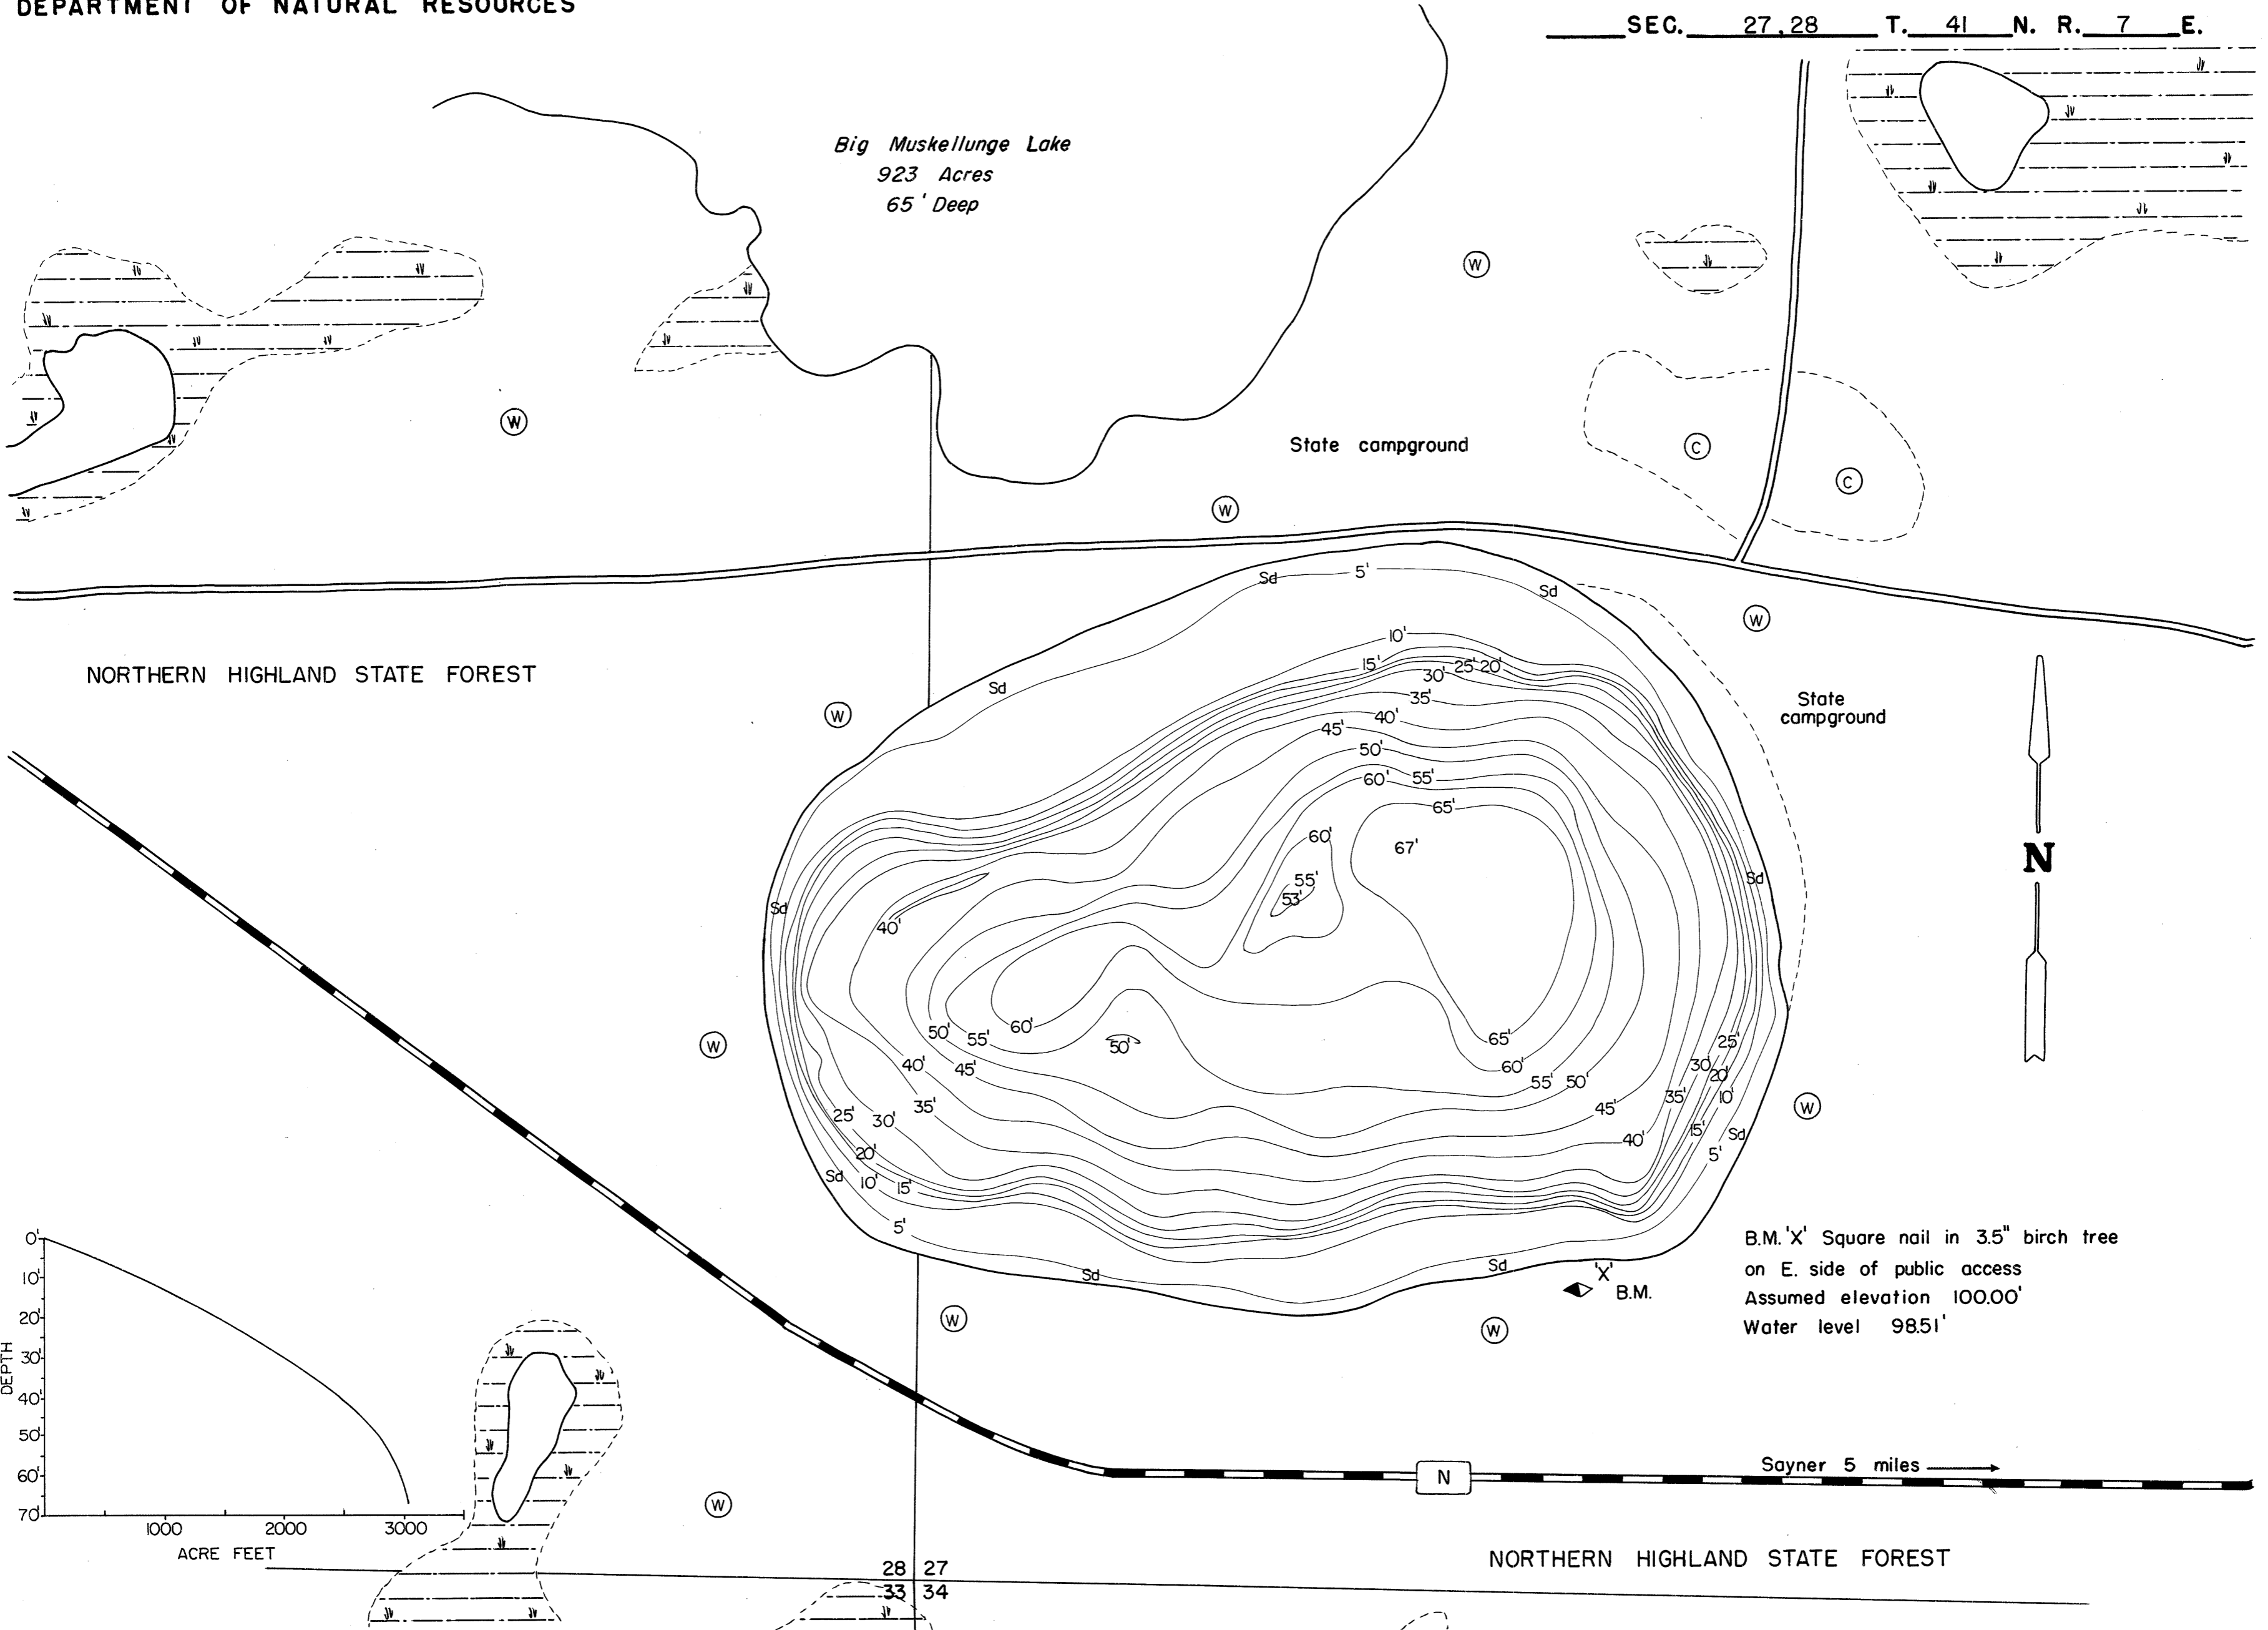
B.M. 'X' Square nail in 3.5" birch tree
on E. side of public access
Assumed elevation 100.00'
Water level 98.51'

WATER AREA 88.3 ACRES
UNDER 3 FT. 5 %
OVER 20 FT. 67 %
MAX. DEPTH 67 FEET.
TOTAL ALK. 2 P.P.M.
VOLUME 3,029 ACRE FT.
SHORELINE 1.36 MILES
