EQUIPMENT RECORDING SONAR MAPPED JULY 1969

Source: Wisconsin Department of Natural Resources 608-266-2621
Spring Lake – Barron County, Wisconsin DNR Lake Map
Date – Jul 1969 - Historical Lake Map - Not for Navigation
A Public Document - Please Identify the Source when using it.

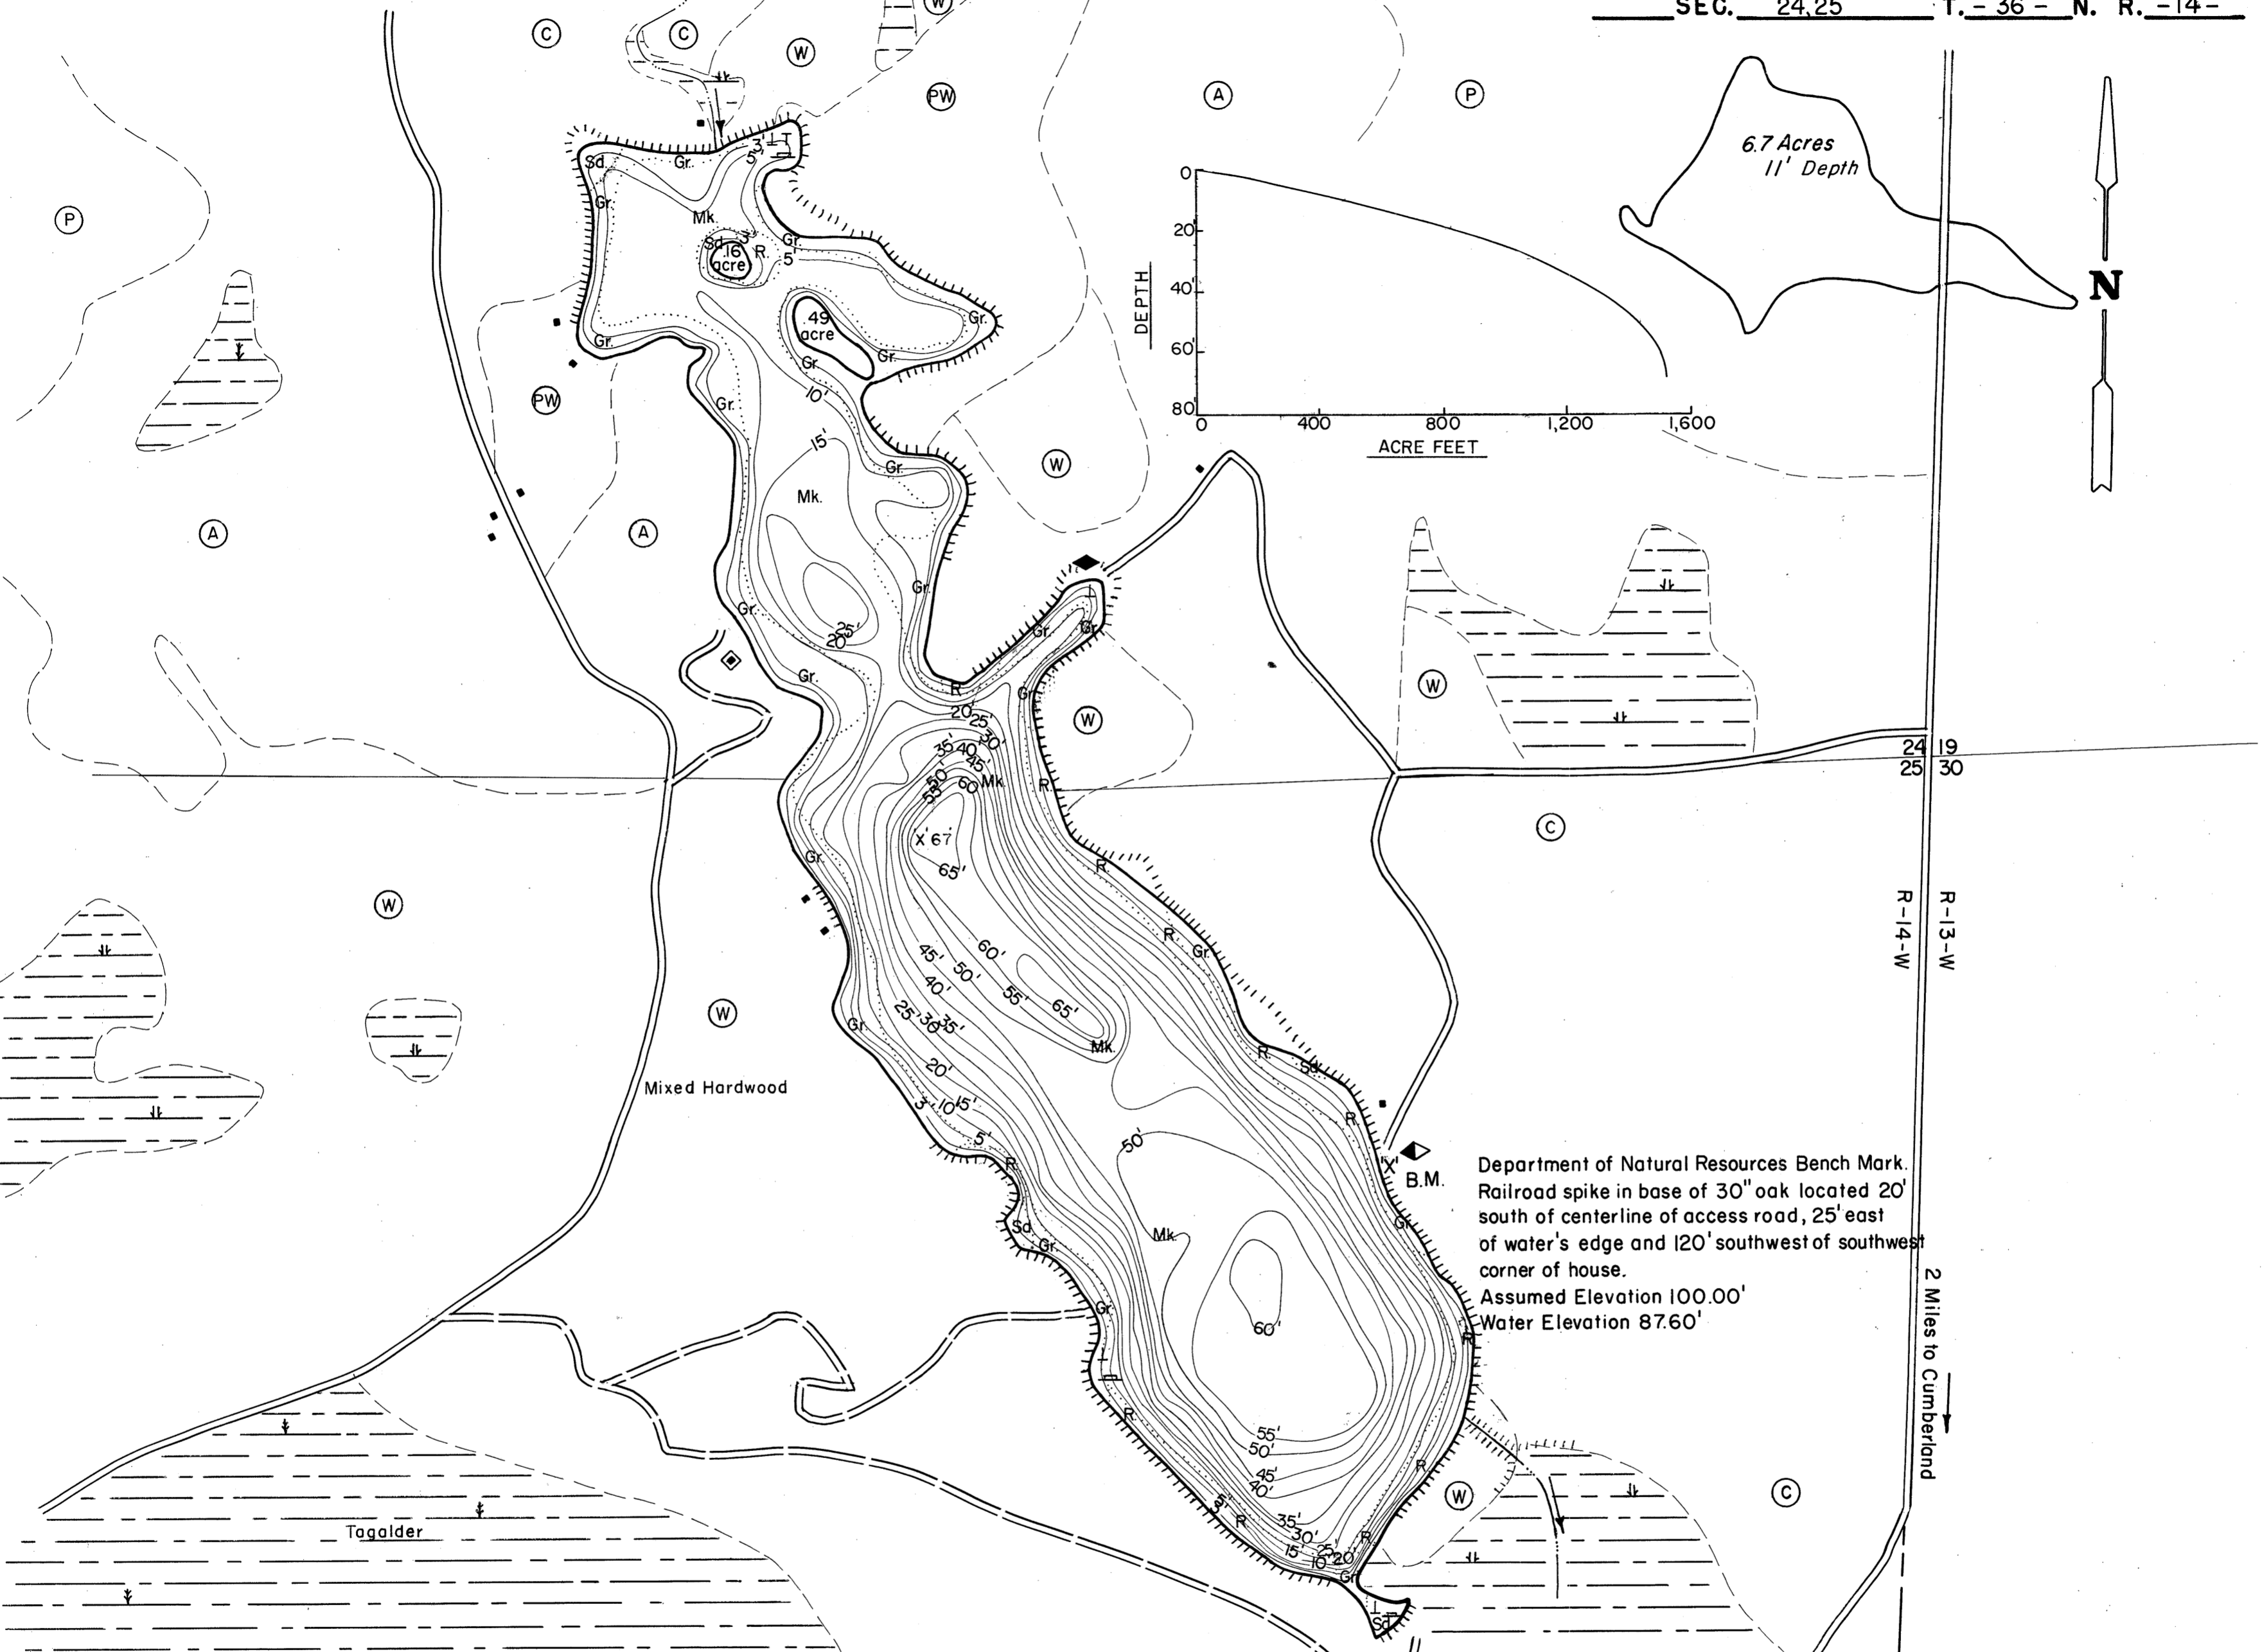
Department of Natural Resources Bench Mark.
Railroad spike in base of 30" oak located 20'
south of centerline of access road, 25' east
of water's edge and 120' southwest of southwest
corner of house.
Assumed Elevation 100.00'
Water Elevation 87.60'

WATER AREA 60.3 ACRES
UNDER 3 FT. 13 %
OVER 20 FT. 51 %
MAX. DEPTH 67 FEET.
TOTAL ALK. 10 P.P.M.
VOLUME 1,520.6 ACRE FT.
SHORELINE 2.30 MILES
WITHOUT ISL. 2.13 MILES
