EQUIPMENT RECORDING SONAR MAPPED OCTOBER 1968

Source: Wisconsin Department of Natural Resources 608-266-2621
Camelia Lake – Polk County, Wisconsin DNR Lake Map
Date – Oct 1968 - Historical Lake Map - Not for Navigation
A Public Document - Please Identify the Source when using it.

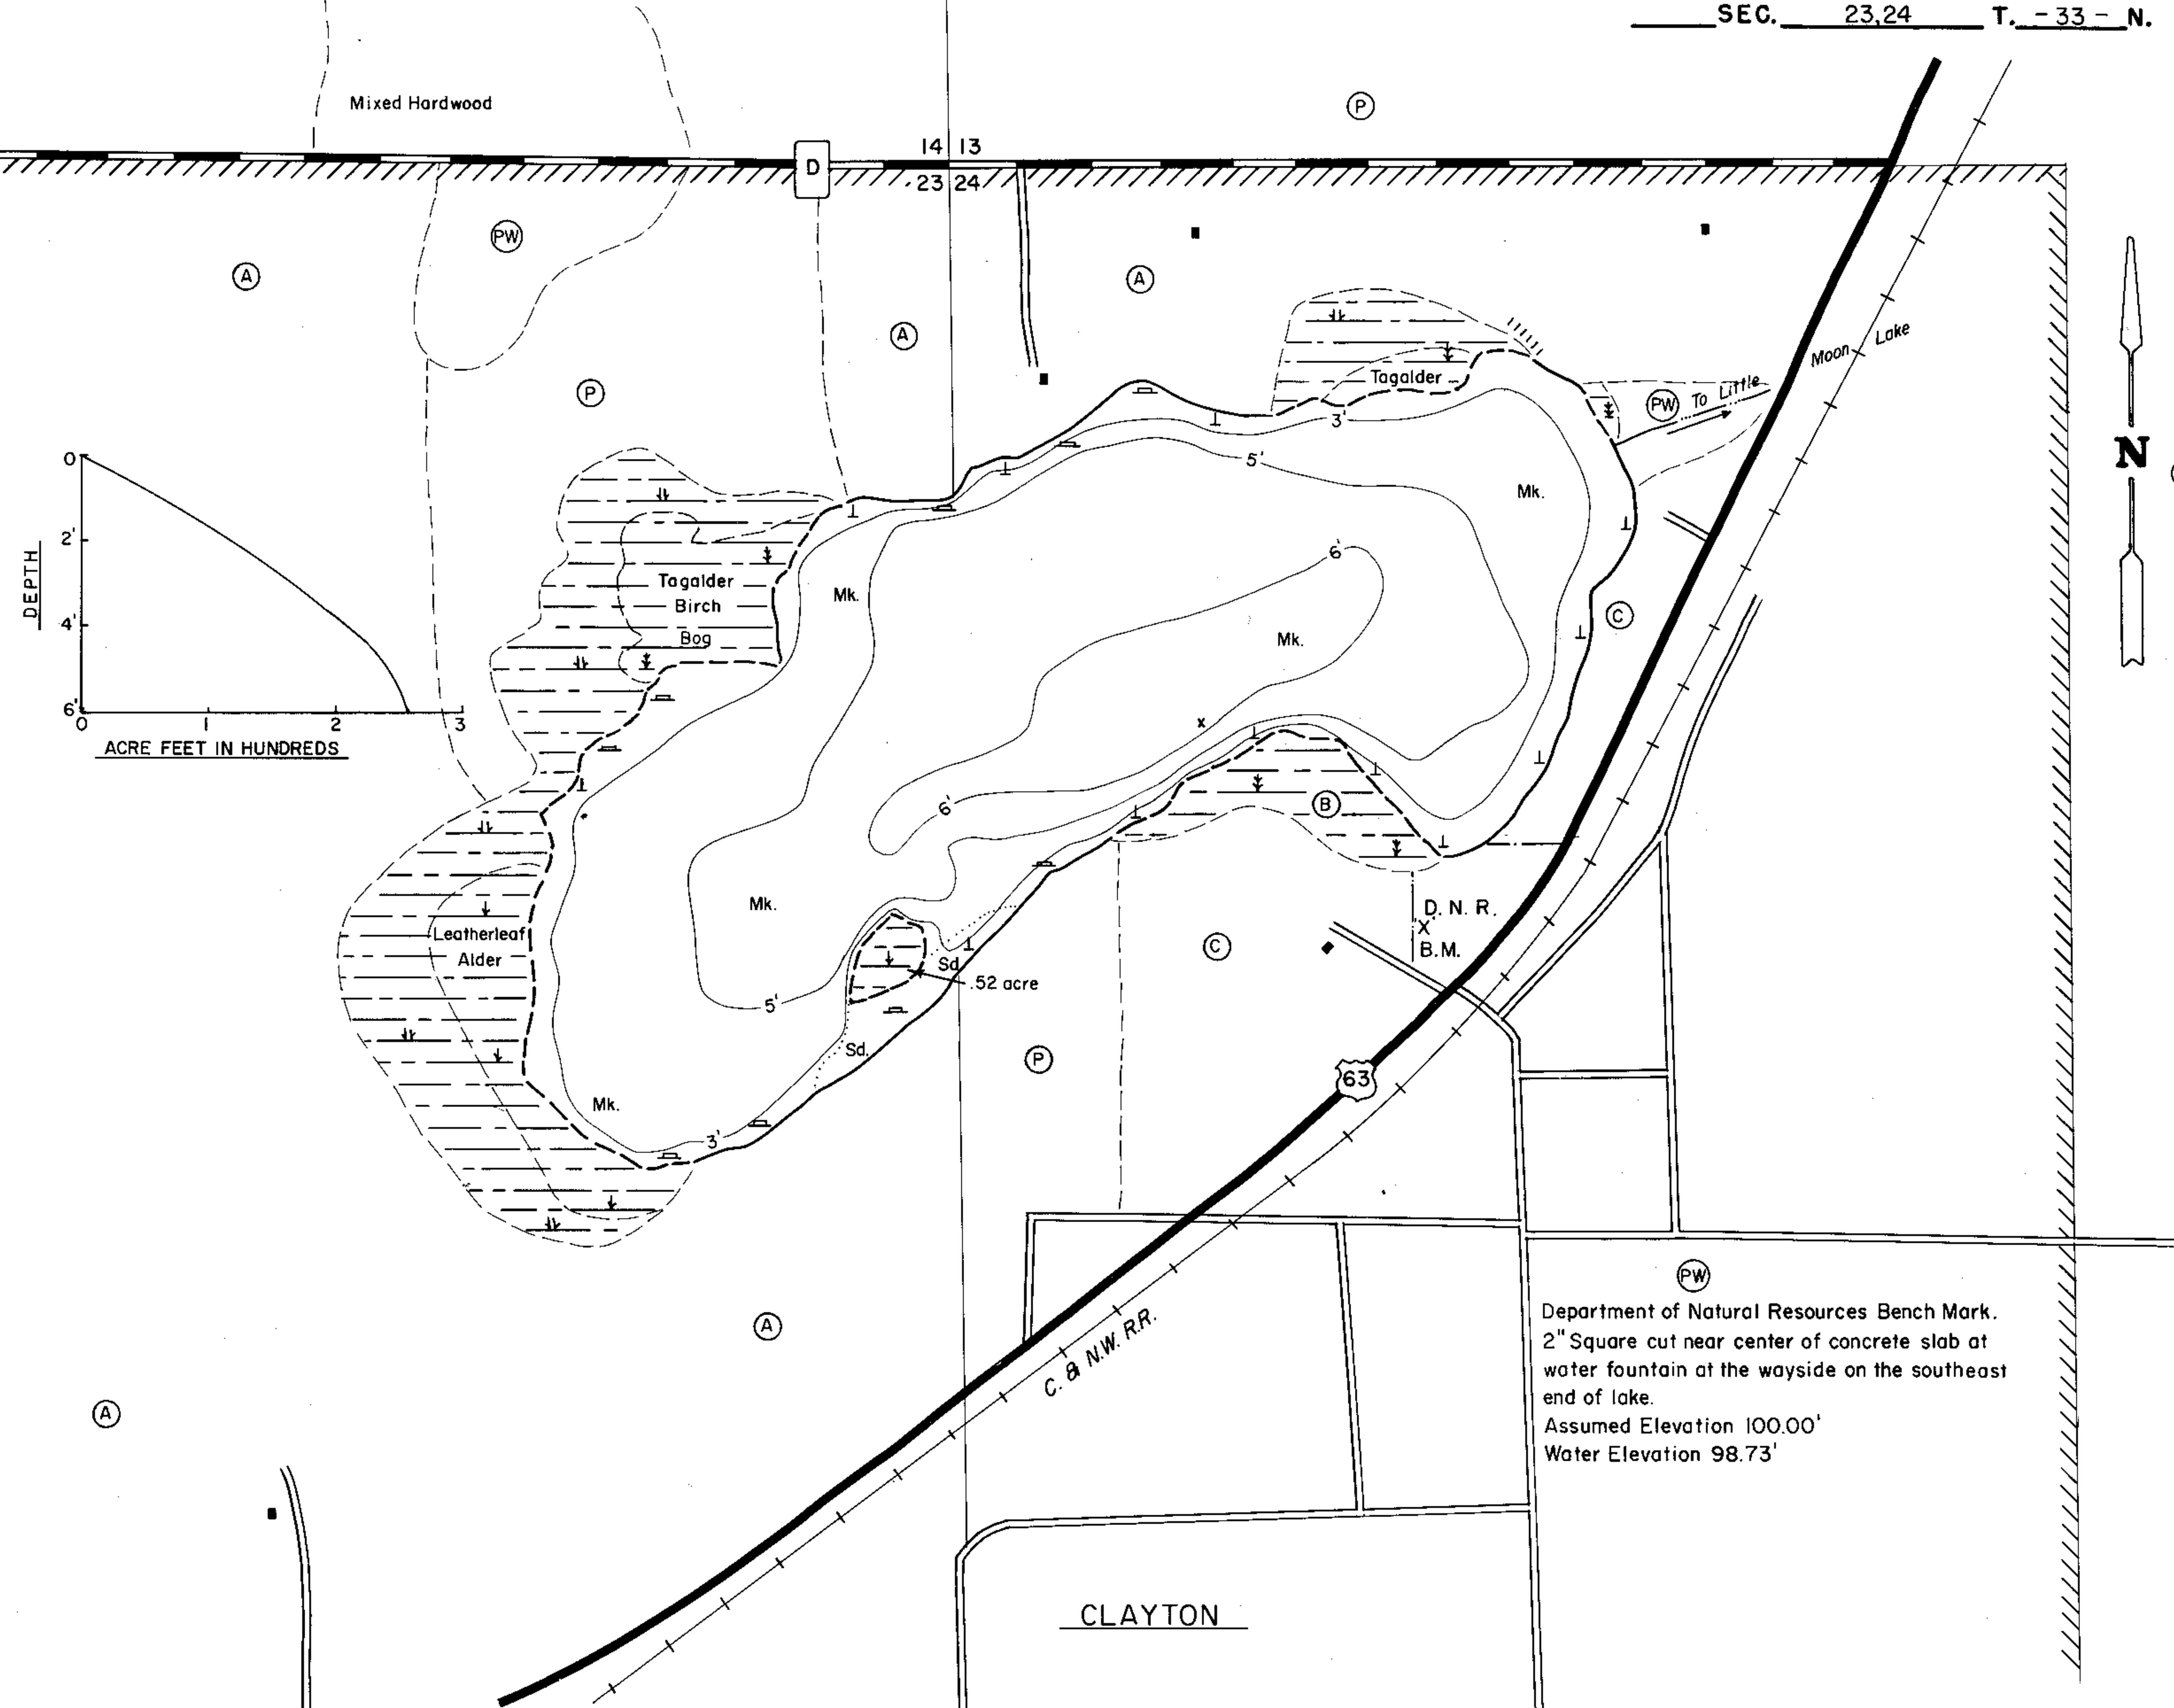
- LAKE BOTTOM SYMBOLS**
- P. Peat
 - Mk. Muck
 - C. Clay
 - M. Marl
 - Sd. Sand
 - St. Silt
 - Gr. Gravel
 - R. Rubble
 - Br. Bedrock
 - ||||| Steep slope
 - - - Indefinite shoreline
 - Marsh
 - Spring
 - Intermittent stream
 - Permanent inlet
 - Permanent outlet
 - Dam
 - D.N.R. State owned land
 - B Boulders
 - o Stumps & Snags
 - Rock danger to navigation
 - T Submergent vegetation
 - Emergent vegetation
 - Floating vegetation
 - Brush shelters

Department of Natural Resources Bench Mark.
2" Square cut near center of concrete slab at
water fountain at the wayside on the southeast
end of lake.
Assumed Elevation 100.00'
Water Elevation 98.73'

WATER AREA 59.6 ACRES
 UNDER 3 FT. 17 %
 OVER 20 FT. 0 %
 MAX. DEPTH 6 FEET.
 TOTAL ALK. 14 P.P.M.
 VOLUME 257.5 ACRE FT.
 SHORELINE 1.58 MILES
 1.47 MILES OF SHORELINE
 EXCLUDING ISLAND
