EQUIPMENT SONAR & POLIE MAPPED JULY 1972
MONTH YEAR

WATER AREA 48.3 ACRES
UNDER 3 FT. 31 %
OVER 20 FT. 0 %
MAX. DEPTH 12 FEET.
TOTAL ALK. 80 P.P.M.
VOLUME 240 ACRE FT.
SHORELINE 2.62 MILES

Source: Wisconsin Department of Natural Resources 608-266-2621
Barron Flowage #1 – Barron County, Wisconsin DNR Lake Map
Date – Jul 1972 - Historical Lake Map - Not for Navigation
A Public Document - Please Identify the Source when using it.

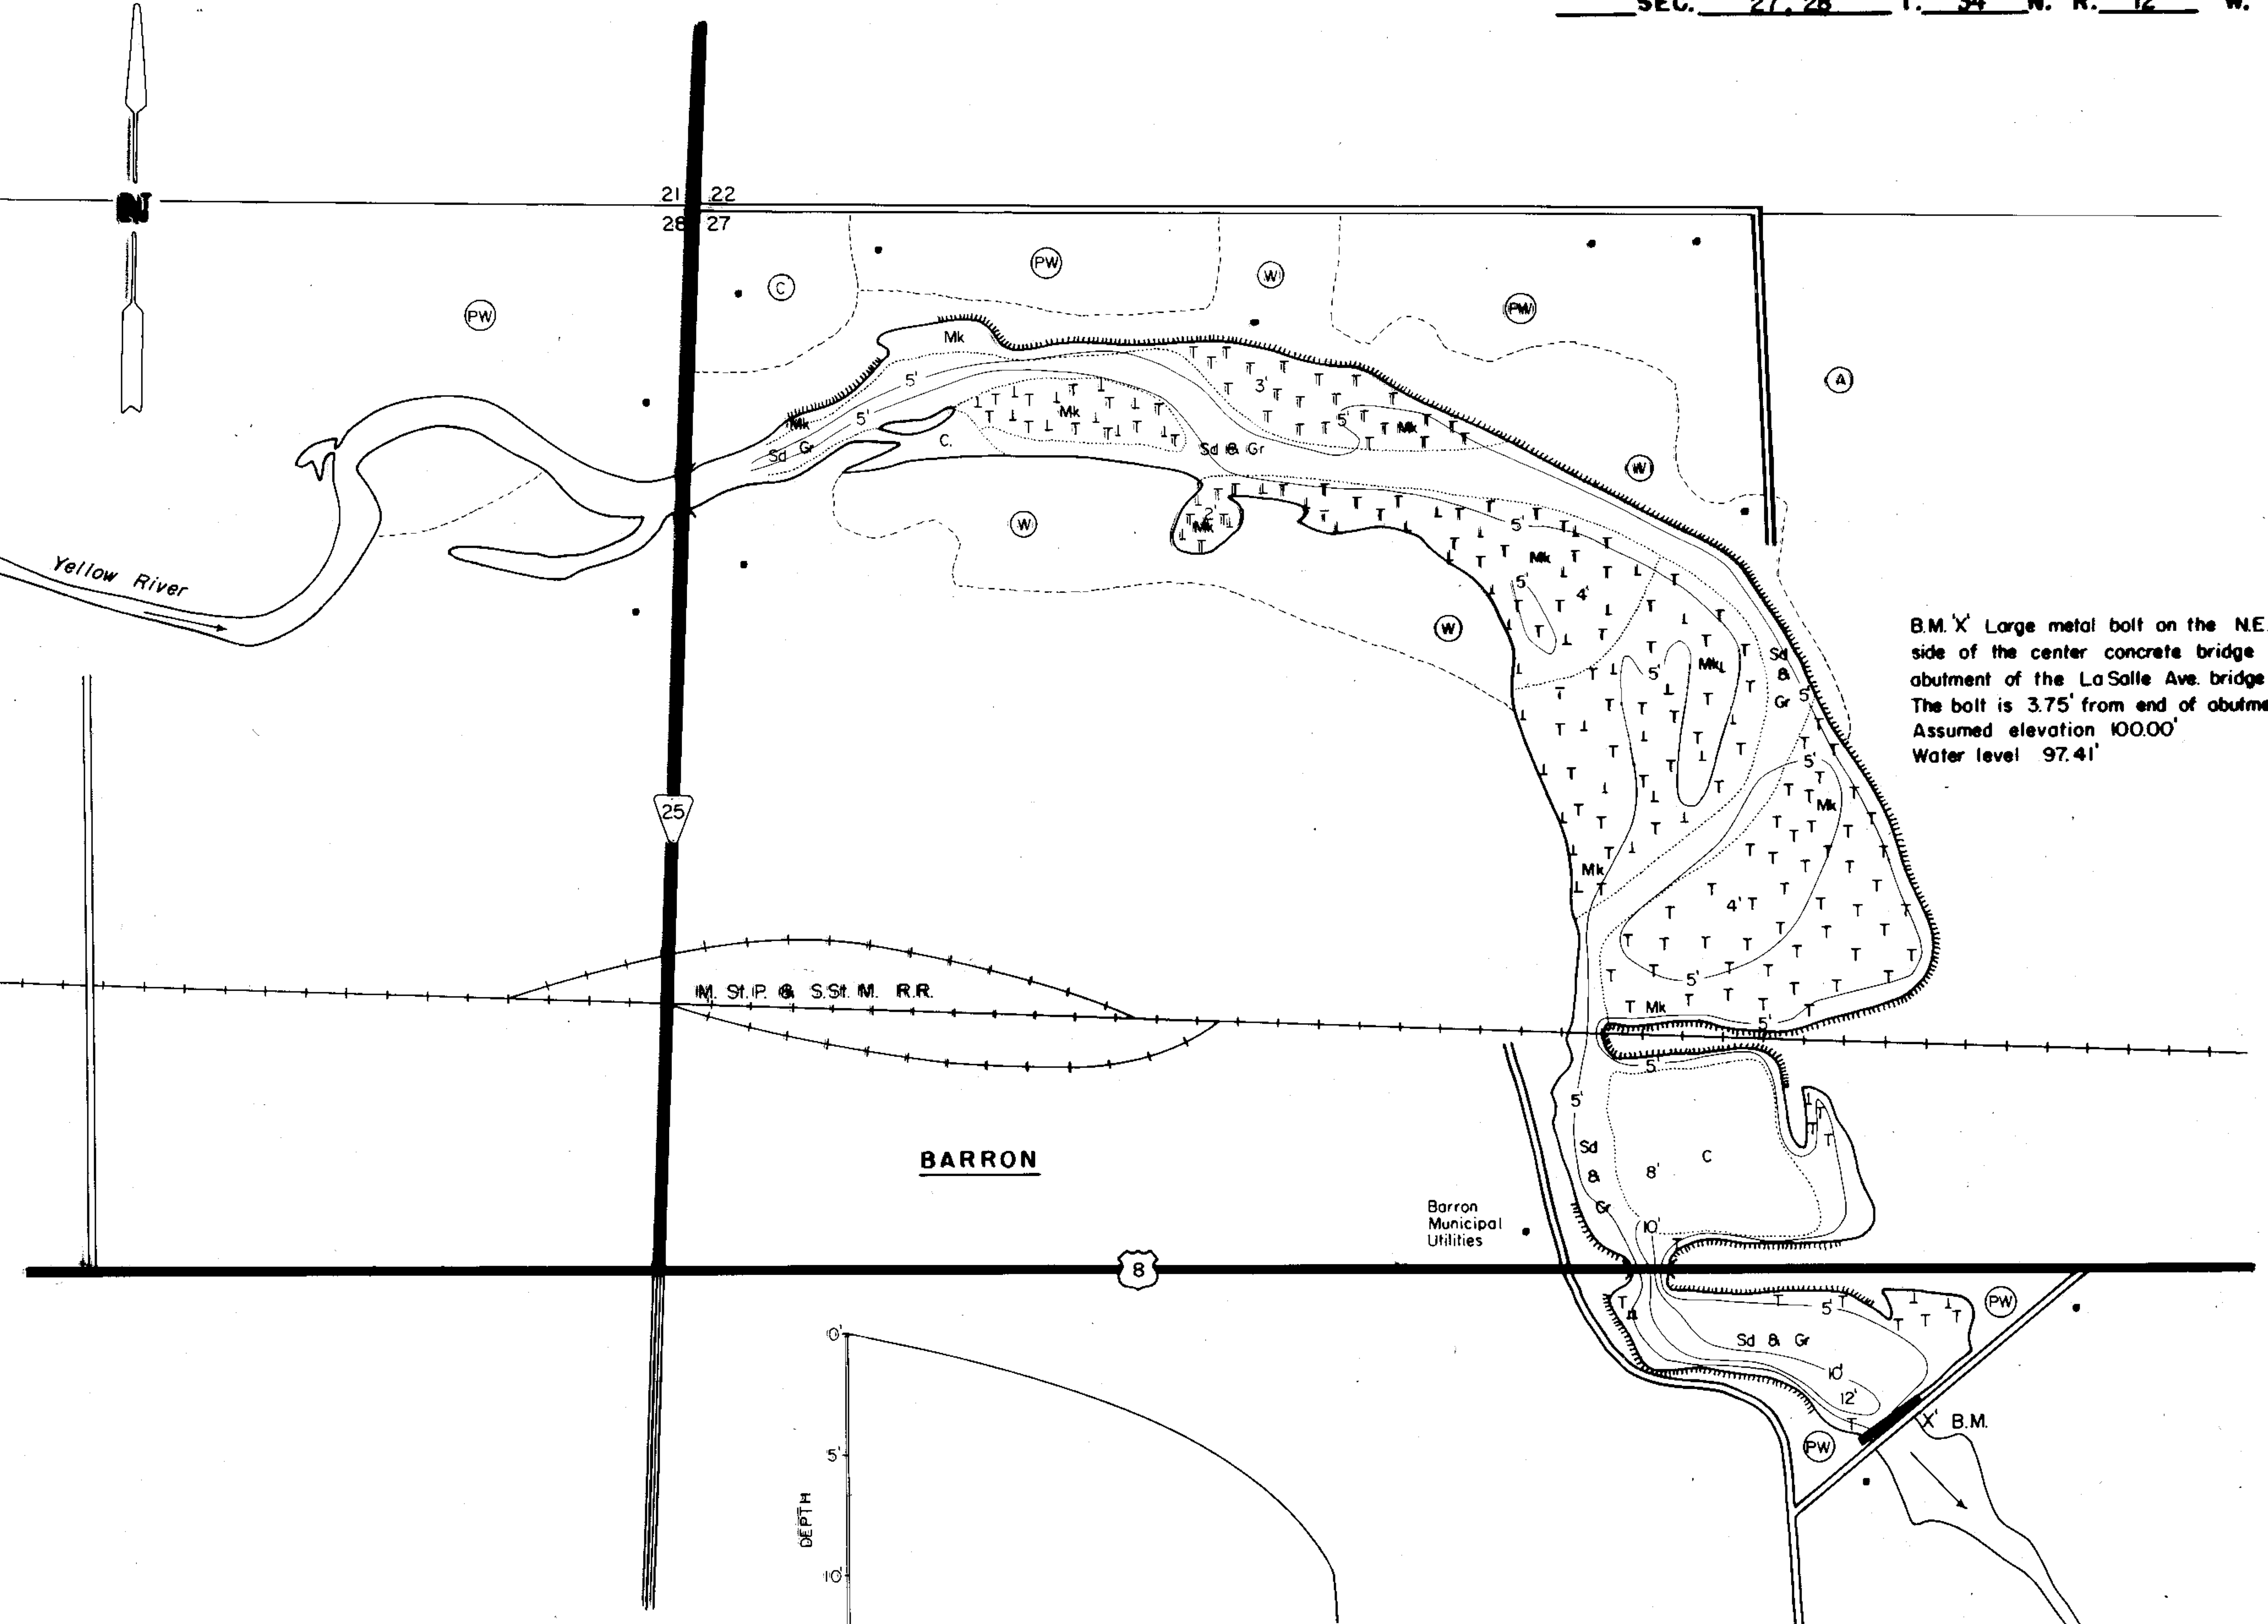
B.M. 'X' Large metal bolt on the NE. side of the center concrete bridge abutment of the LaSalle Ave. bridge
The bolt is 3.75' from end of abutment
Assumed elevation 100.00'
Water level 97.41'
