BUTTERNUT LAKE
140.6 ACRES
15' DEEP

Source: Wisconsin Department of Natural Resources 608-266-2621
Little Butternut Lake – Barron County, Wisconsin DNR Lake Map
Date – Jul 1966 - Historical Lake Map - Not for Navigation
A Public Document - Please Identify the Source when using it.

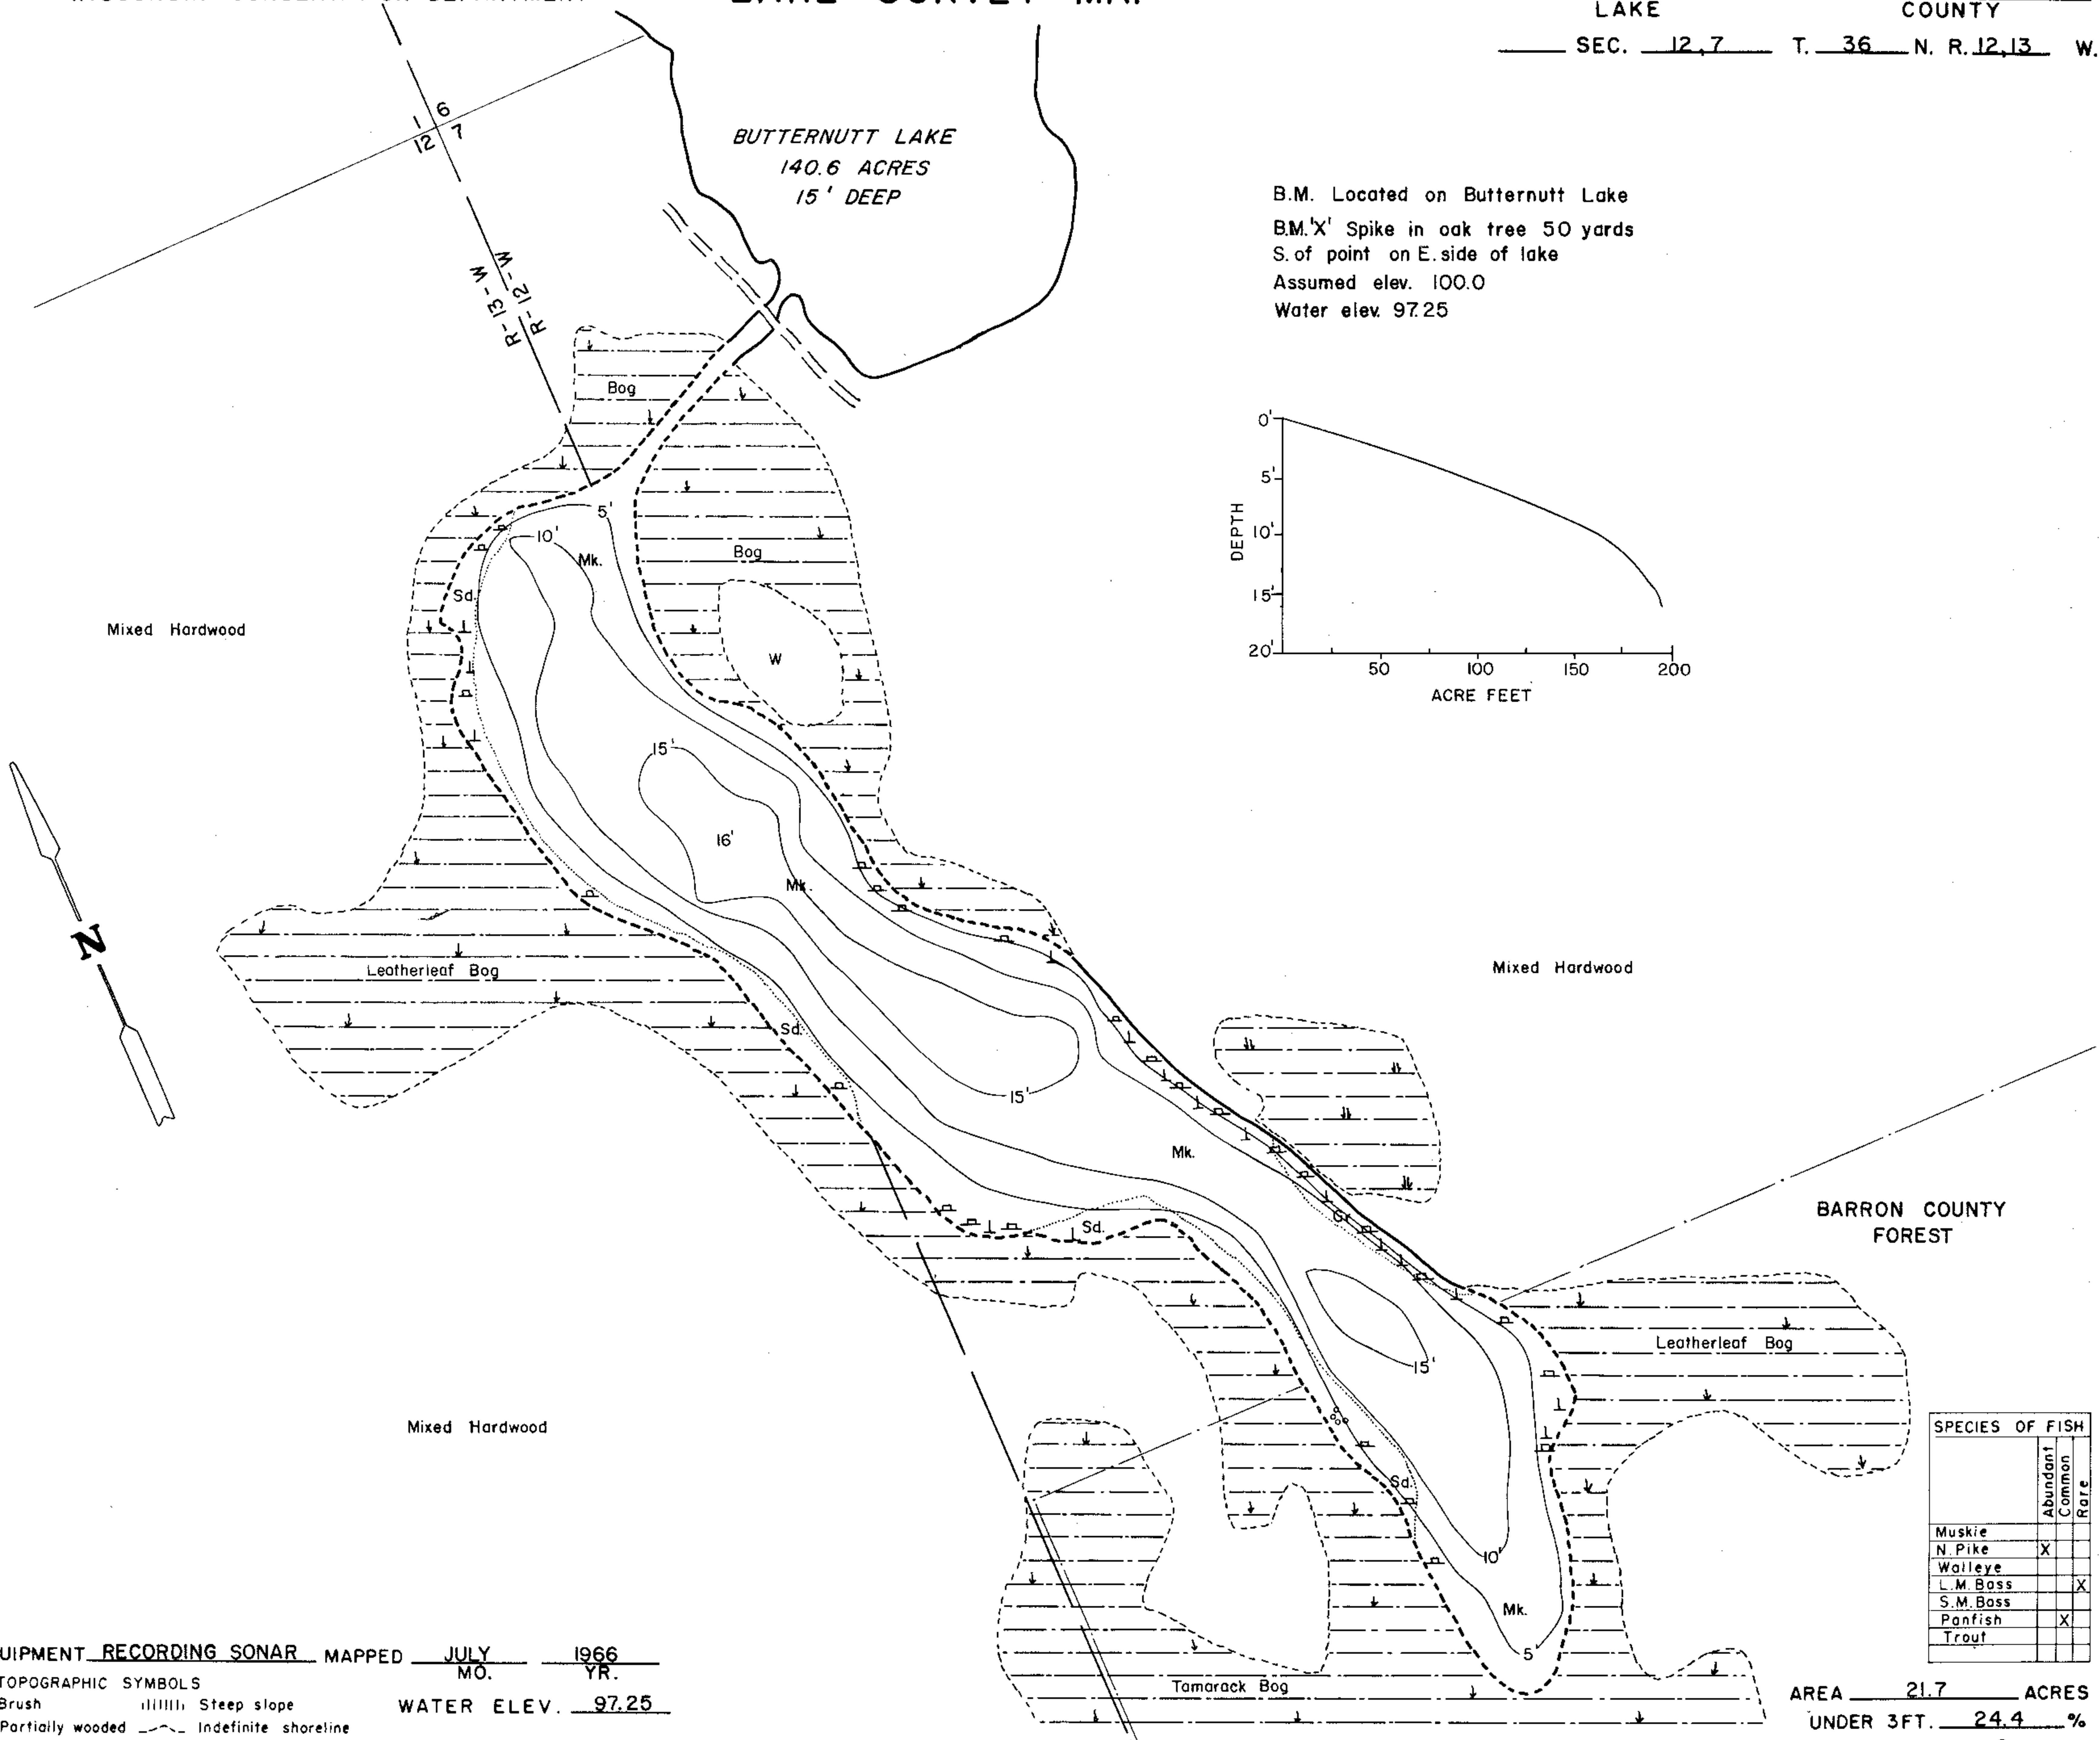
B.M. Located on Butternut Lake
B.M. 'X' Spike in oak tree 50 yards
S. of point on E. side of lake
Assumed elev. 100.0
Water elev. 97.25

EQUIPMENT RECORDING SONAR MAPPED JULY 1966
MO. YR.

WATER ELEV. 97.25

AREA 21.7 ACRES
UNDER 3FT. 24.4 %
OVER 20FT. 0 %
VOLUME 196.3 ACRE FT.
TOTAL ALK. 11 P.P.M.
SHORELINE 12 MILES
MAX. DEPTH 16 FEET
