EQUIPMENT SONAR AND POLE MAPPED JUNE 1966
MO. YR.

Source: Wisconsin Department of Natural Resources 608-266-2621
Rock Dam Lake – Clark County, Wisconsin DNR Lake Map
Date – Jun 1966 - Historical Lake Map - Not for Navigation
A Public Document - Please Identify the Source when using it.

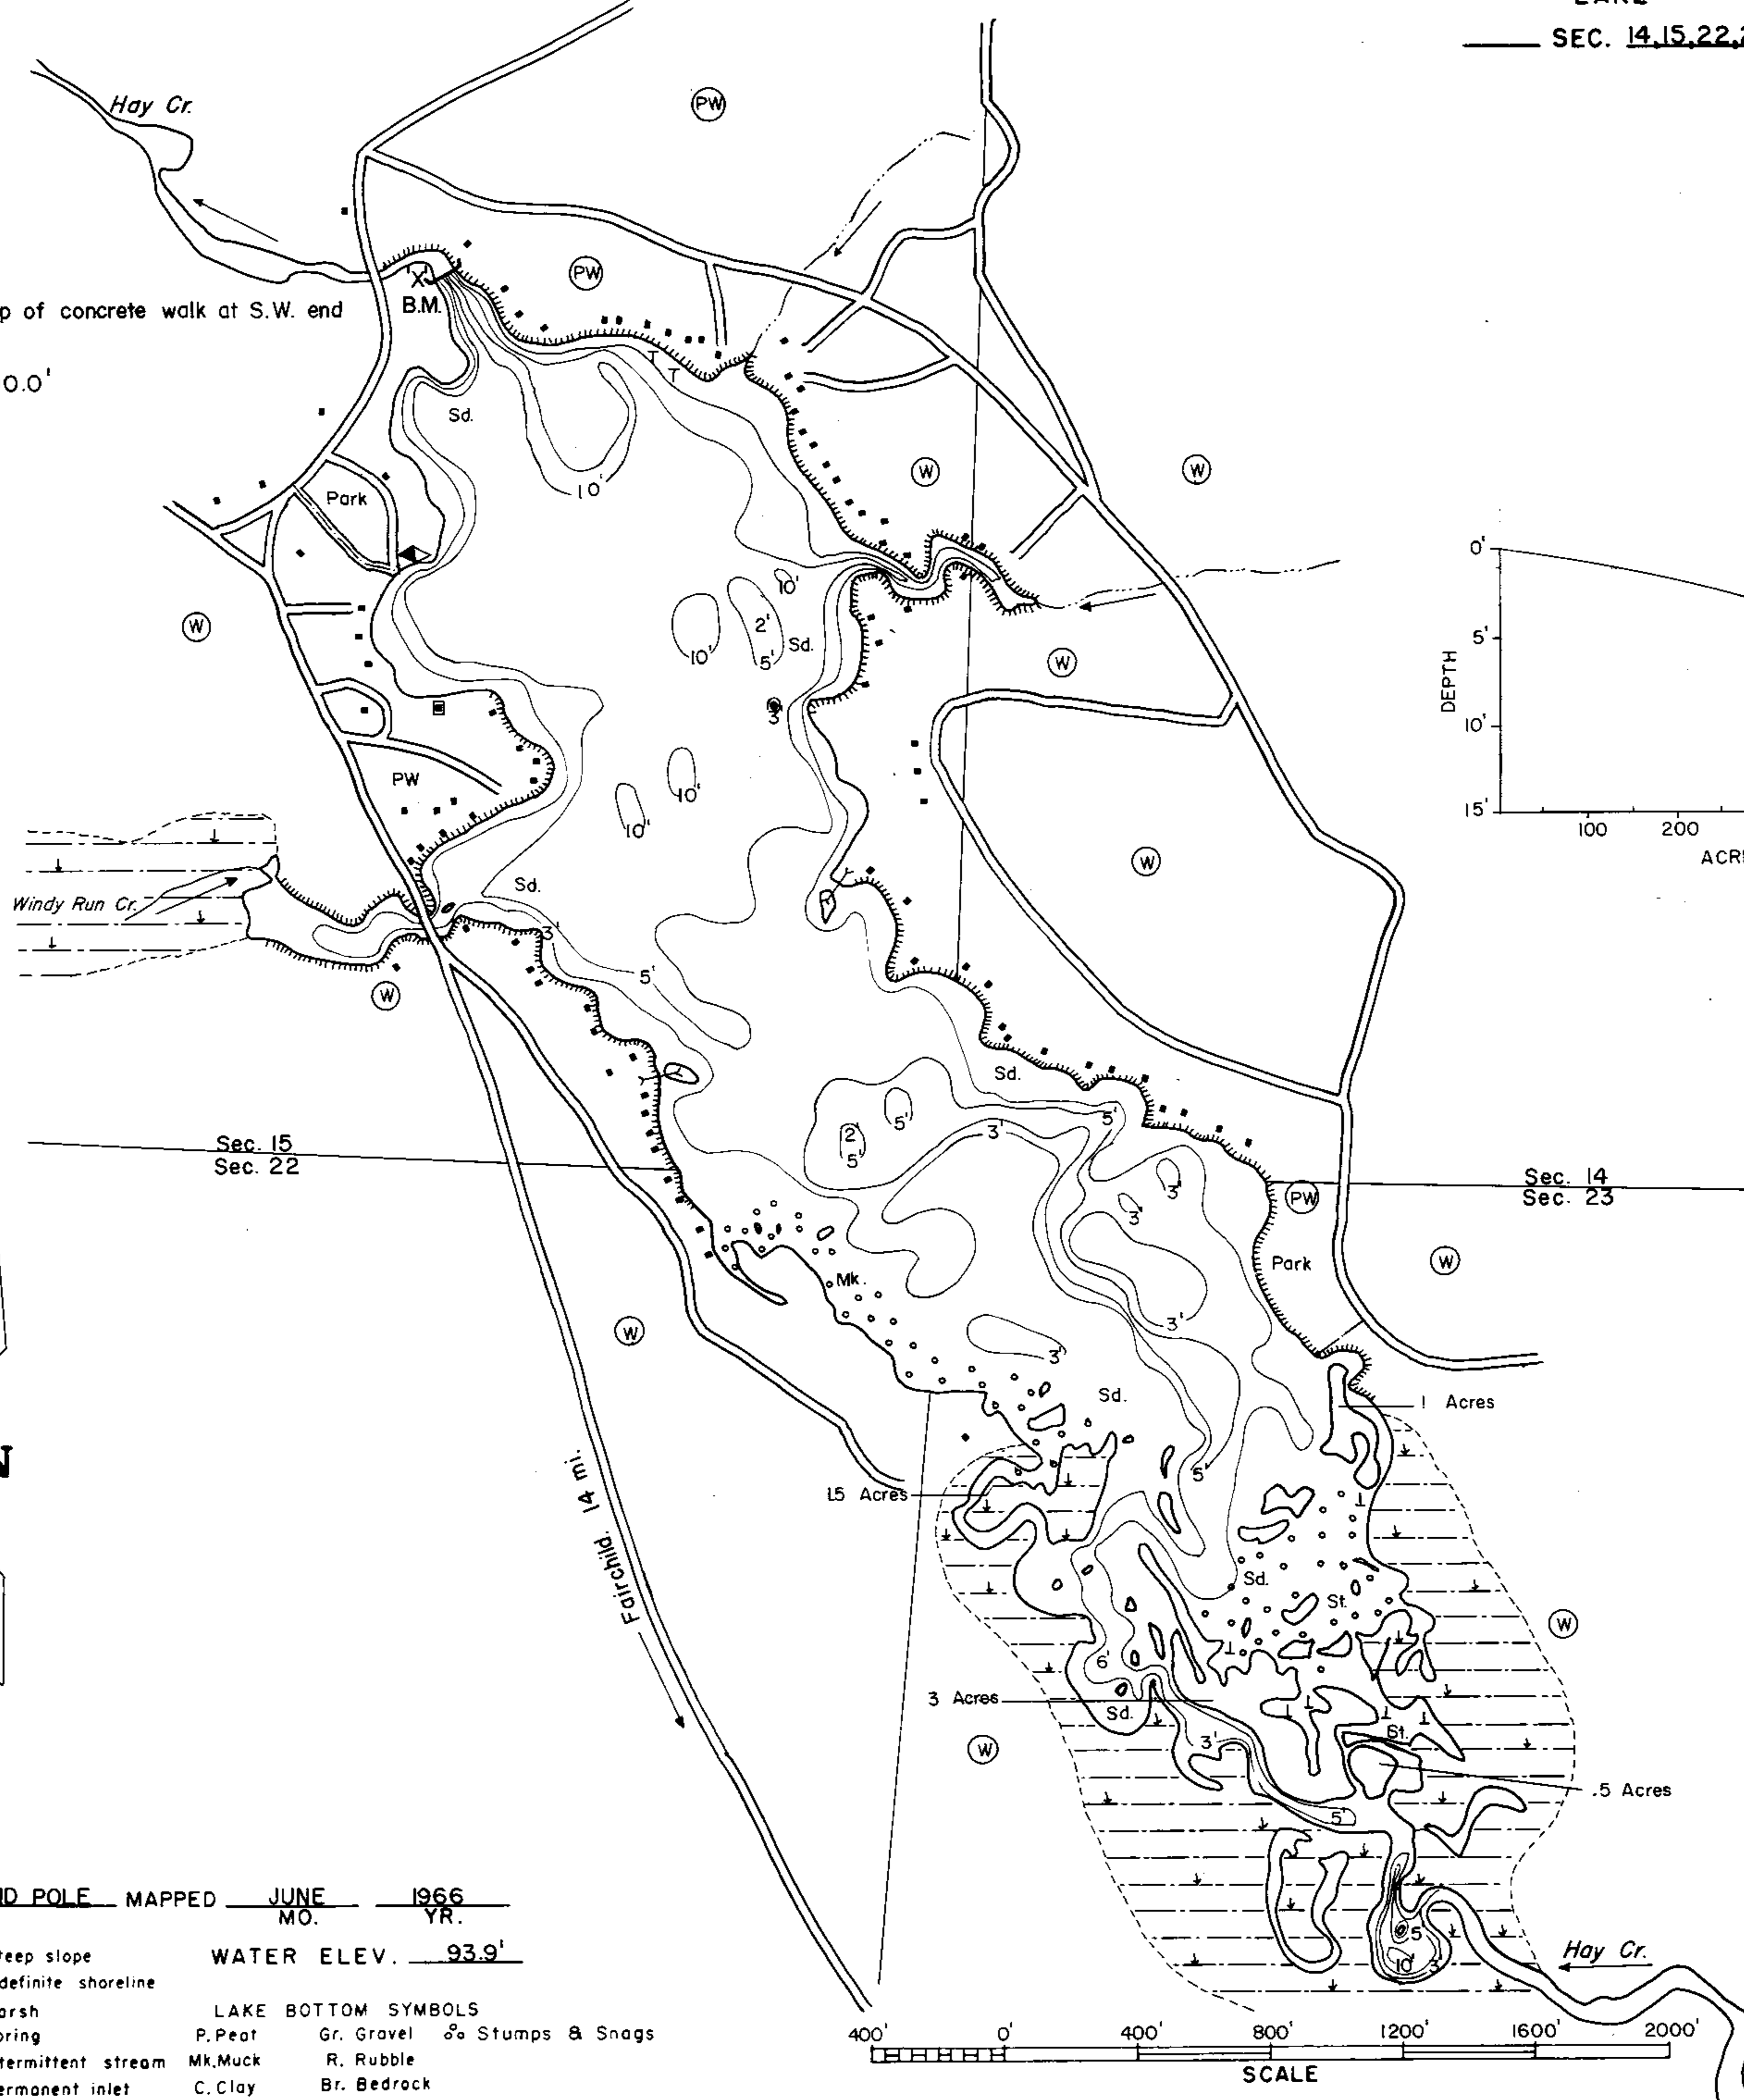
B.M. 'X' P.S.C. on top of concrete walk at S.W. end of dam abutment
Assumed elev. 100.0'
Water elev. 93.9'

117.7 WITHOUT IS.
AREA 125 ACRES
UNDER 3FT. 42.2 %
OVER 20FT. 0 %
VOLUME 525.7 ACRE FT.
TOTAL ALK. 15 P.P.M.
SHORELINE 5.3 MILES
MAX. DEPTH 10 FEET
