Source: Wisconsin Department of Natural Resources 608-266-2621  
Mead Lake – Clark County, Wisconsin DNR Lake Map  
Date – May 1966 - Historical Lake Map - Not for Navigation  
A Public Document - Please Identify the Source when using it.

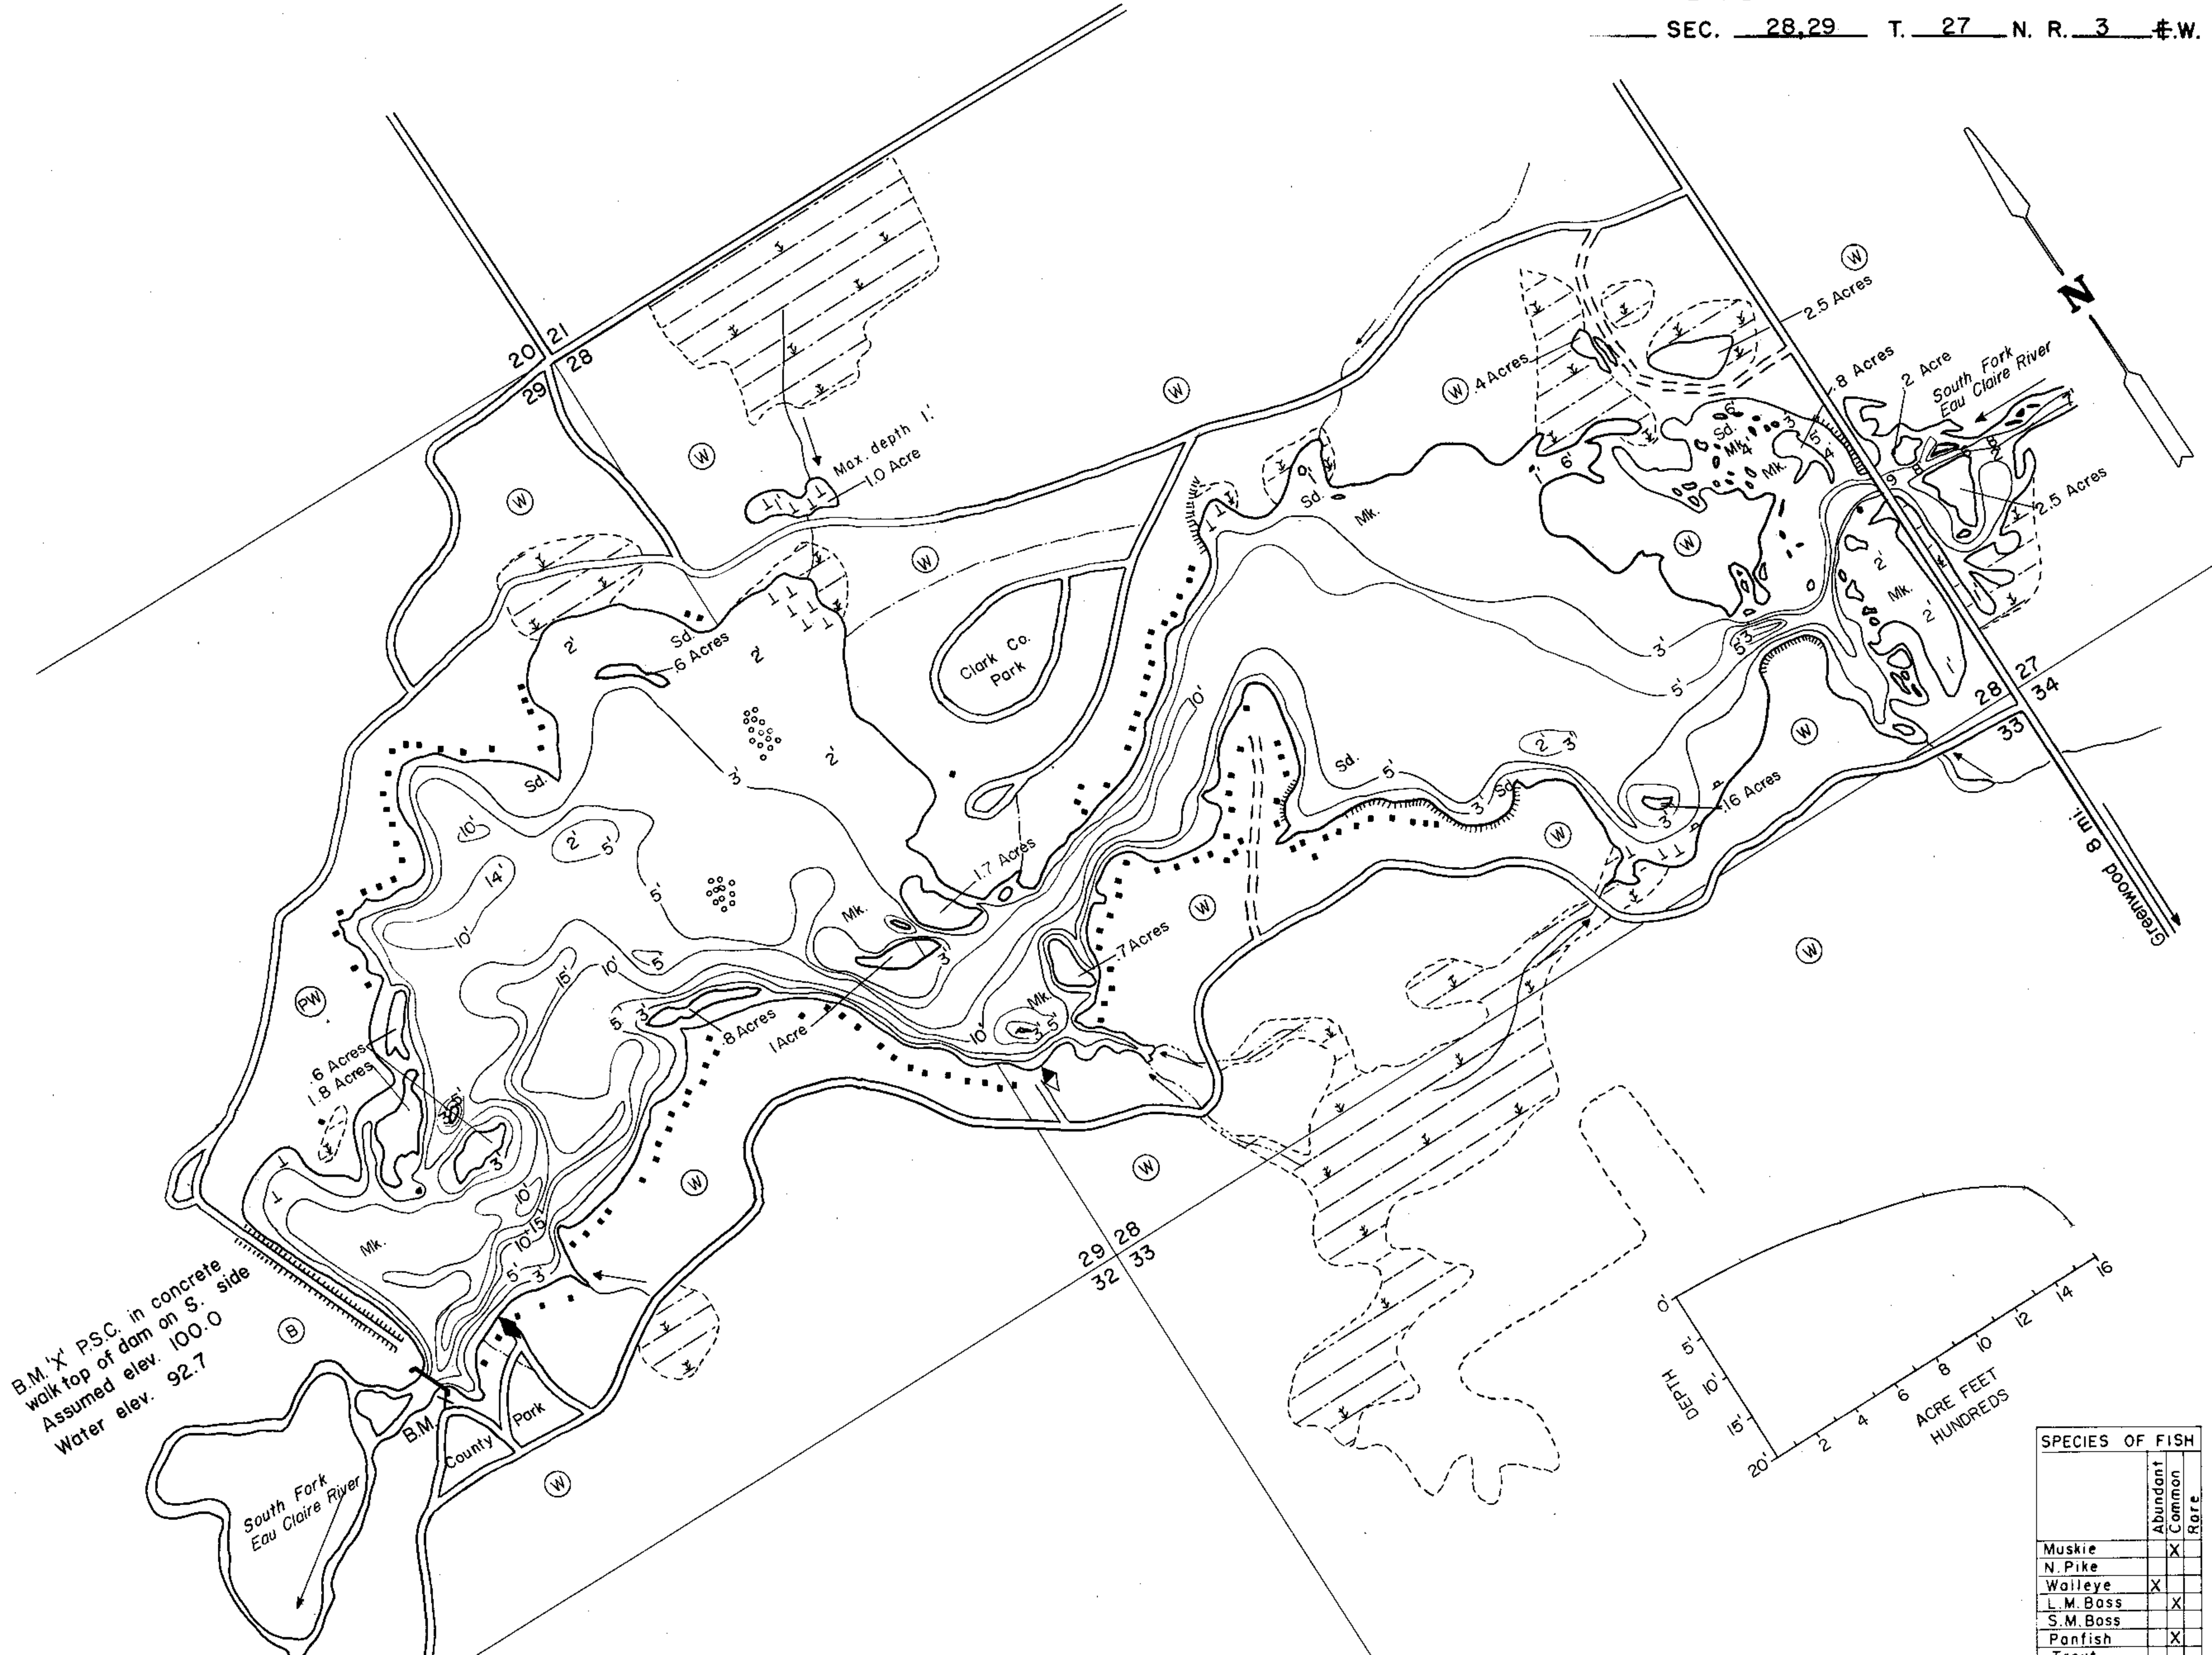
B.M. 'X' P.S.C. in concrete  
walk top of dam on S. side  
Assumed elev. 100.0  
Water elev. 92.7

- TOPOGRAPHIC SYMBOLS
- (B) Brush
  - (PW) Partially wooded
  - (W) Wooded
  - (C) Cleared
  - (P) Pastured
  - (A) Agricultural
  - B.M. Bench Mark
  - Dwelling
  - Resort
  - ||||| Steep slope
  - - - Indefinite shoreline
  - ||||| Marsh
  - Spring
  - Intermittent stream
  - Permanent inlet
  - Permanent outlet
  - Dam

WATER ELEV. 92.7

- LAKE BOTTOM SYMBOLS
- P. Peat
  - Mk. Muck
  - C. Clay
  - M. Marl
  - Sd. Sand
  - St. Silt
  - Gr. Gravel
  - R. Rubble
  - Br. Bedrock
  - T Submergent vegetation
  - ↓ Emergent vegetation
  - ⊕ Floating vegetation
  - ⊙ Stumps & Snags

AREA 330.2 WITH IS.  
319.5 ACRES  
UNDER 3FT. 39.2 %  
OVER 20 FT. 0 %  
VOLUME 1534.1 ACRE FT.  
TOTAL ALK. 20 P.P.M.  
SHORELINE 8.2 MILES  
MAX. DEPTH 16.0 FEET
