LAKE SURVEY MAP

OGEMA MILL POND PRICE
LAKE COUNTY
SEC. 12 T. 34 N. R. 1 E.

Source: Wisconsin Department of Natural Resources 608-266-2621
Ogema Millpond Lake – Price County, Wisconsin DNR Lake Map
Date – Sep 1968 - Historical Lake Map - Not for Navigation
A Public Document - Please Identify the Source when using it.

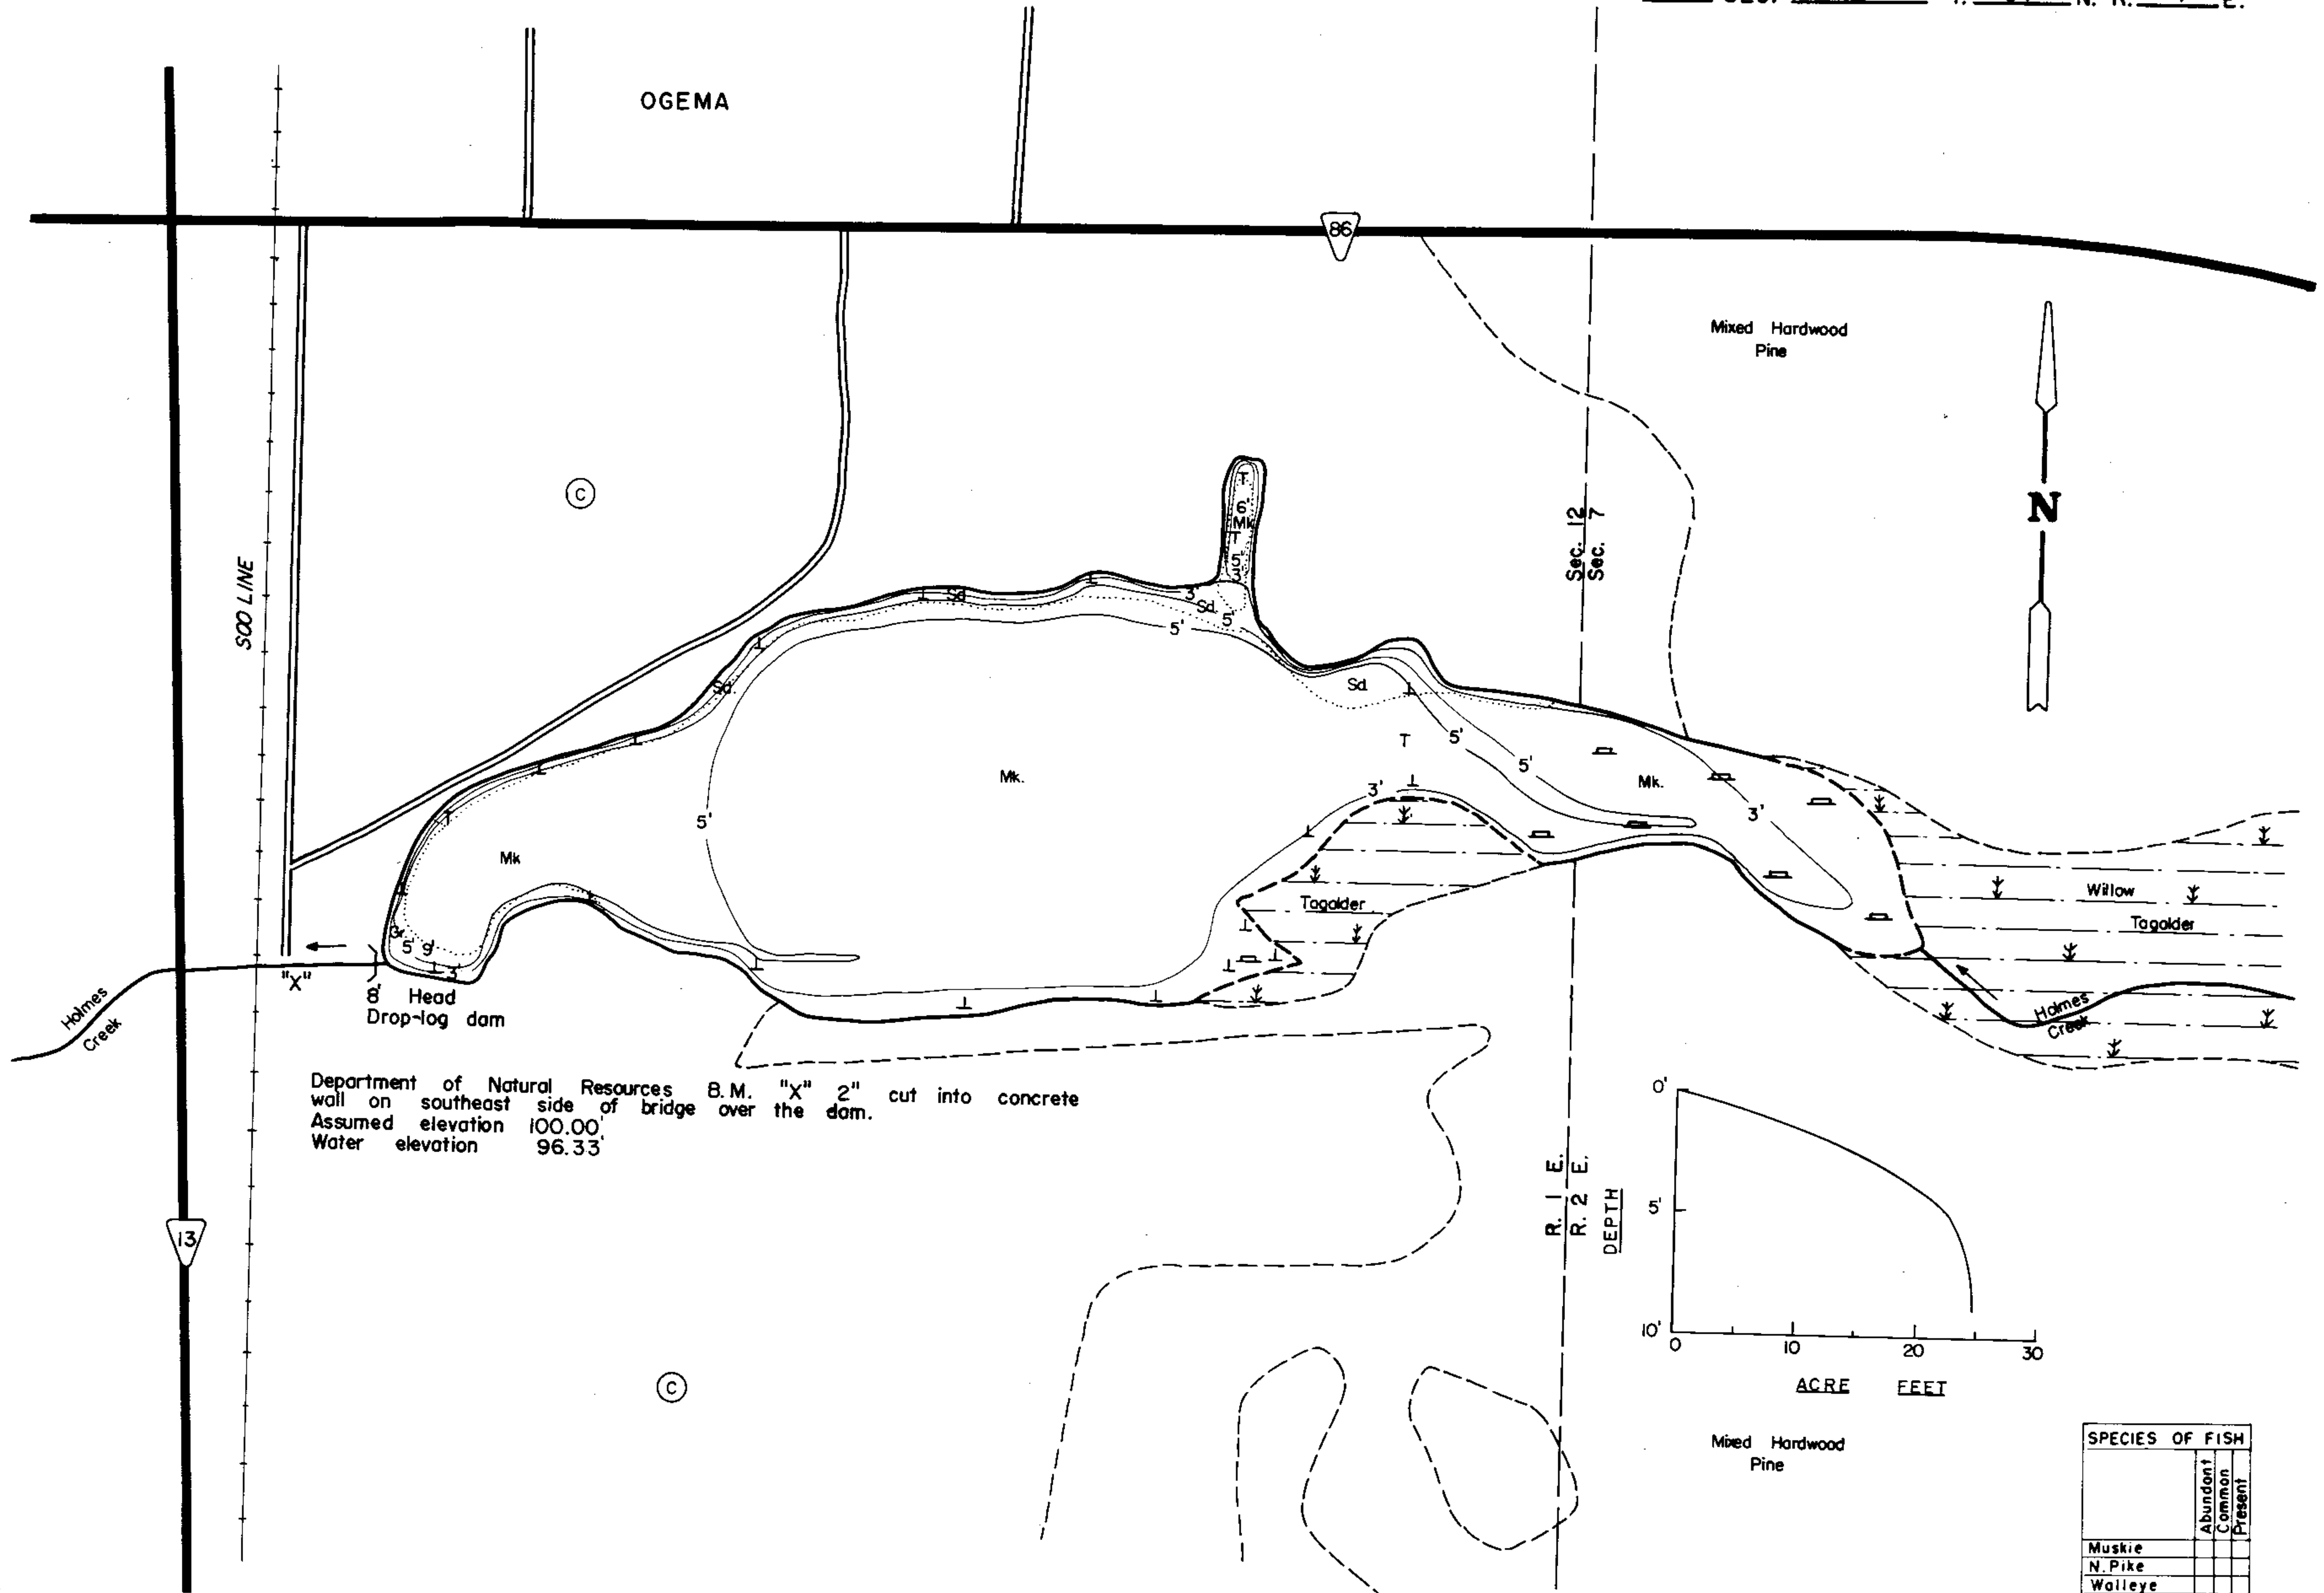
Department of Natural Resources B.M. "X" 2" cut into concrete wall on southeast side of bridge over the dam.
Assumed elevation 100.00'
Water elevation 96.33'

WATER ELEV. 96.33'

AREA 6.02 ACRES
UNDER 3FT. 15.0 %
OVER 20FT. 0.0 %
VOLUME 24.86 ACRE FT.
TOTAL ALK. 48 P.P.M.
SHORELINE .61 MILES
MAX. DEPTH 9 FEET
