Source: Wisconsin Department of Natural Resources 608-266-2621
Augustine Lake – Ashland County, Wisconsin DNR Lake Map
Date – Sep 1966 - Historical Lake Map - Not for Navigation
A Public Document - Please Identify the Source when using it.

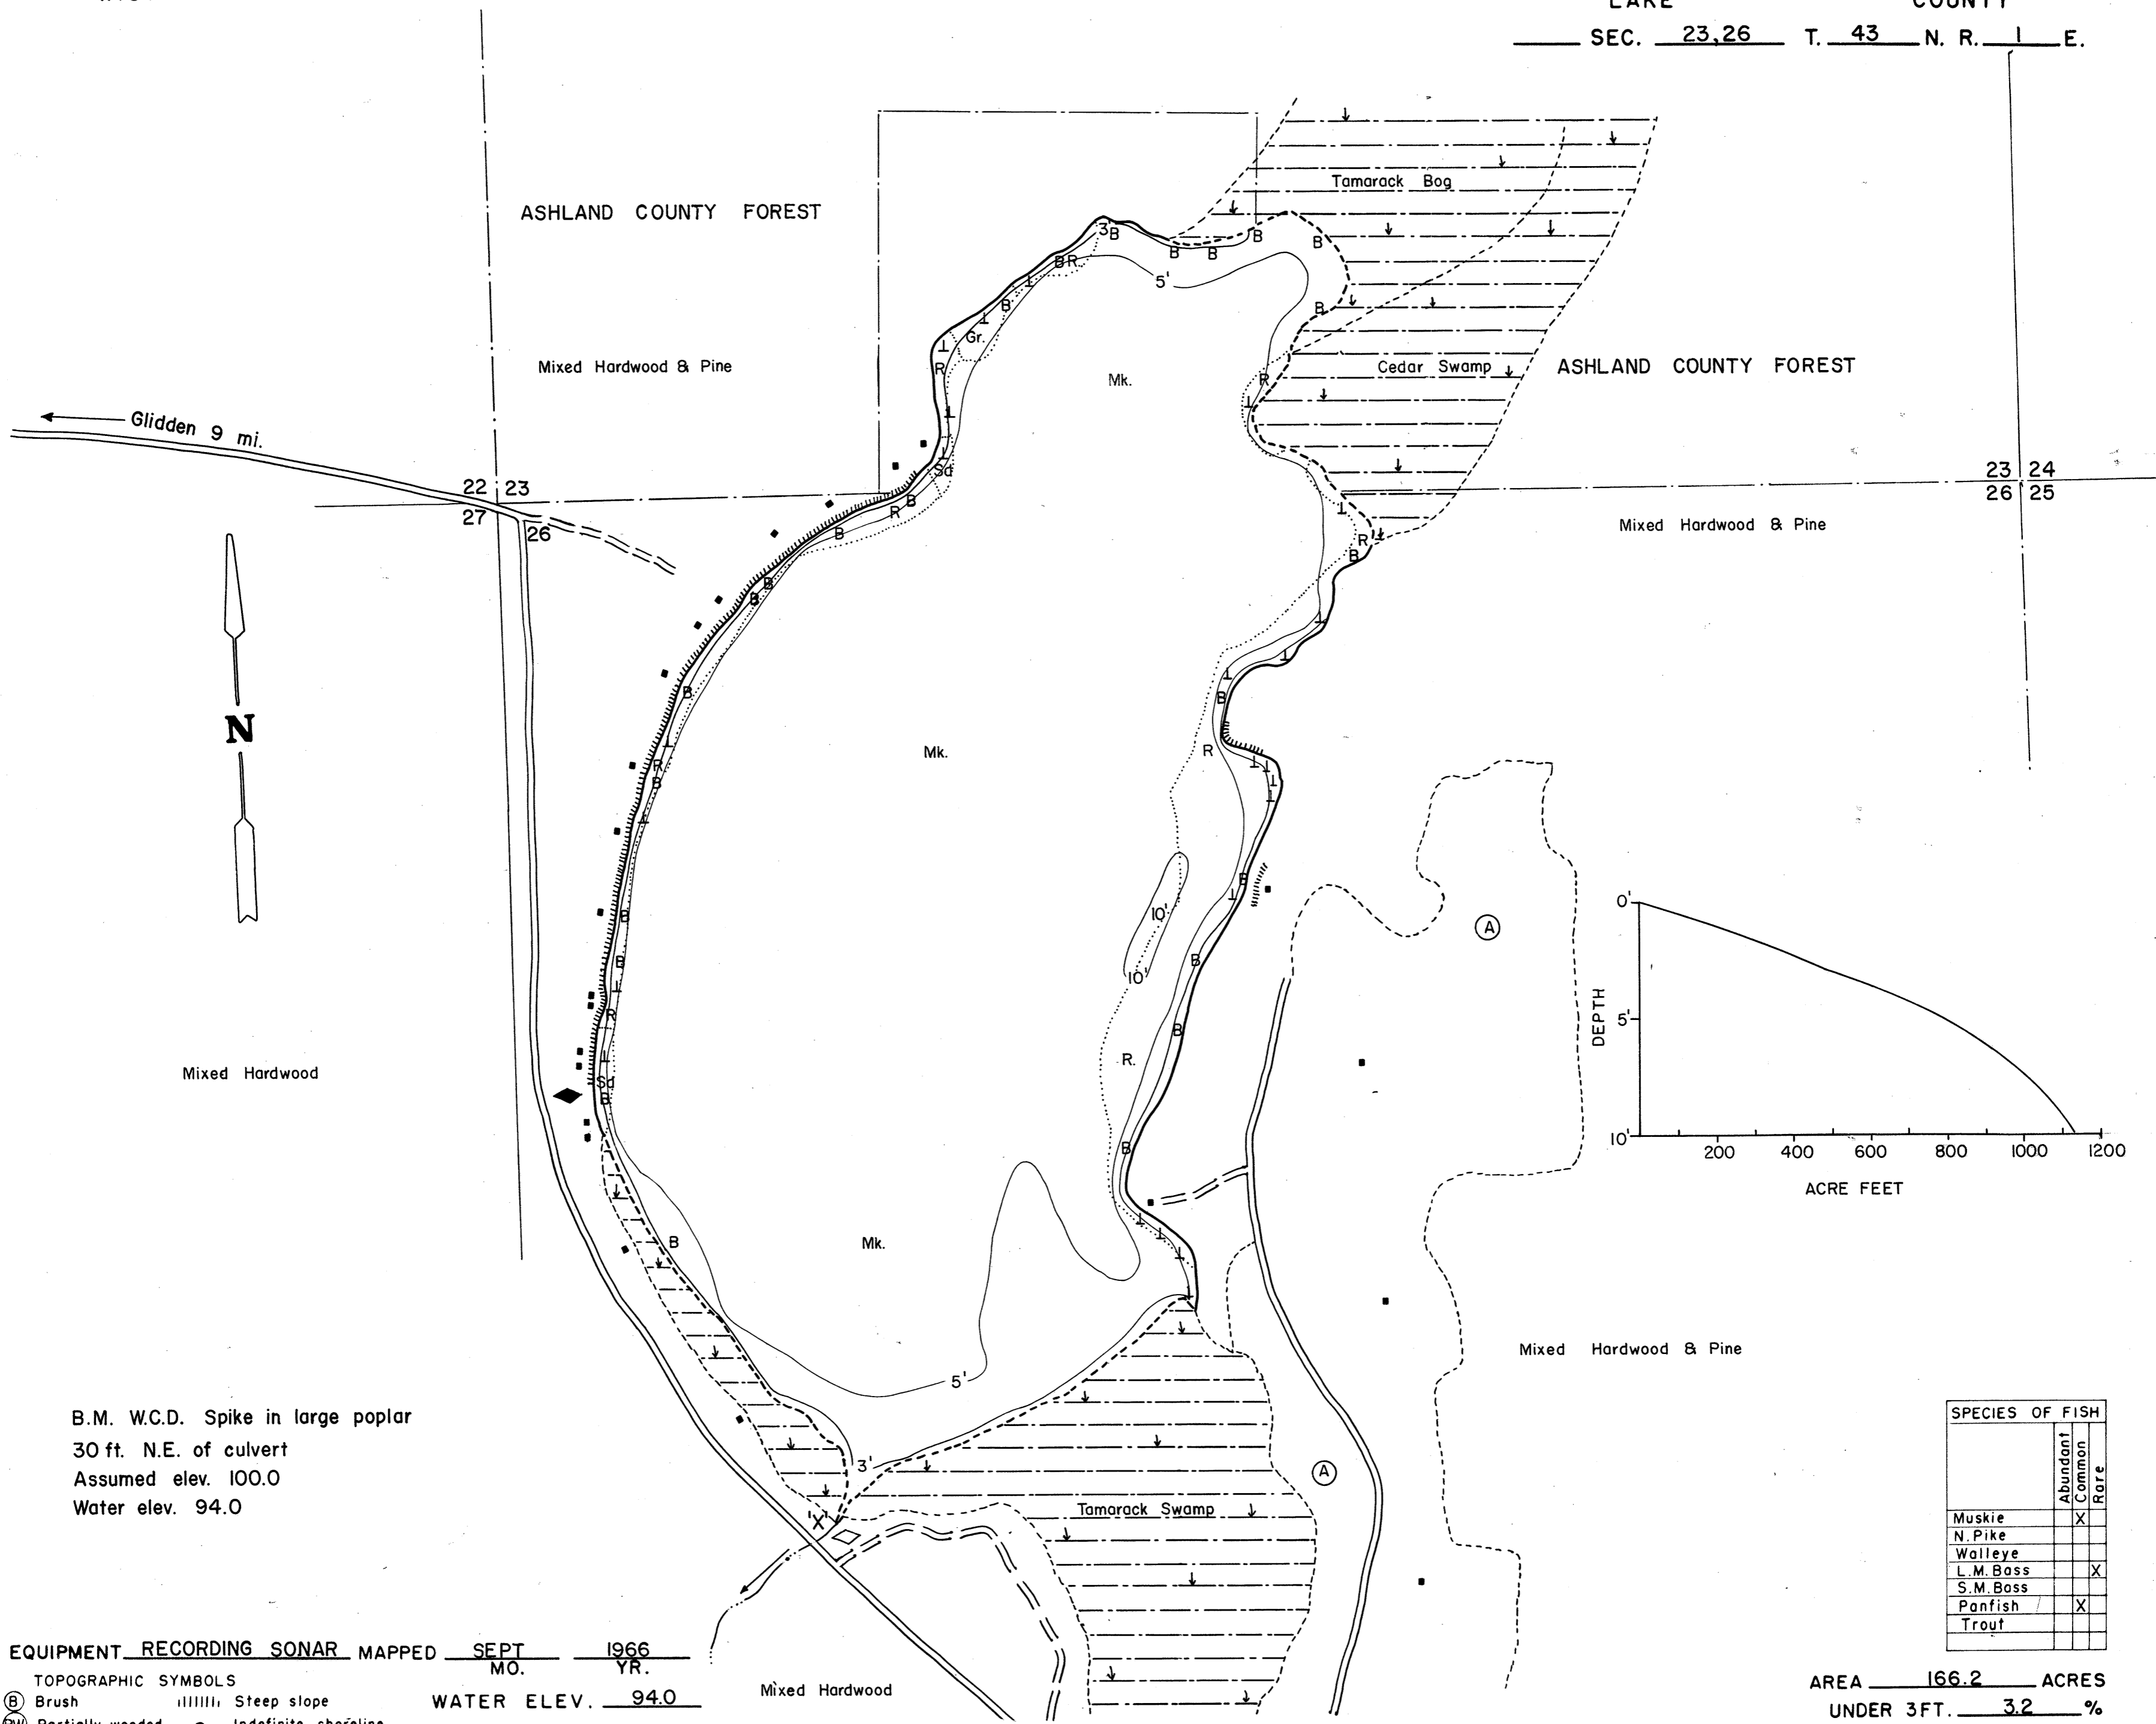
B.M. W.C.D. Spike in large poplar
30 ft. N.E. of culvert
Assumed elev. 100.0
Water elev. 94.0

WATER ELEV. 94.0

AREA 166.2 ACRES
UNDER 3 FT. 3.2 %
OVER 20 FT. 0 %
VOLUME 1132.9 ACRE FT.
TOTAL ALK. 9 P.P.M.
SHORELINE 2.3 MILES
MAX. DEPTH 10 FEET

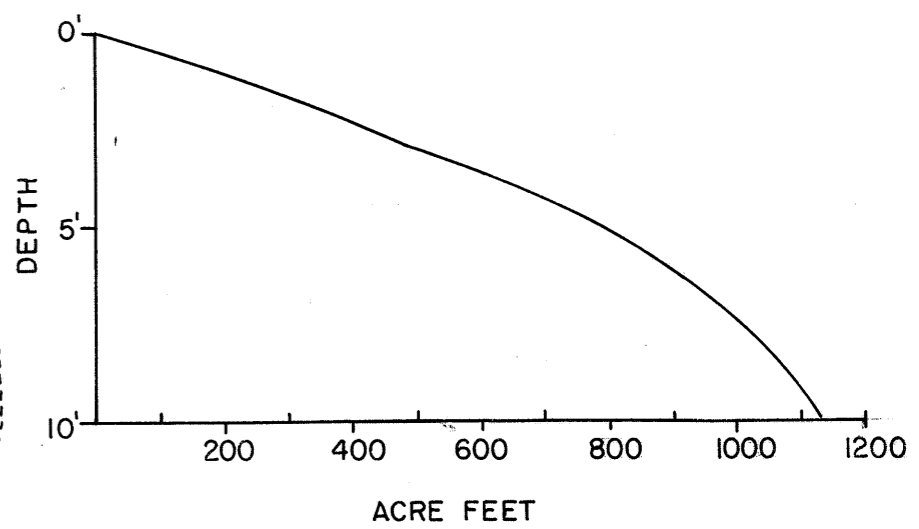
EQUIPMENT RECORDING SONAR MAPPED SEPT 1966
MO. YR.
