EQUIPMENT RECORDING SONAR MAPPED OCT 1968  
MONTH YEAR

Source: Wisconsin Department of Natural Resources 608-266-2621  
Herby Lake (Twin Lake) – Polk County, Wisconsin DNR Lake Map  
Date – Oct 1968 - Historical Lake Map - Not for Navigation  
A Public Document - Please Identify the Source when using it.

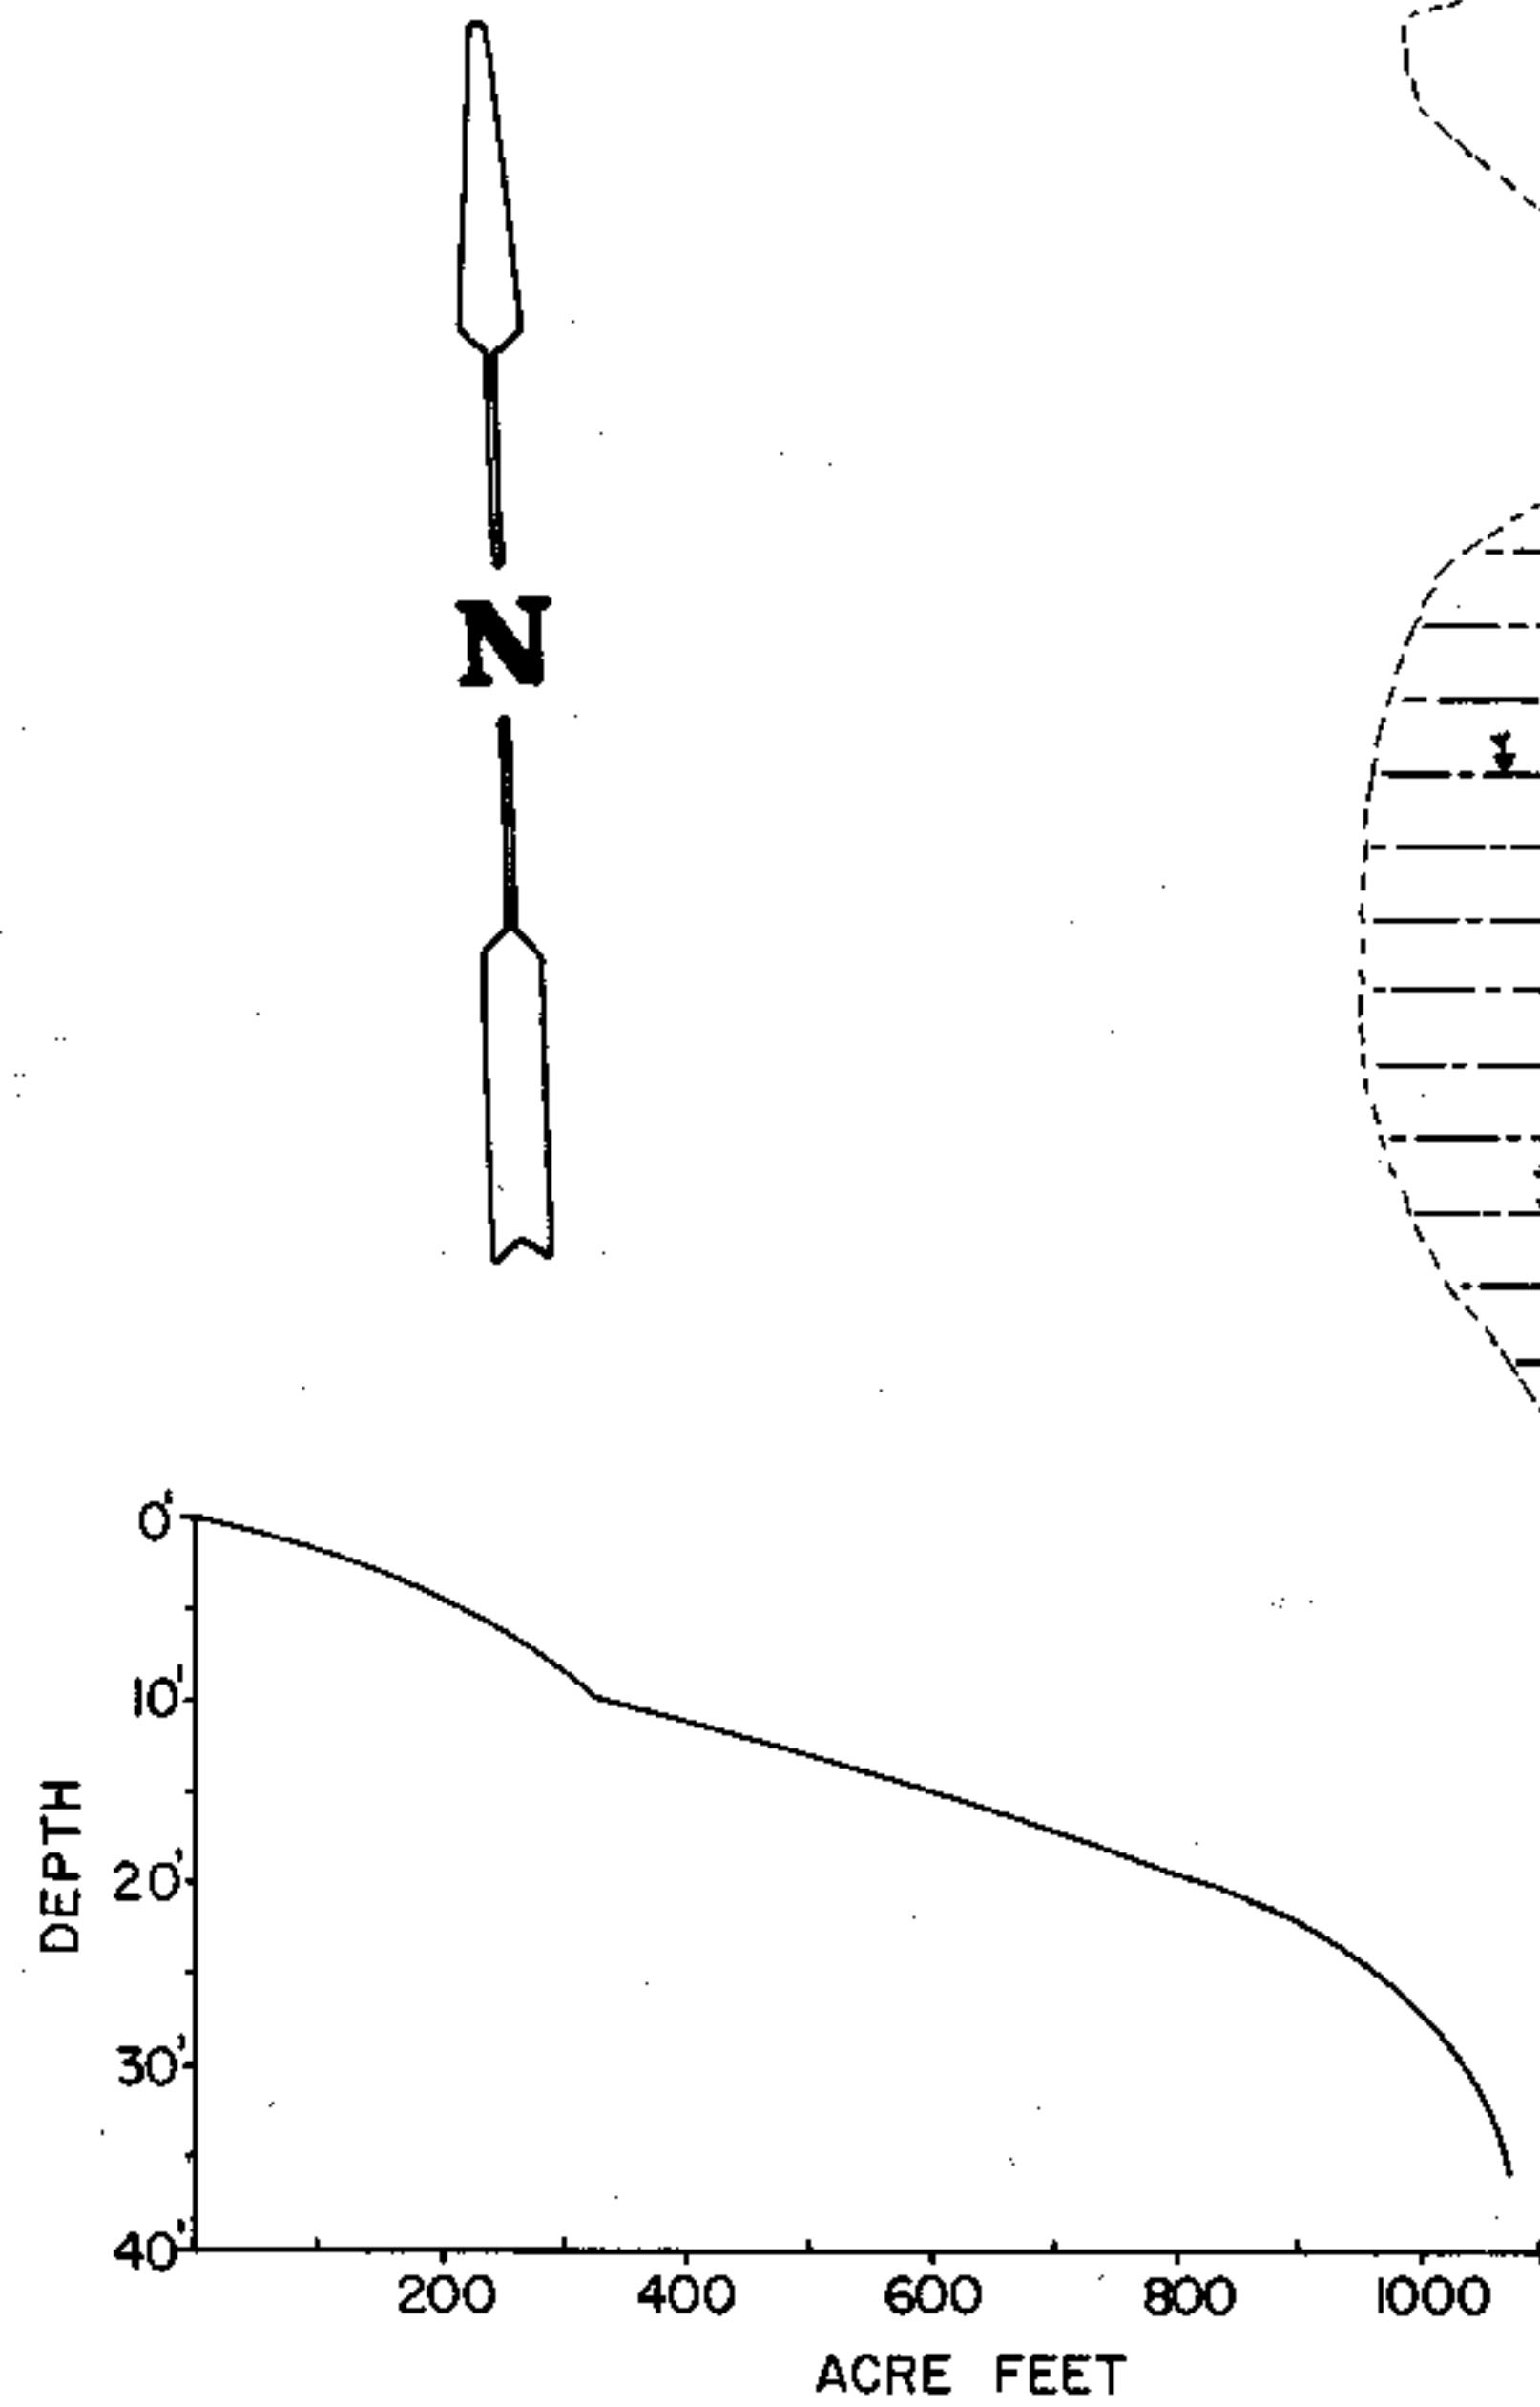
Department of Natural Resources  
B.M. 'X' 2" Square cut in base of outhouse  
30' S. of lake and 15' W. of centerline  
of road to private access  
Assumed elevation 100.00'  
Water level 98.02'

- LAKE BOTTOM SYMBOLS
- P. Peat
  - Mk. Muck
  - C. Clay
  - M. Marl
  - Sd. Sand
  - St. Silt
  - Gr. Gravel
  - R. Rubble
  - Br. Bedrock
  - B Boulders
  - Stumps & Snags
  - Rock danger to navigation
  - Submergent vegetation
  - Emergent vegetation
  - Floating vegetation
  - Brush shelters

WATER AREA 68.7 ACRES  
UNDER 3 FT. 7 %  
OVER 20 FT. 37 %  
MAX. DEPTH 36 FEET.  
TOTAL ALK. 51 P.P.M.  
VOLUME 1084.9 ACRE FT.  
SHORELINE 2.4 MILES
