EQUIPMENT RECORDING SONAR MAPPED JULY 1969

Source: Wisconsin Department of Natural Resources 608-266-2621
Little McGraw Lake – Burnett County, Wisconsin DNR Lake Map
Date – Jul 1969 - Historical Lake Map - Not for Navigation
A Public Document - Please Identify the Source when using it.

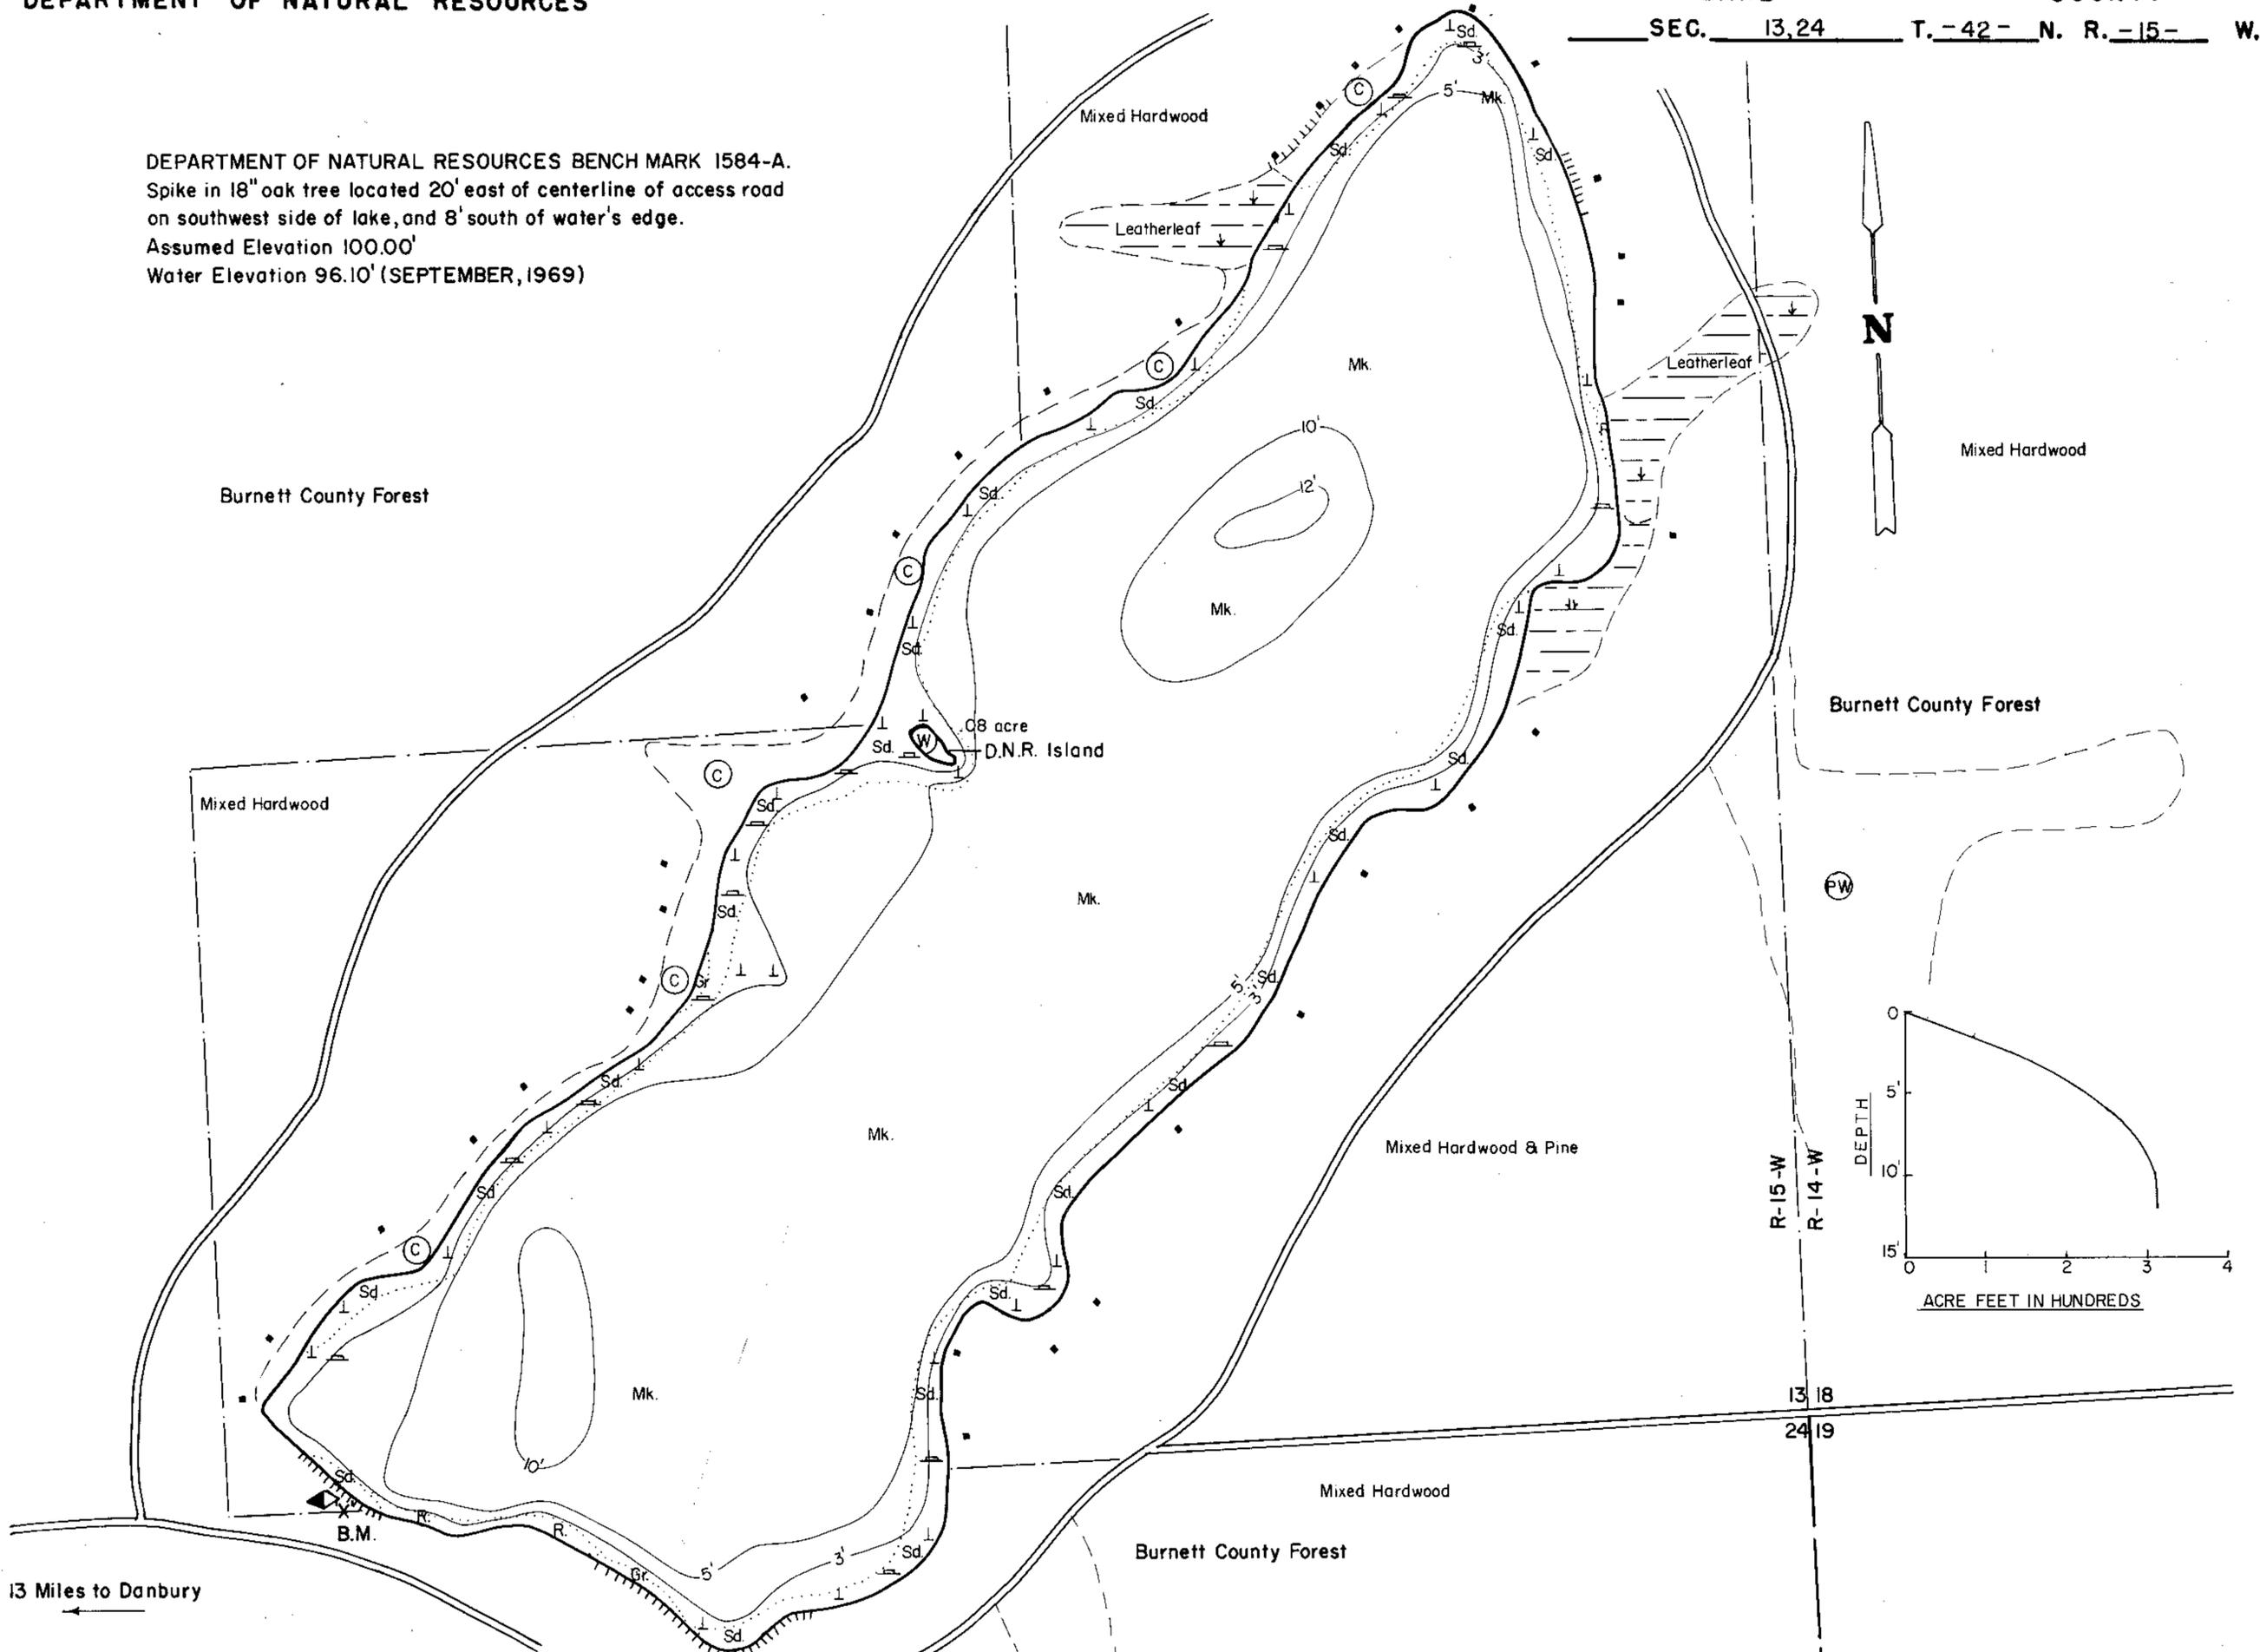
DEPARTMENT OF NATURAL RESOURCES BENCH MARK 1584-A.
Spike in 18" oak tree located 20' east of centerline of access road on southwest side of lake, and 8' south of water's edge.
Assumed Elevation 100.00'
Water Elevation 96.10' (SEPTEMBER, 1969)

WATER AREA 54.9 ACRES
UNDER 3 FT. 18 %
OVER 20 FT. 0 %
MAX. DEPTH 12 FEET.
TOTAL ALK. 15 P.P.M.
VOLUME 314.2 ACRE FT.
SHORELINE 1.46 MILES
1.42 MILES OF SHORELINE
EXCLUDING ISLANDS
