EQUIPMENT RECORDING SONAR MAPPED SEPT. 1969

Source: Wisconsin Department of Natural Resources 608-266-2621
Spur Lake (Little Pine Lake) – Polk County, Wisconsin DNR Lake Map
Date – Sep 1969 - Historical Lake Map - Not for Navigation
A Public Document - Please Identify the Source when using it.

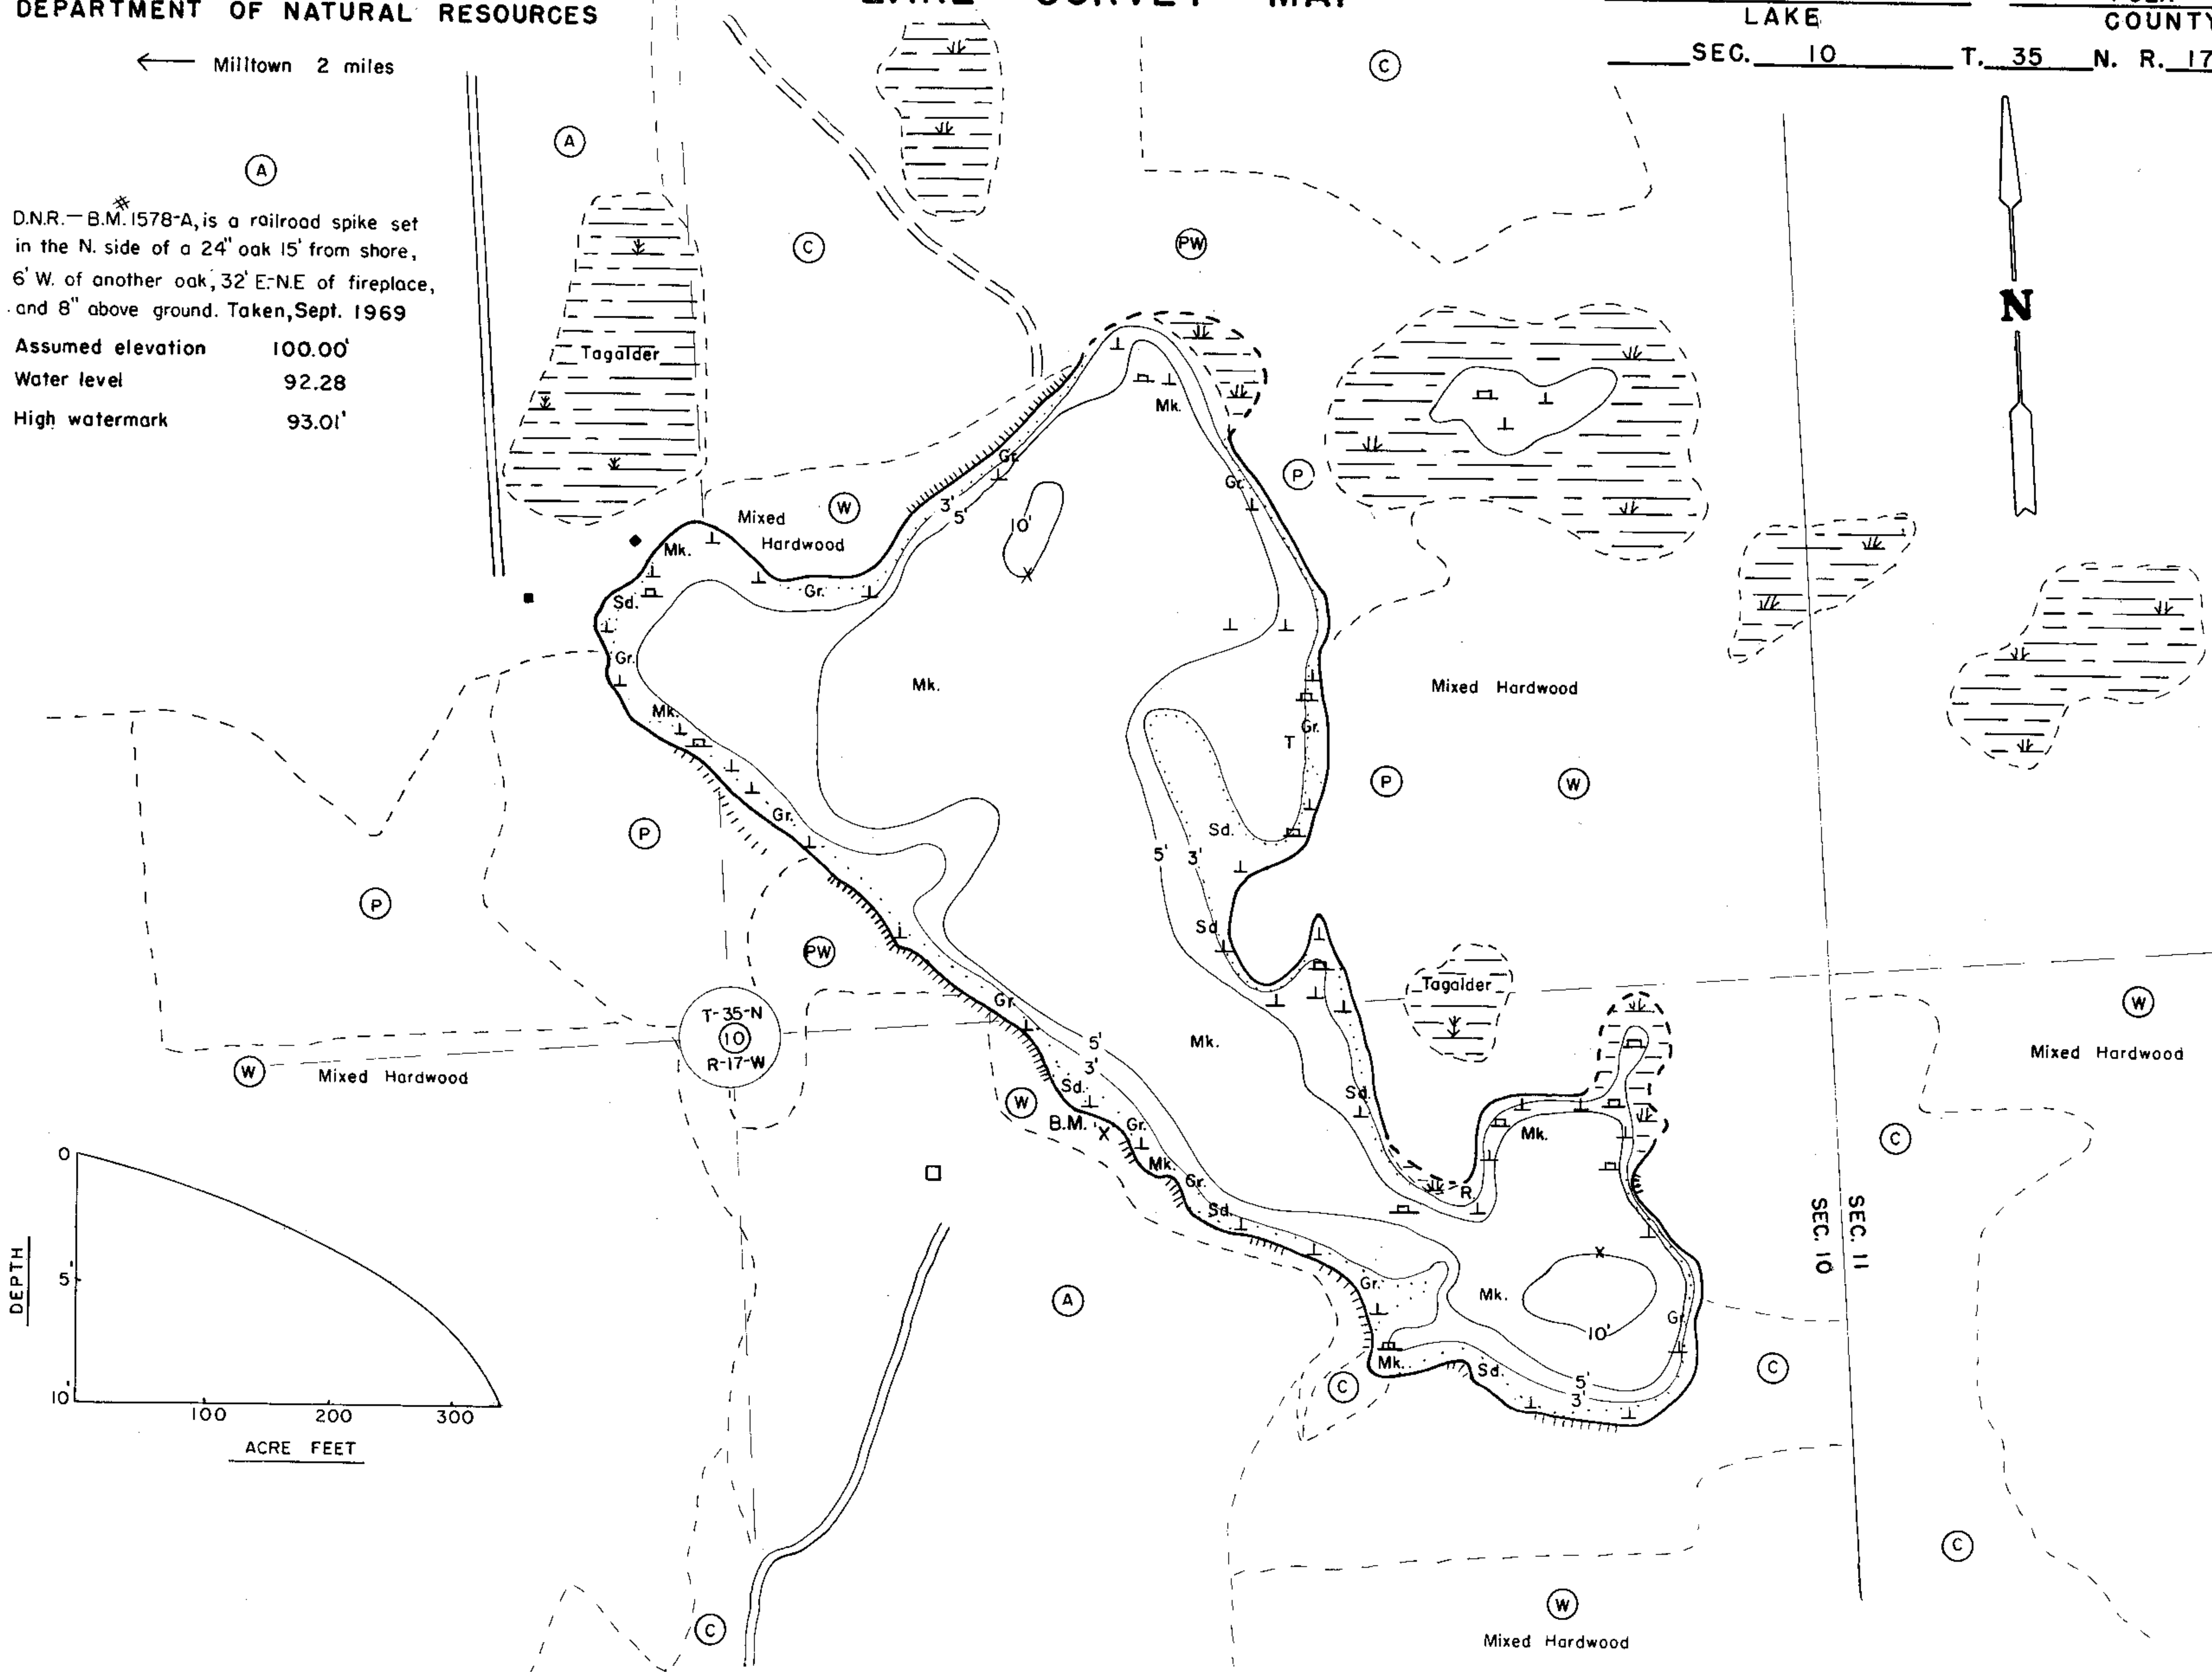
* D.N.R.—B.M. 1578-A, is a railroad spike set in the N. side of a 24" oak 15' from shore, 6' W. of another oak, 32' E.-N.E. of fireplace, and 8" above ground. Taken, Sept. 1969

Assumed elevation 100.00'
Water level 92.28
High watermark 93.01'

WATER AREA 61.3 ACRES
UNDER 3 FT. 19 %
OVER 20 FT. 0 %
MAX. DEPTH 10 FEET.
TOTAL ALK. 10 P.P.M.
VOLUME 337.65 ACRE FT.
SHORELINE 1.89 MILES
