AREA 378 ACRES  
UNDER 3FT 9 %  
OVER 20FT 0 %  
VOLUME 4,876.5 ACRE FT.  
TOTAL ALK 83 P.P.M  
SHORELINE 3.4 MILES  
MAX. DEPTH 19 FEET

Source: Wisconsin Department of Natural Resources 608-266-2621  
Big Butternut Lake – Polk County, Wisconsin DNR Lake Map  
Date – Jul 1965 - Historical Lake Map - Not for Navigation  
A Public Document - Please Identify the Source when using it.

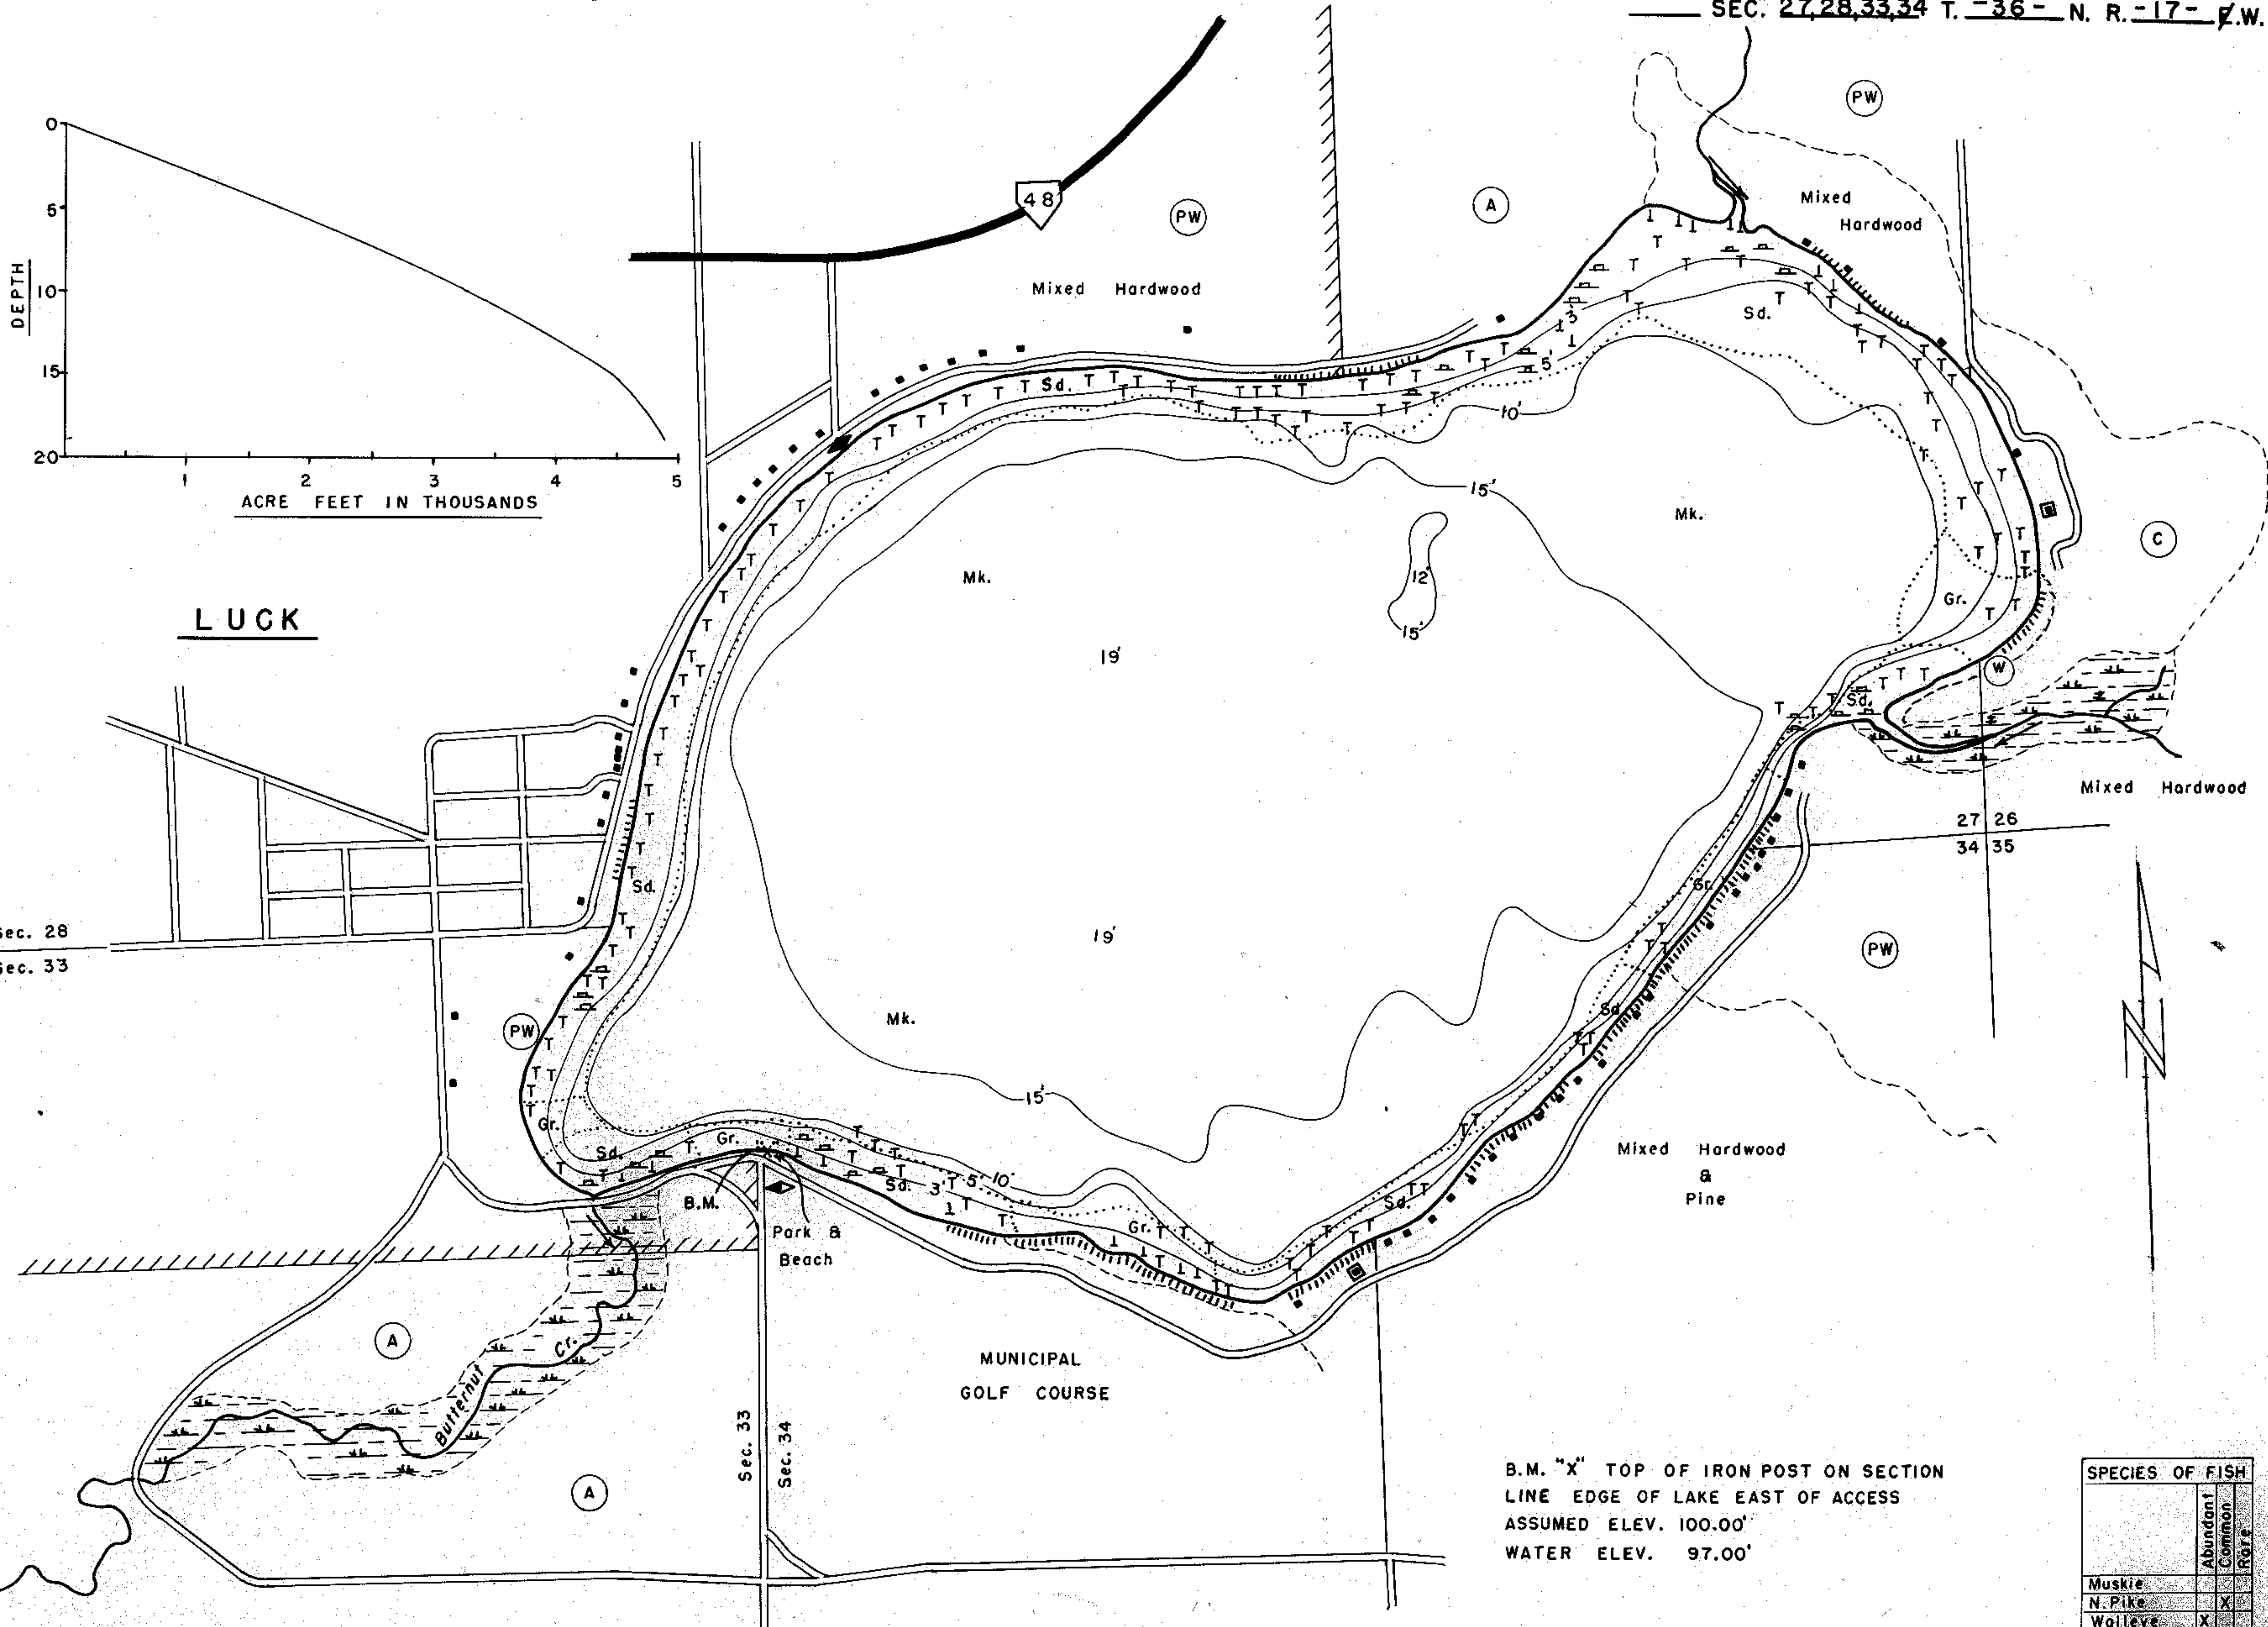
B.M. "X" TOP OF IRON POST ON SECTION LINE EDGE OF LAKE EAST OF ACCESS  
ASSUMED ELEV. 100.00'  
WATER ELEV. 97.00'

EQUIPMENT RECORDING SONAR MAPPED JULY 1965  
MO. YR.
