Source: Wisconsin Department of Natural Resources 608-266-2621  
Gilmore Lake - Washburn County, Wisconsin DNR Lake Map  
Date – Jul 1964 - Historical Lake Map - Not for Navigation  
A Public Document - Please Identify the Source when using it.

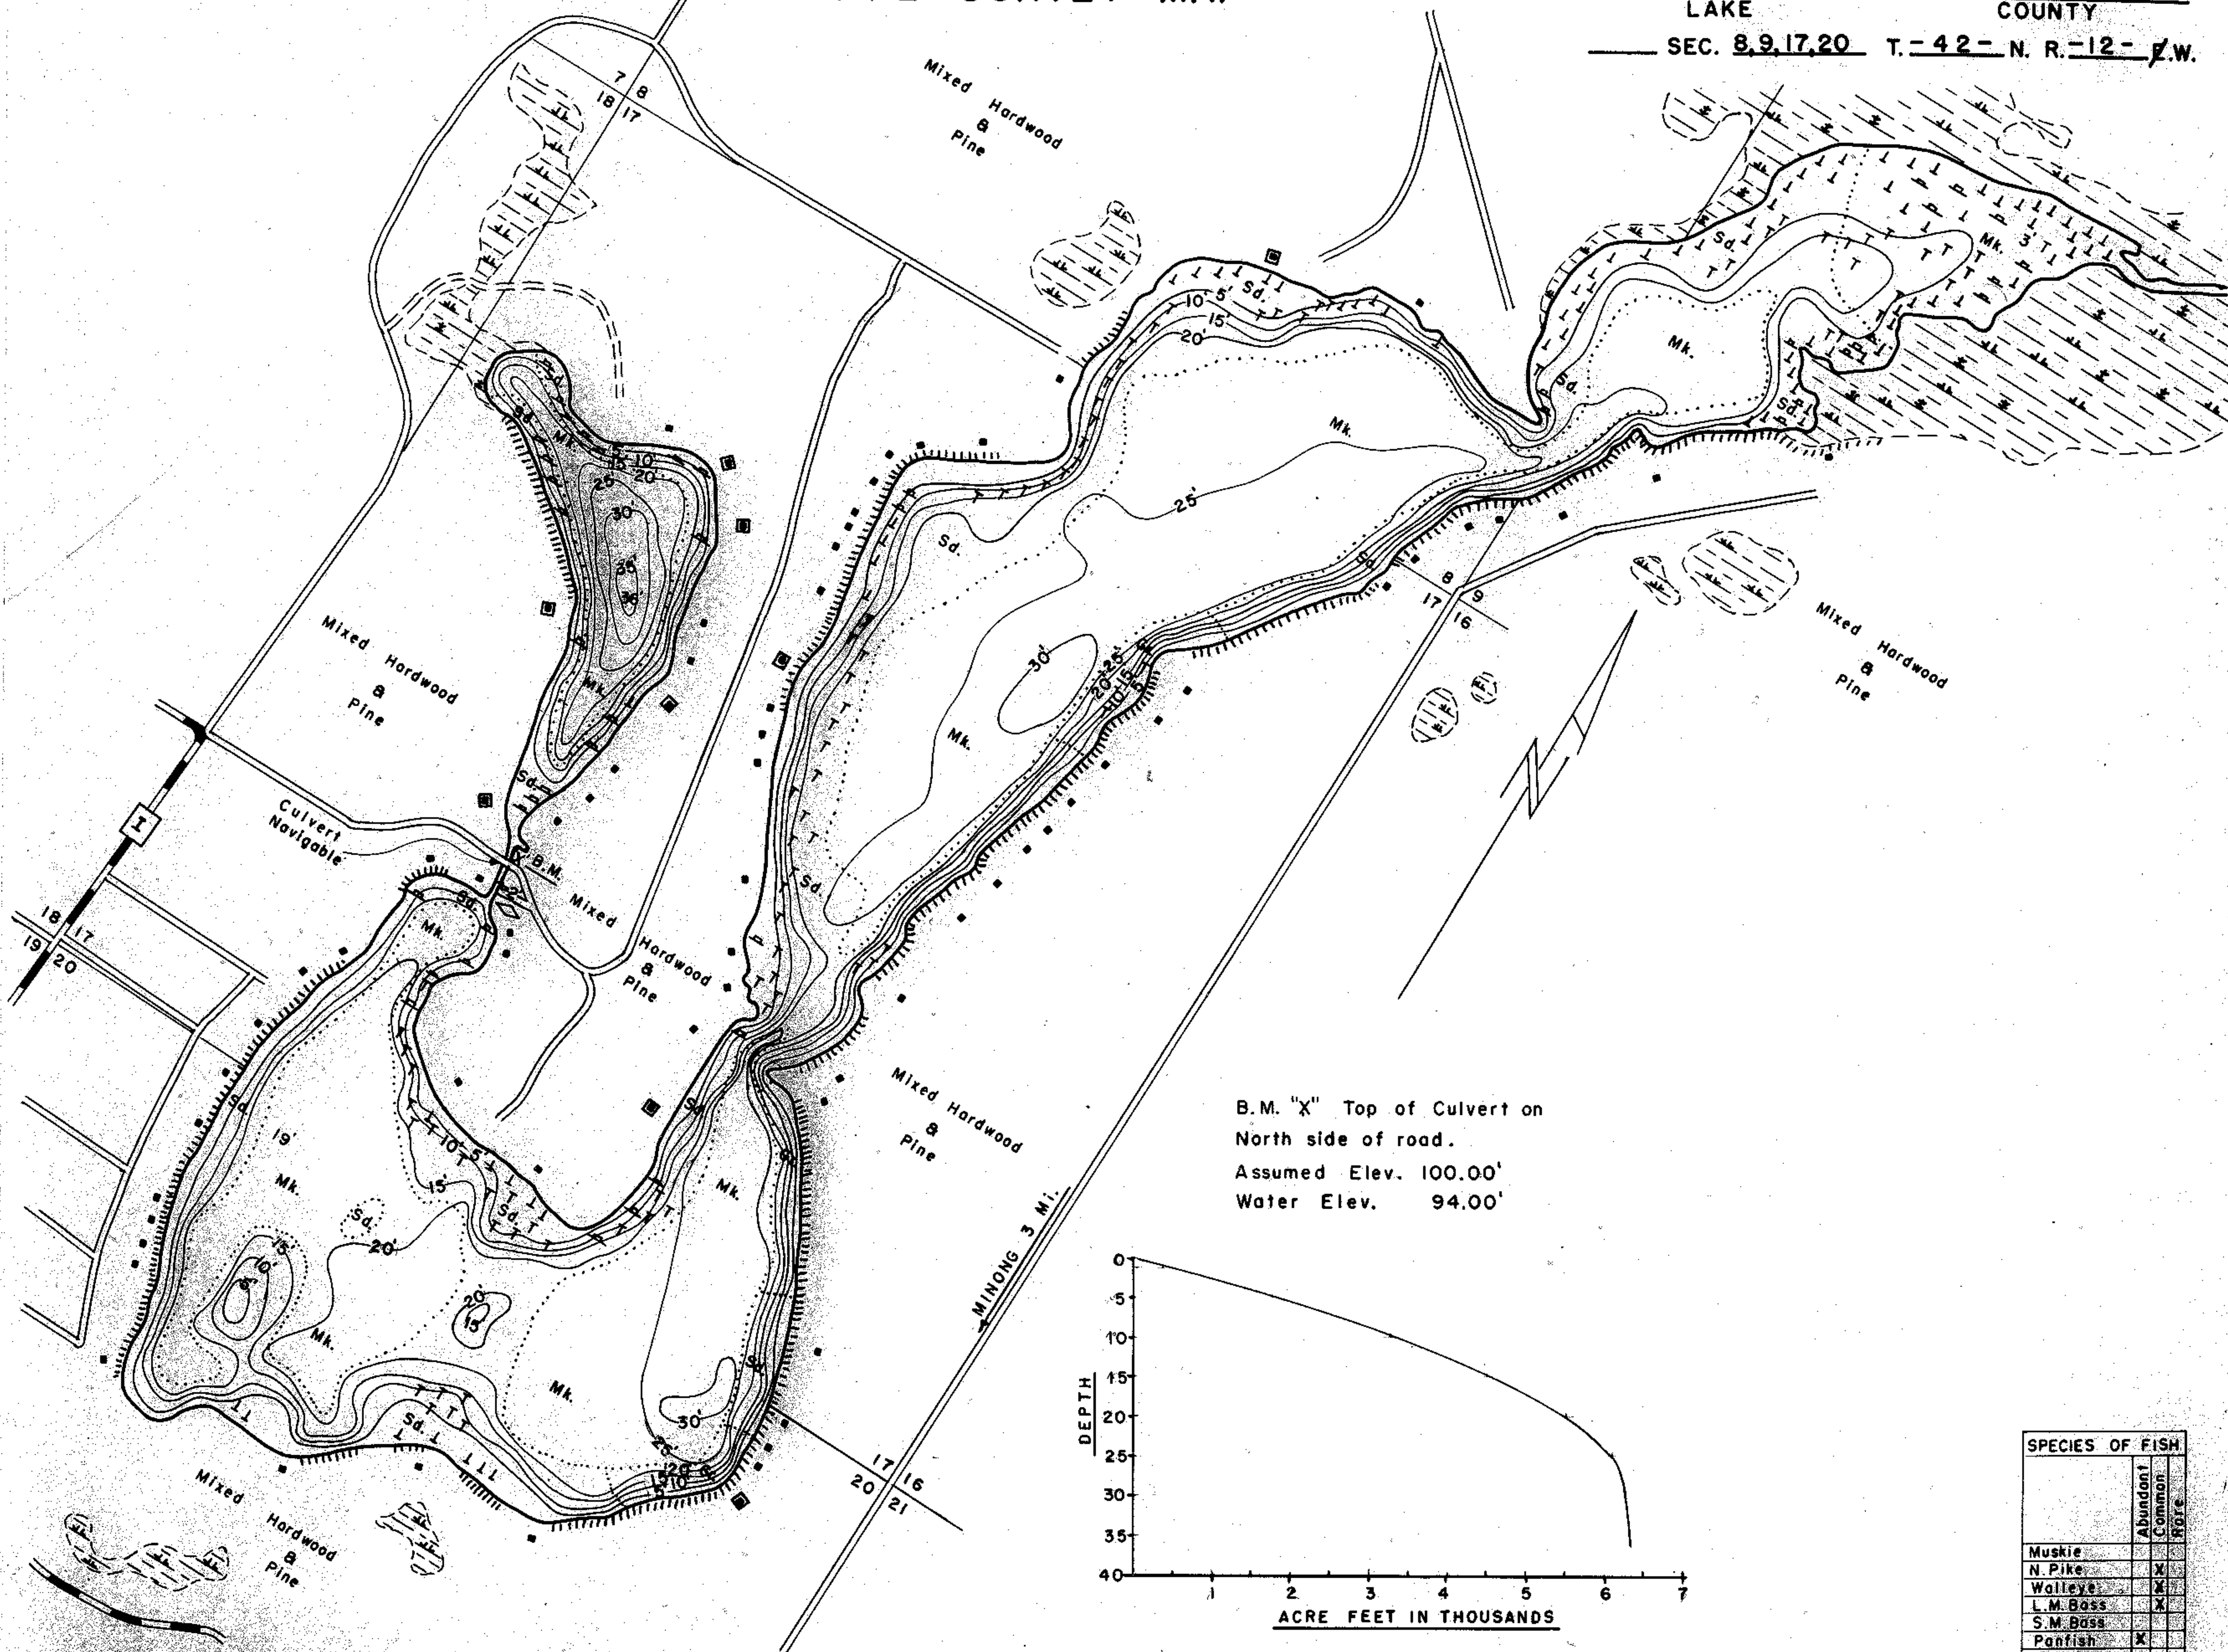
B.M. "X" Top of Culvert on North side of road.  
Assumed Elev. 100.00'  
Water Elev. 94.00'

- TOPOGRAPHIC SYMBOLS
- (B) Brush
  - (PW) Partially wooded
  - (W) Wooded
  - (C) Cleared
  - (P) Pastured
  - (A) Agricultural
  - B.M. Bench Mark
  - Dwelling
  - Resort
- WATER ELEV. 94.00'
- LAKE BOTTOM SYMBOLS
- P. Peat
  - Mk. Muck
  - C. Clay
  - M. Marl
  - Sd. Sand
  - St. Silt
  - Gr. Gravel
  - R. Rubble
  - Br. Bedrock
  - T Submergent vegetation
  - ⊥ Emergent vegetation
  - ▭ Floating vegetation
- Steep slope  
Indefinite shoreline  
Marsh  
Spring  
Intermittent stream  
Permanent inlet  
Permanent outlet  
Dam

AREA 389.4 ACRES  
UNDER 5 FT. 18 %  
OVER 20 FT. 2 %  
VOLUME 6,301.7 ACRE FT.  
TOTAL ALK. 38 P.P.M.  
SHORELINE 7.6 MILES  
MAX. DEPTH 36 FEET
