EQUIPMENT RECORDING SONAR MAPPED JULY 1976

Source: Wisconsin Department of Natural Resources 608-266-2621  
Pacwawong Lake – Sawyer County, Wisconsin DNR Lake Map  
Date – Jul 1976 - Historical Lake Map - Not for Navigation  
A Public Document - Please Identify the Source when using it.

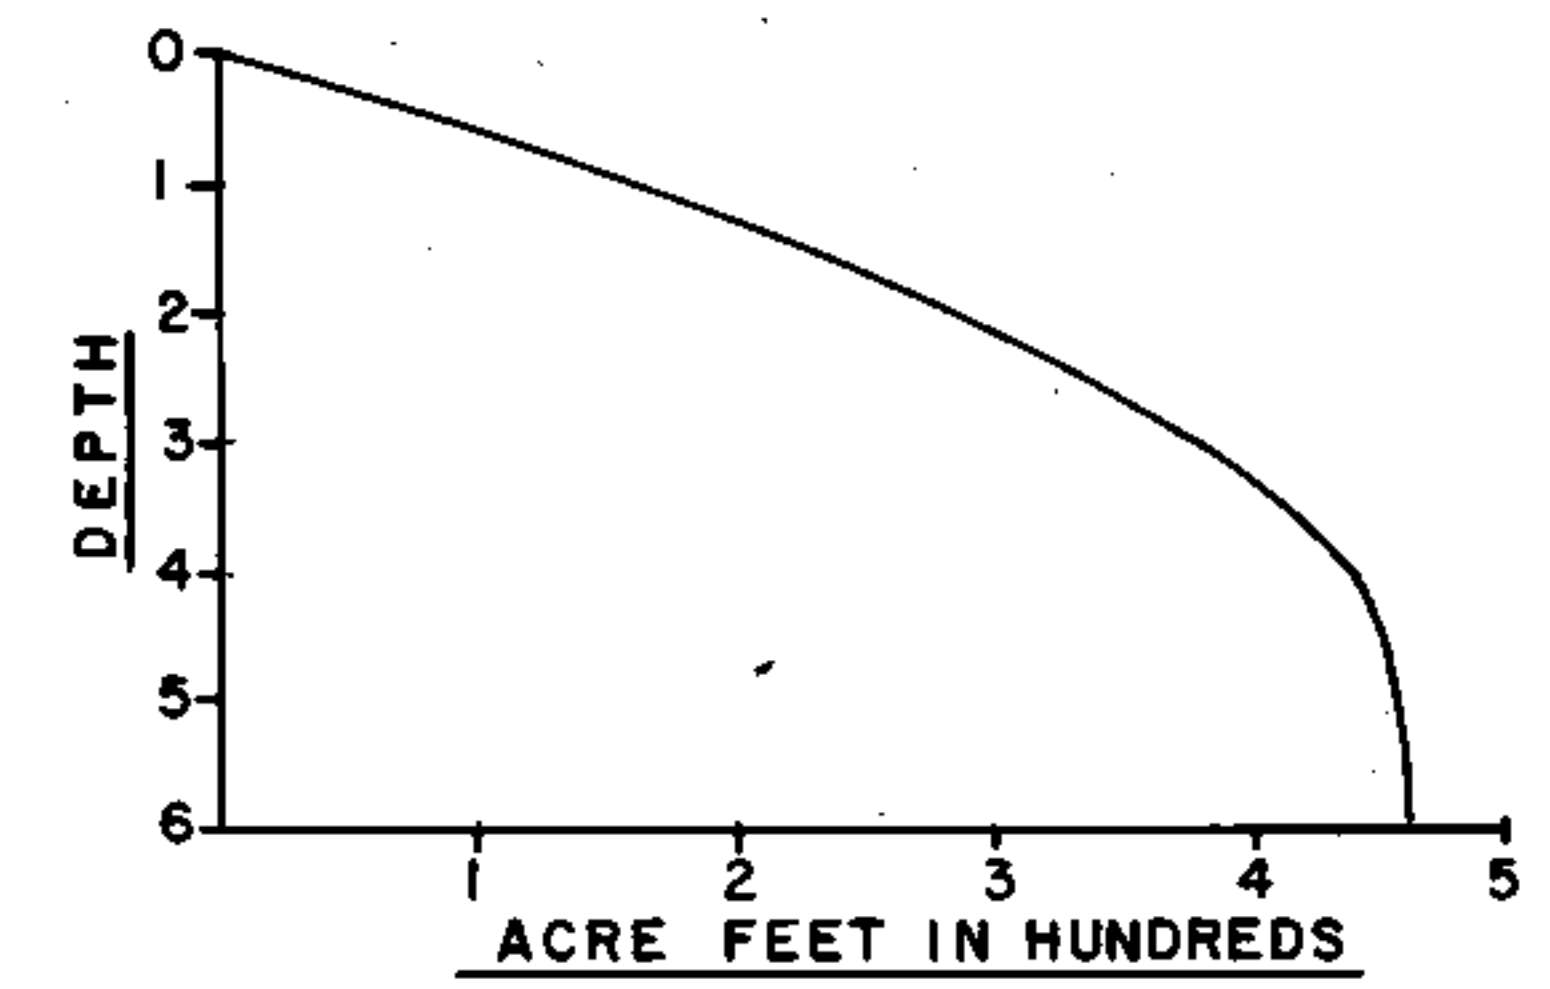
B.M. 'X' is a railroad spike in the base of a 12" Elm tree south of Ⓞ of access west of shoreline on southwest side of lake  
Assumed Elevation 100.00'  
Water Elevation 97.29'  
Tailwater Elevation 95.44'

WATER AREA 159.6 ACRES  
UNDER 3 FT. 48 %  
OVER 20 FT. 0 %  
MAX. DEPTH 6 FEET.  
TOTAL ALK. 55 P.P.M.  
VOLUME 459.1 ACRE FT.  
MAIN SHORELINE 4.37 MI.  
ISLAND SHORELINE .33 MI.
