# LAKE SURVEY MAP

CARSON POND LAKE BAYFIELD COUNTY  
SEC. 17 T. 46 N. R. 7 E.W.

Source: Wisconsin Department of Natural Resources 608-266-2621  
Carson Lake – Bayfield County, Wisconsin DNR Lake Map  
Date – Oct 1977 - Historical Lake Map - Not for Navigation  
A Public Document - Please Identify the Source when using it.

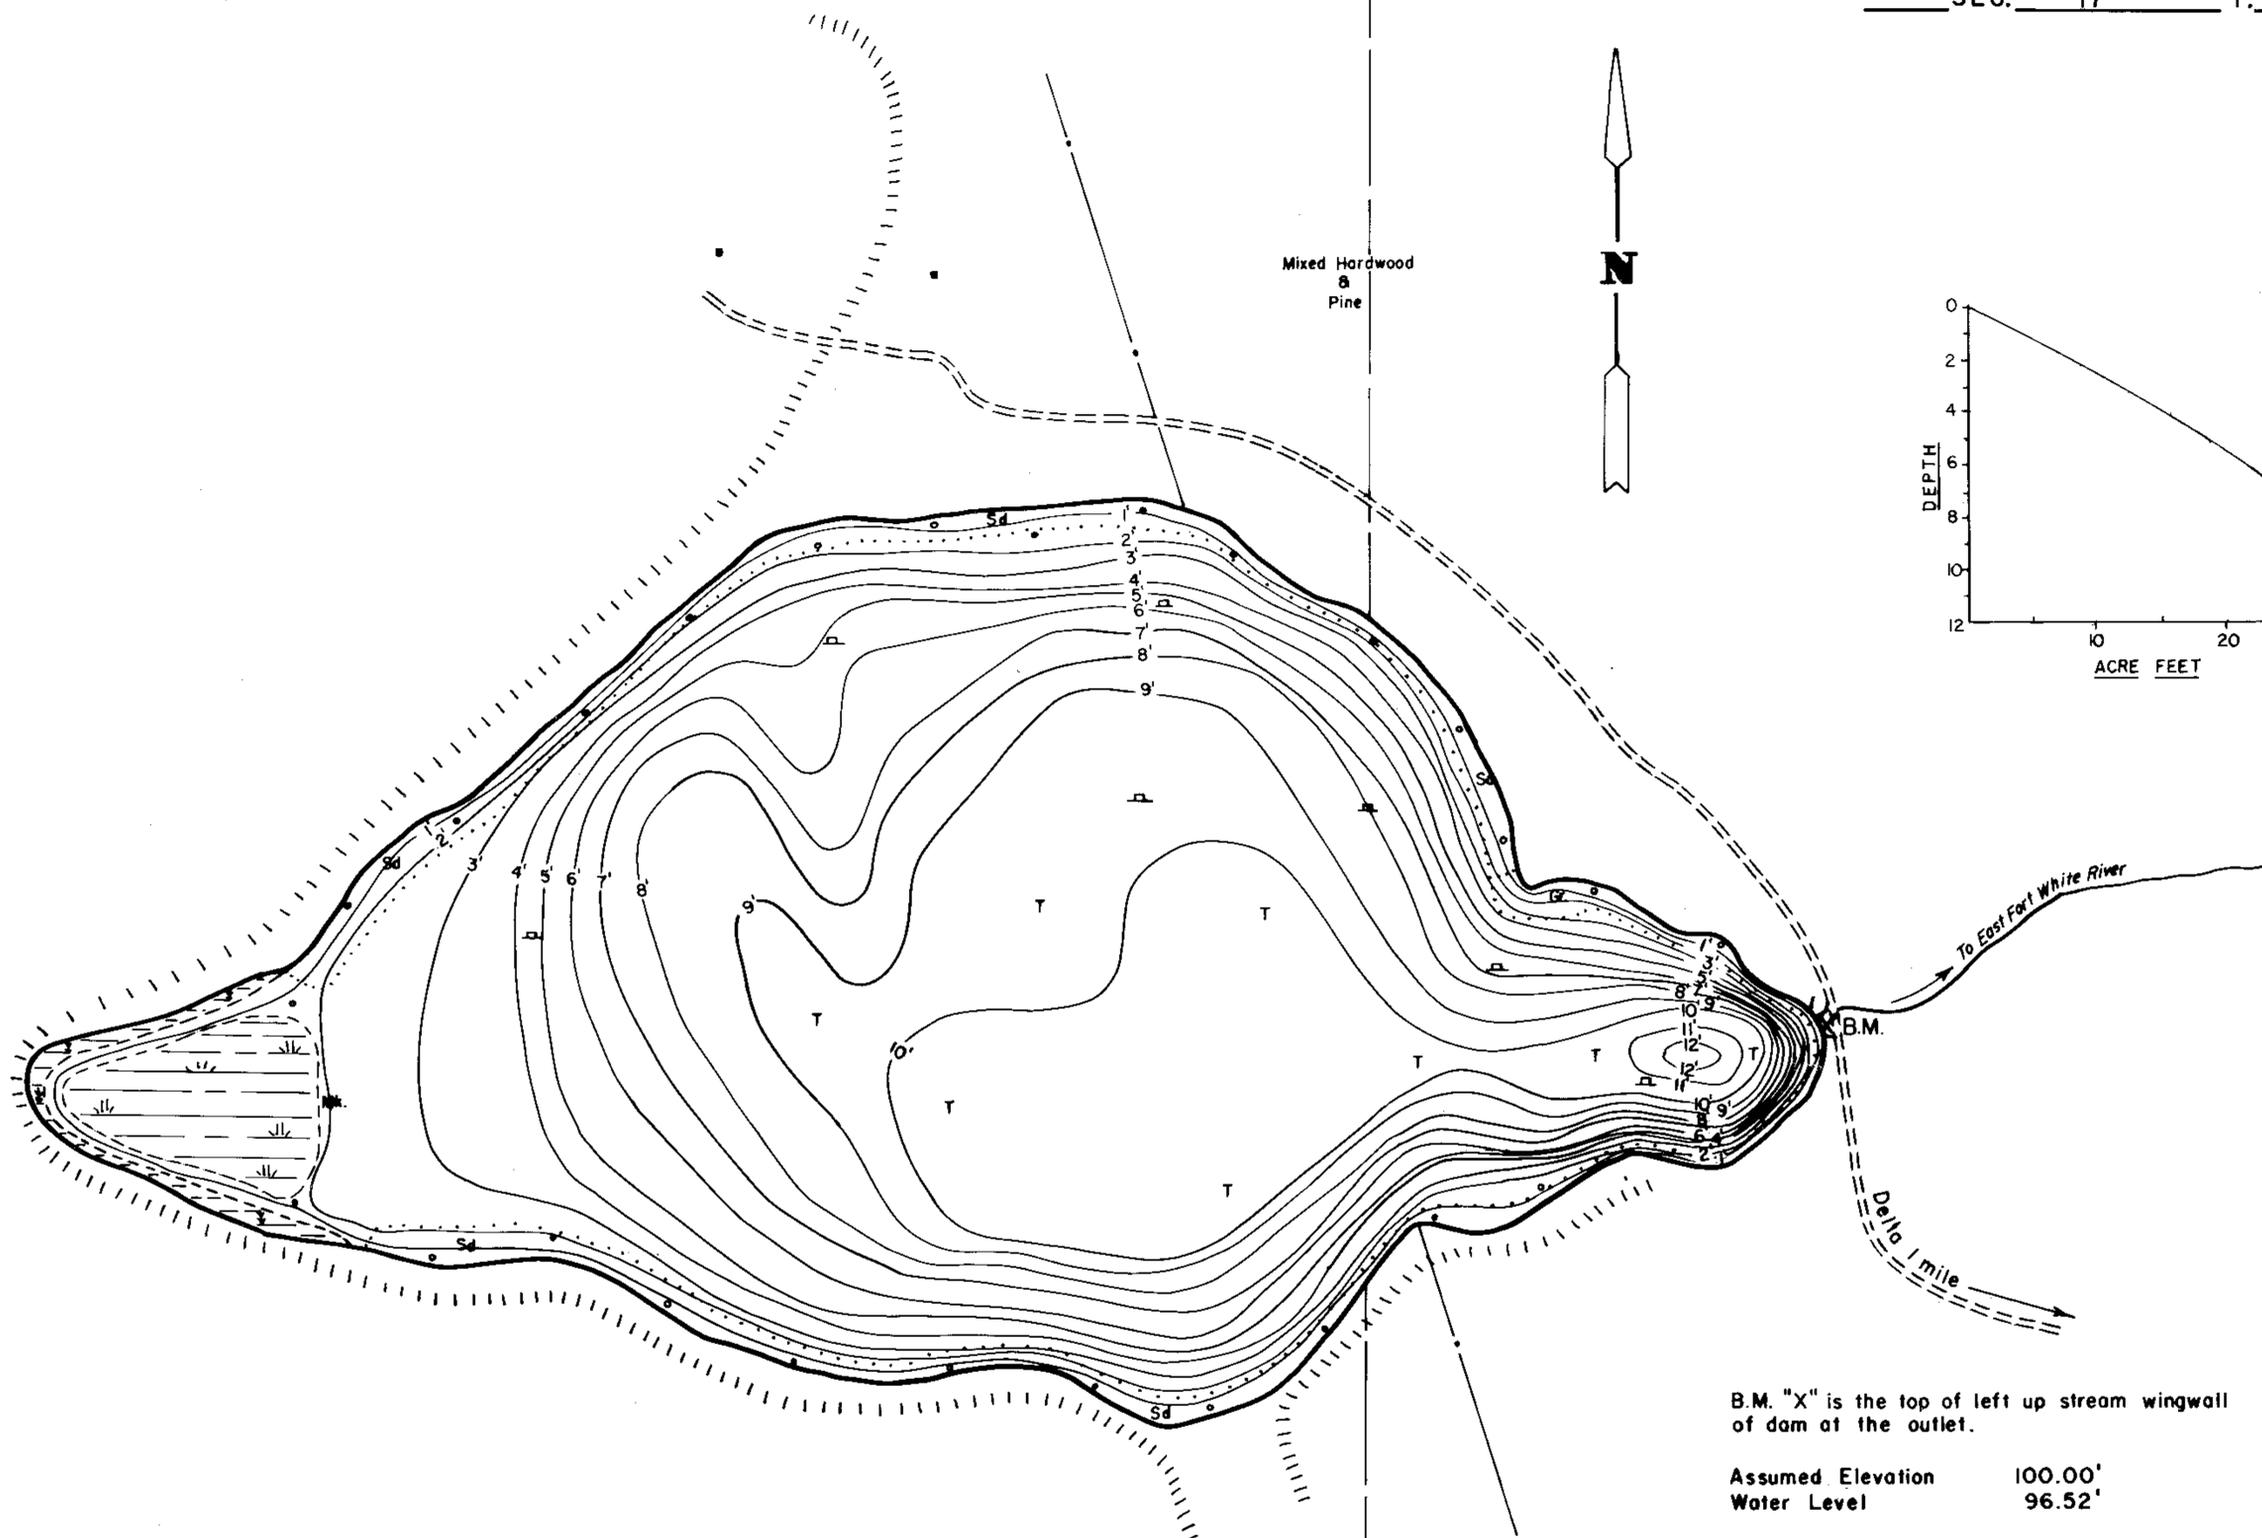
B.M. "X" is the top of left up stream wingwall of dam at the outlet.

Assumed Elevation 100.00'  
Water Level 96.52'

EQUIPMENT RECORDING SONAR MAPPED OCT. 1977  
MONTH YEAR  
LAKE BOTTOM SYMBOLS

WATER AREA 4.5 ACRES  
UNDER 3 FT. 25 %  
OVER 20 FT. 0 %  
MAX. DEPTH 12 FEET.  
TOTAL ALK. 73 P.P.M.  
VOLUME 29.68 ACRE FT.  
MAIN SHORELINE .38 MI.  
ISLAND SHORELINE 0 MI.
