WALLACE LAKE  
51.7 Acres  
35' Max. depth

Source: Wisconsin Department of Natural Resources 608-266-2621  
Lenwood Lake – Washington County, Wisconsin DNR Lake Map  
Date – Apr 1968 - Historical Lake Map - Not for Navigation  
A Public Document - Please Identify the Source when using it.

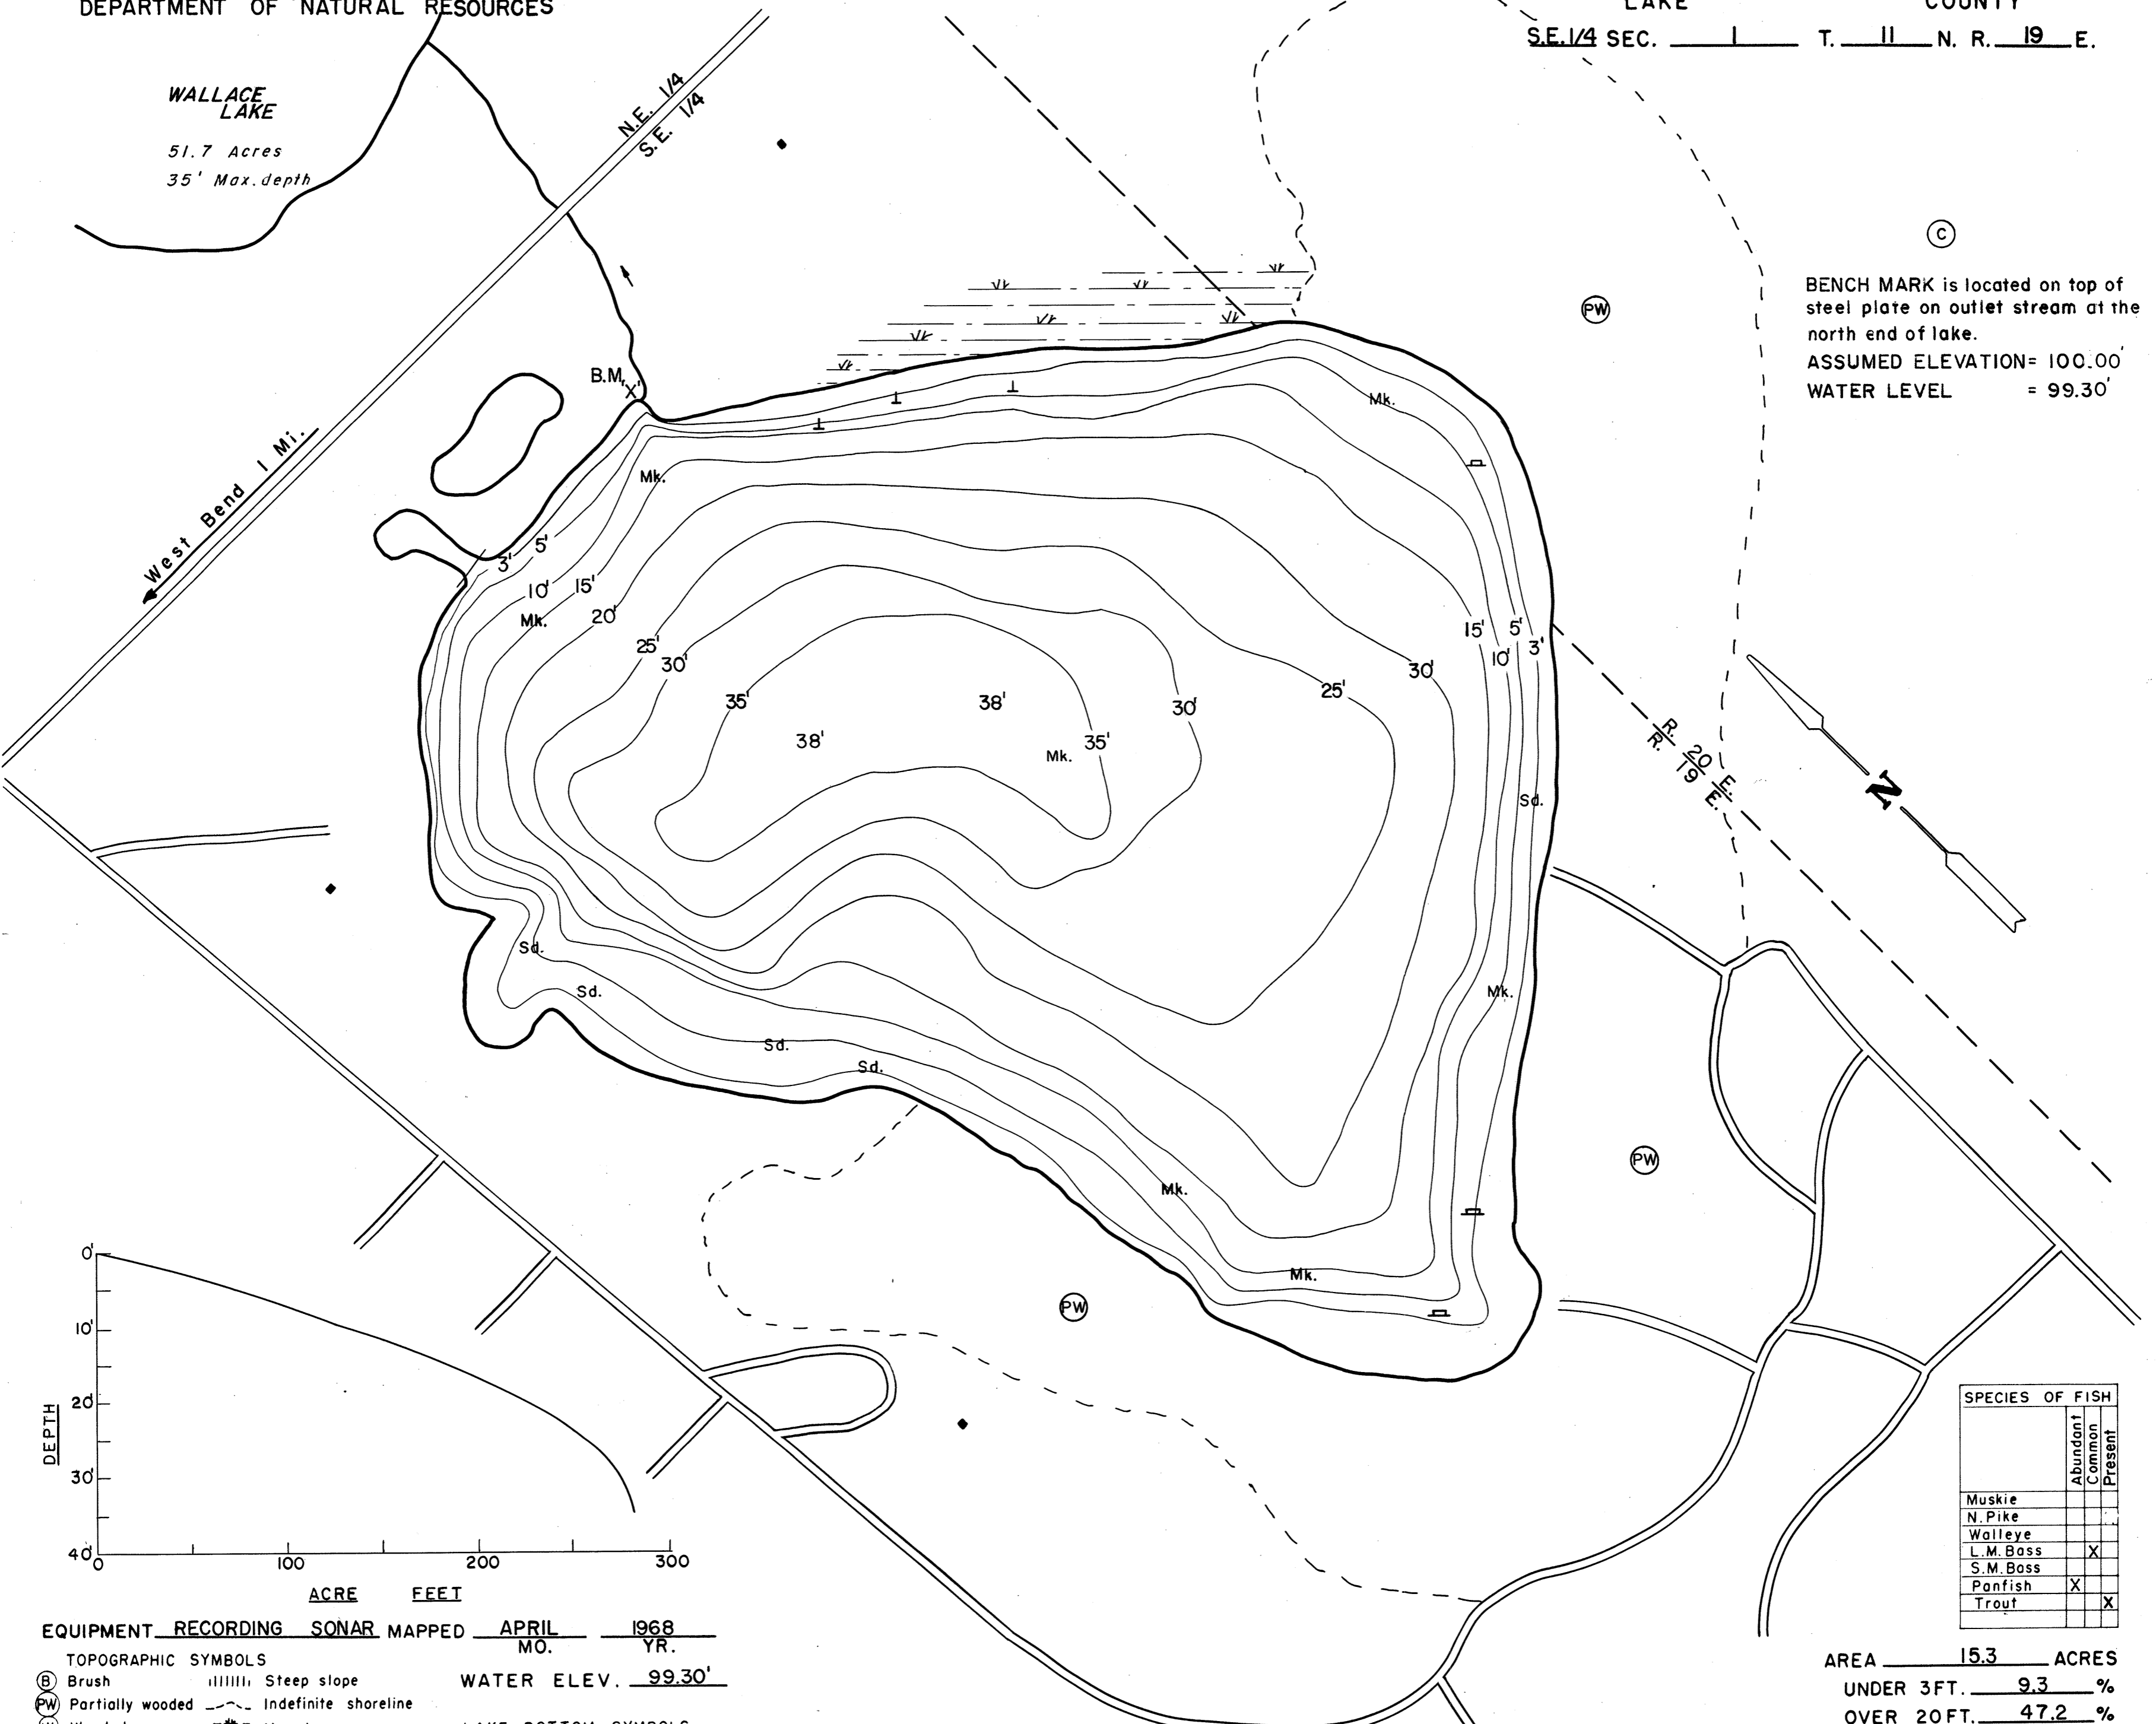
(C)  
BENCH MARK is located on top of steel plate on outlet stream at the north end of lake.  
ASSUMED ELEVATION= 100.00'  
WATER LEVEL = 99.30'

AREA 15.3 ACRES  
UNDER 3 FT. 9.3 %  
OVER 20 FT. 47.2 %  
VOLUME 281.3 ACRE FT.  
TOTAL ALK. 220 P.P.M.  
SHORELINE .7 MILES  
MAX. DEPTH 38 FEET
