Hatch Lake – Waupaca County, Wisconsin DNR Lake Map

Date – Jun 1965 - Historical Lake Map - Not for Navigation

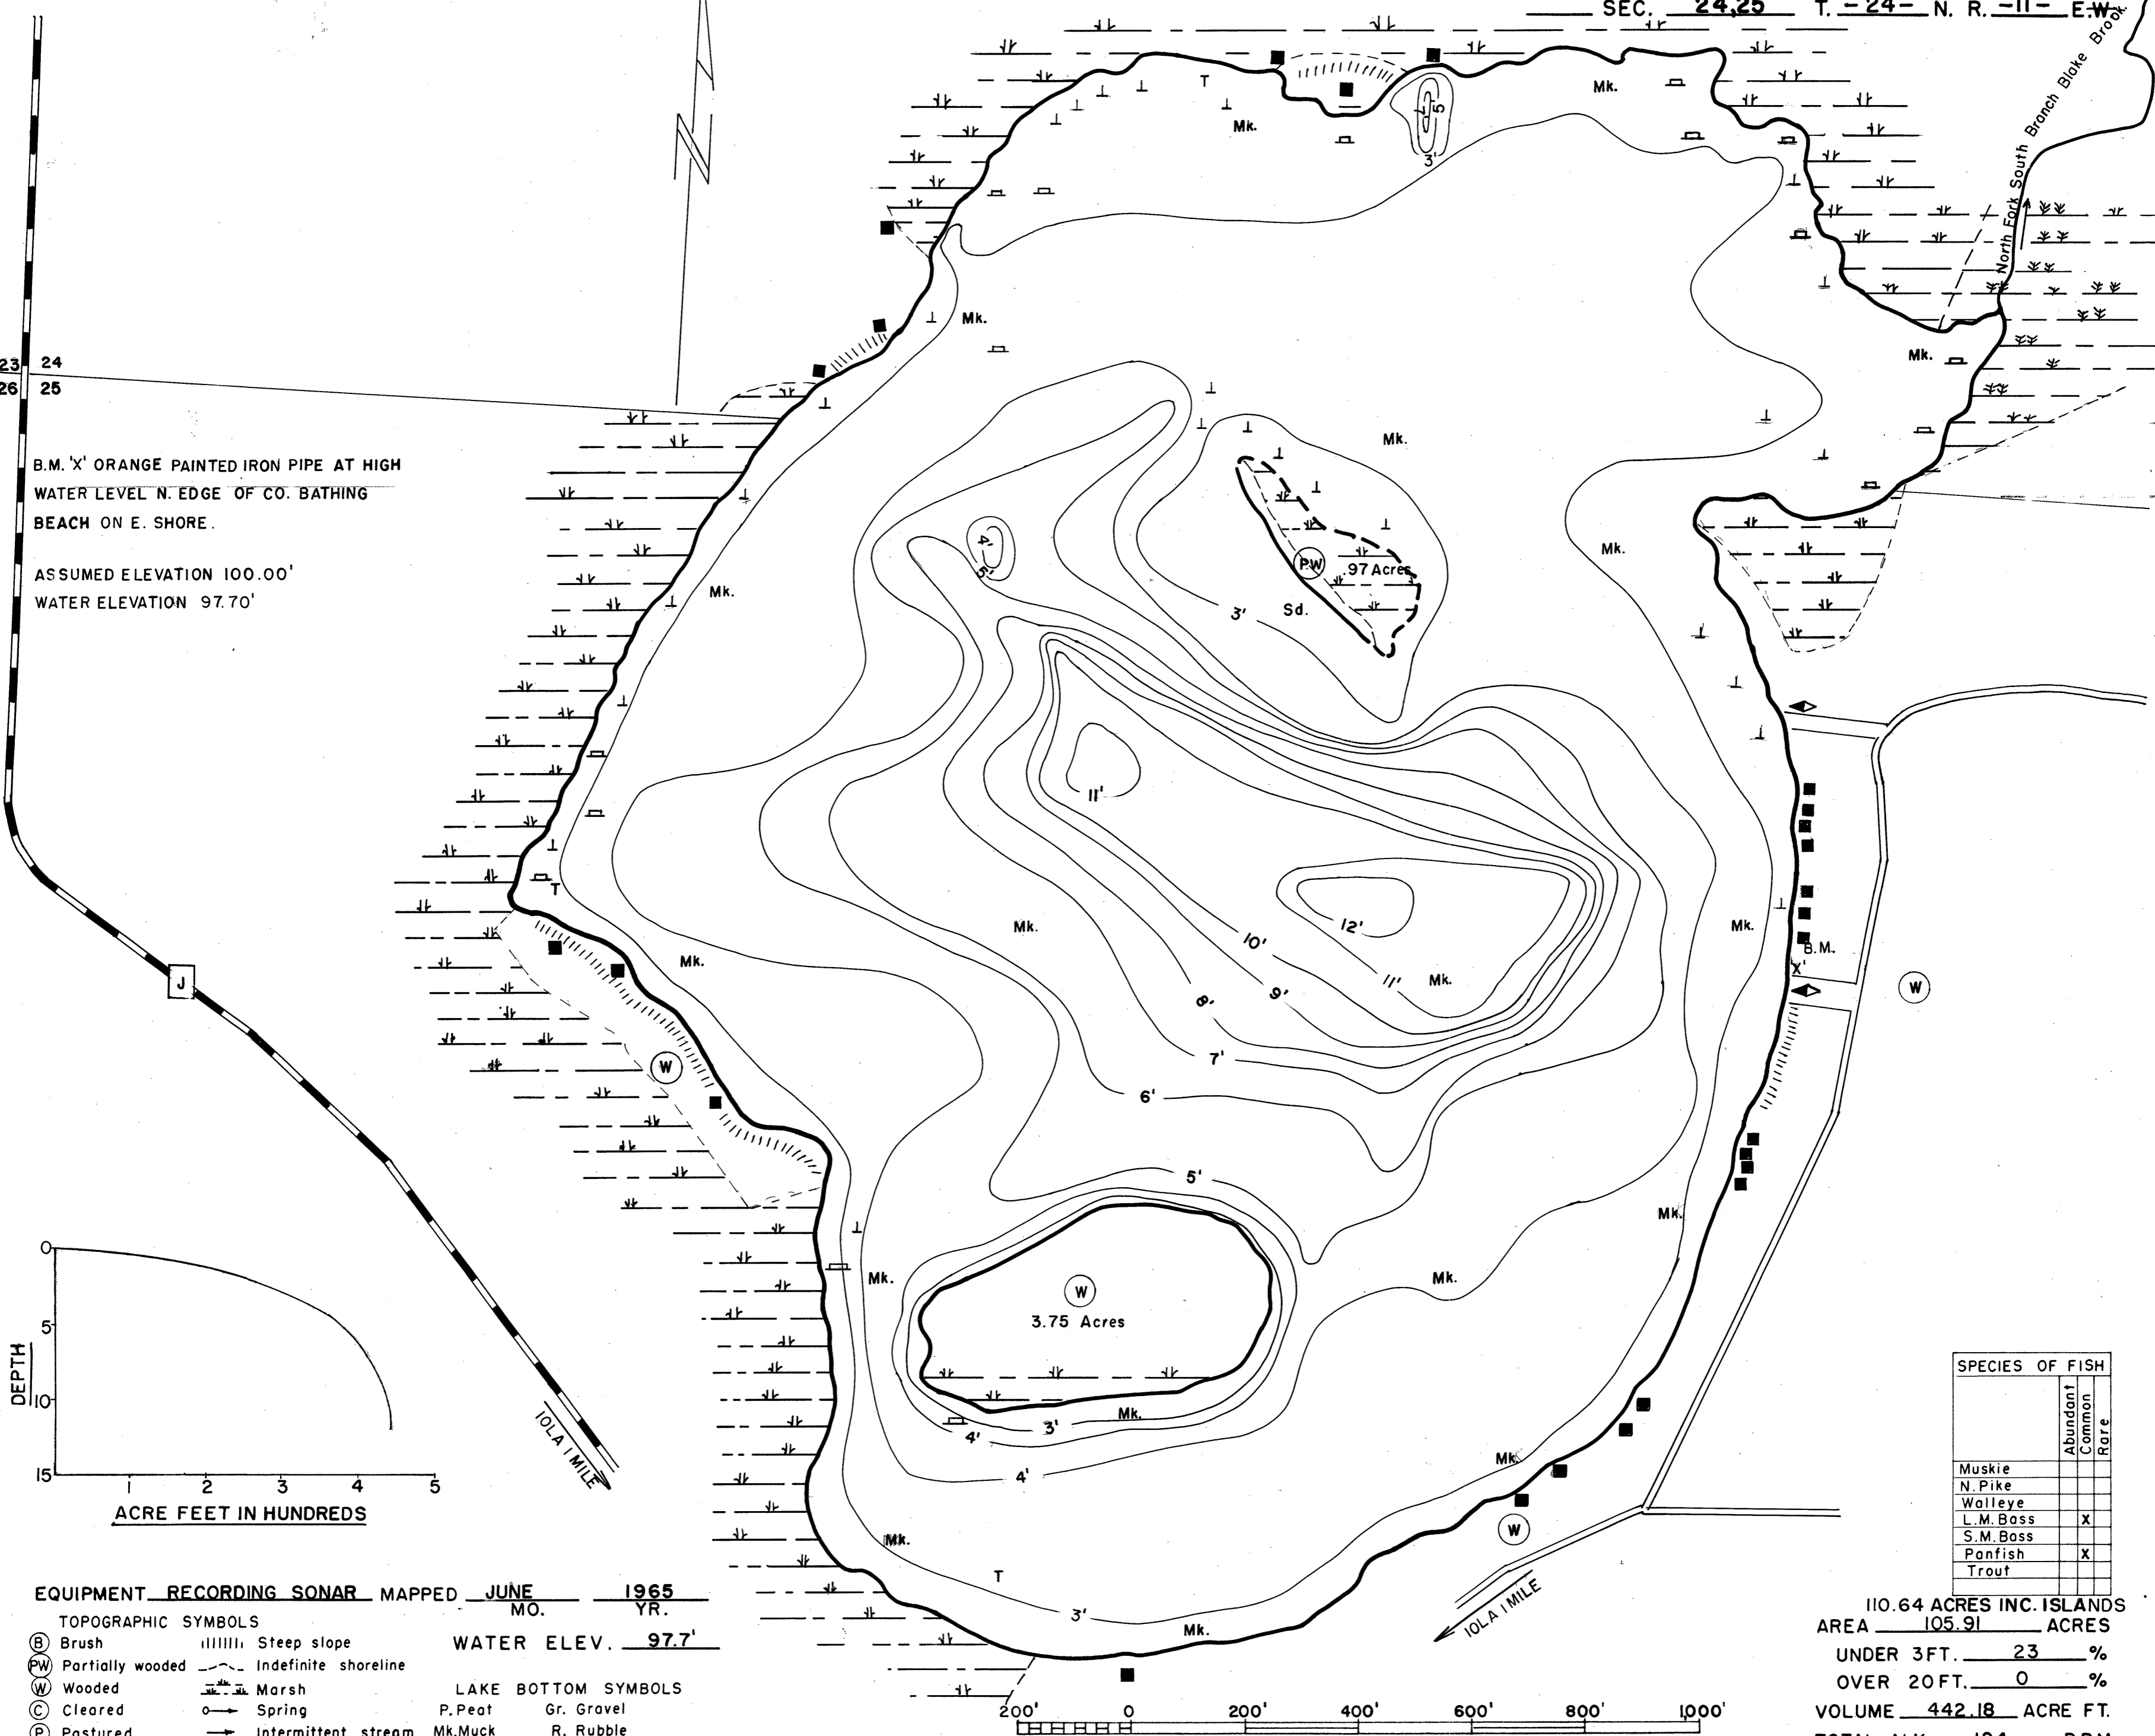
B.M. 'X' ORANGE PAINTED IRON PIPE AT HIGH WATER LEVEL N. EDGE OF CO. BATHING BEACH ON E. SHORE.

ASSUMED ELEVATION 100.00'
WATER ELEVATION 97.70'

110.64 ACRES INC. ISLANDS
AREA 105.91 ACRES
UNDER 3FT. 23 %
OVER 20FT. 0 %
VOLUME 442.18 ACRE FT.
TOTAL ALK. 124 P.P.M.
SHORELINE 17.48 MILES
MAX. DEPTH 12 FEET
