EQUIPMENT ECHO SOUNDER MAPPED FEBRUARY 1953  
MO. YR.

UPDATED AUGUST 1966  
WATER ELEV. 94.60'

Source: Wisconsin Department of Natural Resources 608-266-2621  
Potters Lake – Walworth County, Wisconsin DNR Lake Map  
Date – Aug 1966 - Historical Lake Map - Not for Navigation  
A Public Document - Please Identify the Source when using it.

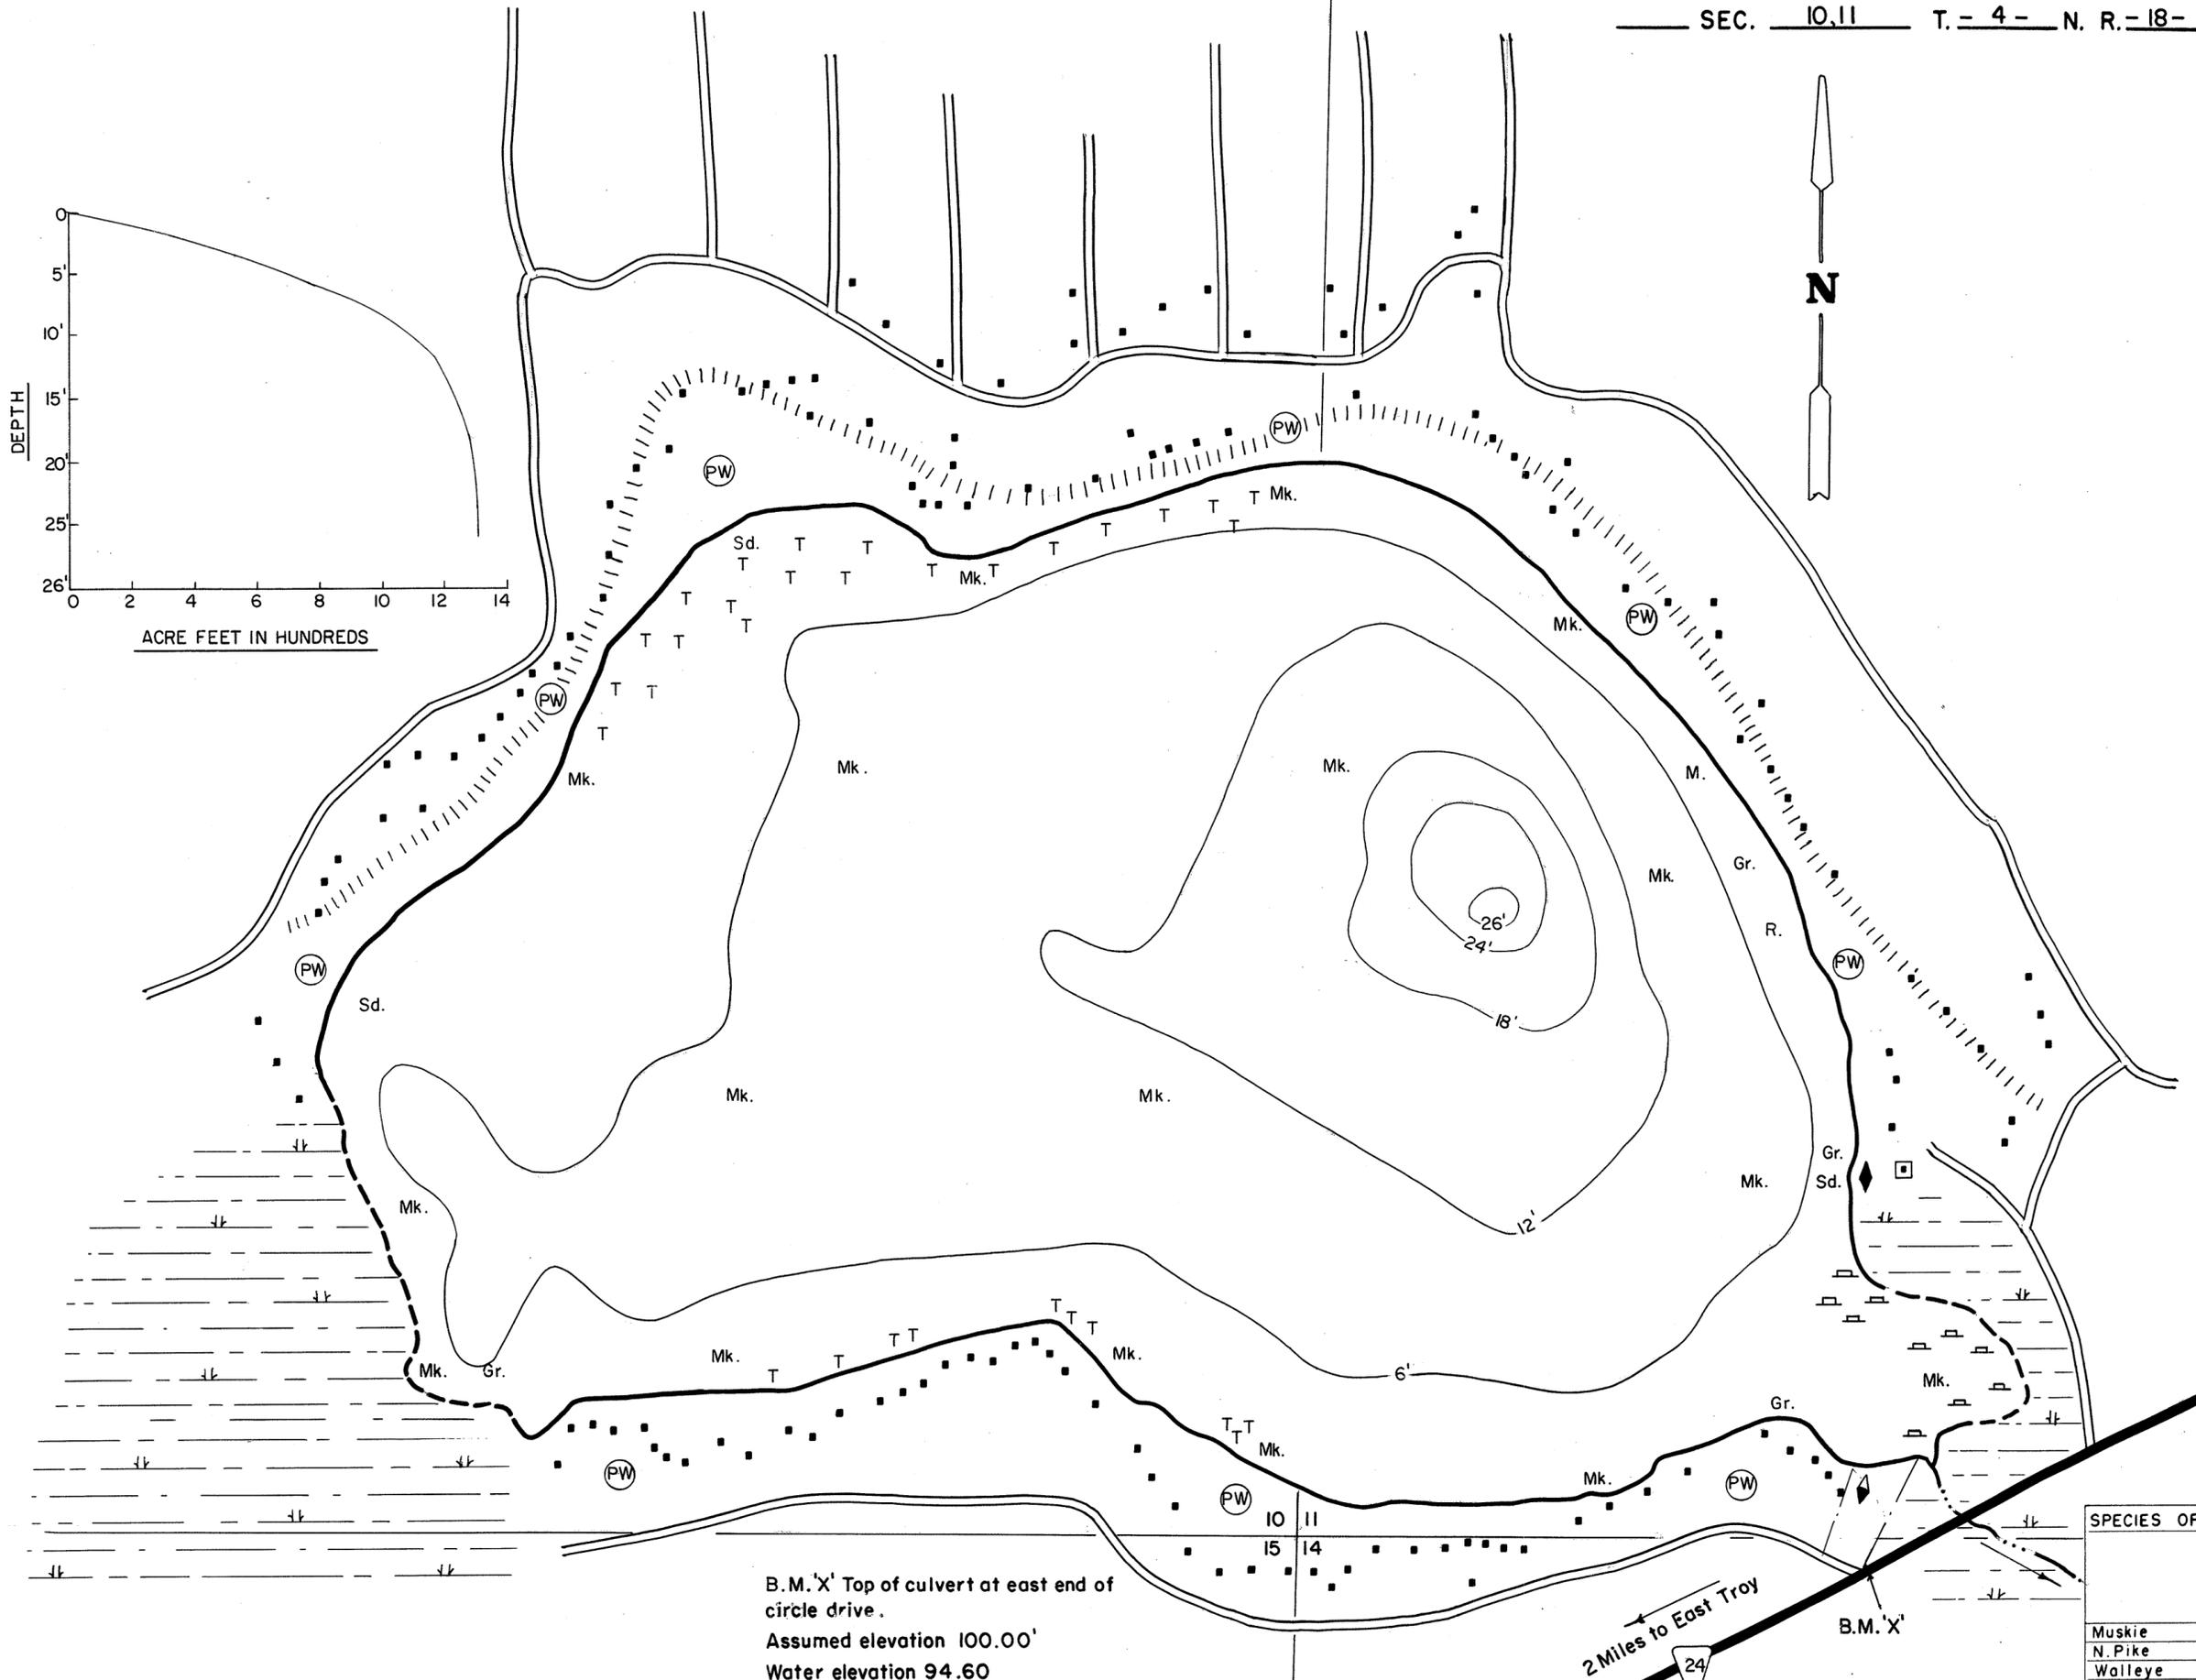
B.M. 'X' Top of culvert at east end of circle drive.  
Assumed elevation 100.00'  
Water elevation 94.60'

AREA 162.0 ACRES  
UNDER 3 FT. 19 %  
OVER 20 FT. 5.5 %  
VOLUME 1,304.2 ACRE FT.  
TOTAL ALK. 137 P.P.M.  
SHORELINE 2.2 MILES  
MAX. DEPTH 26 FEET
