# Cranberry Lake Critical Habitat Designation Report

*Bayfield County, WI*

April 2013

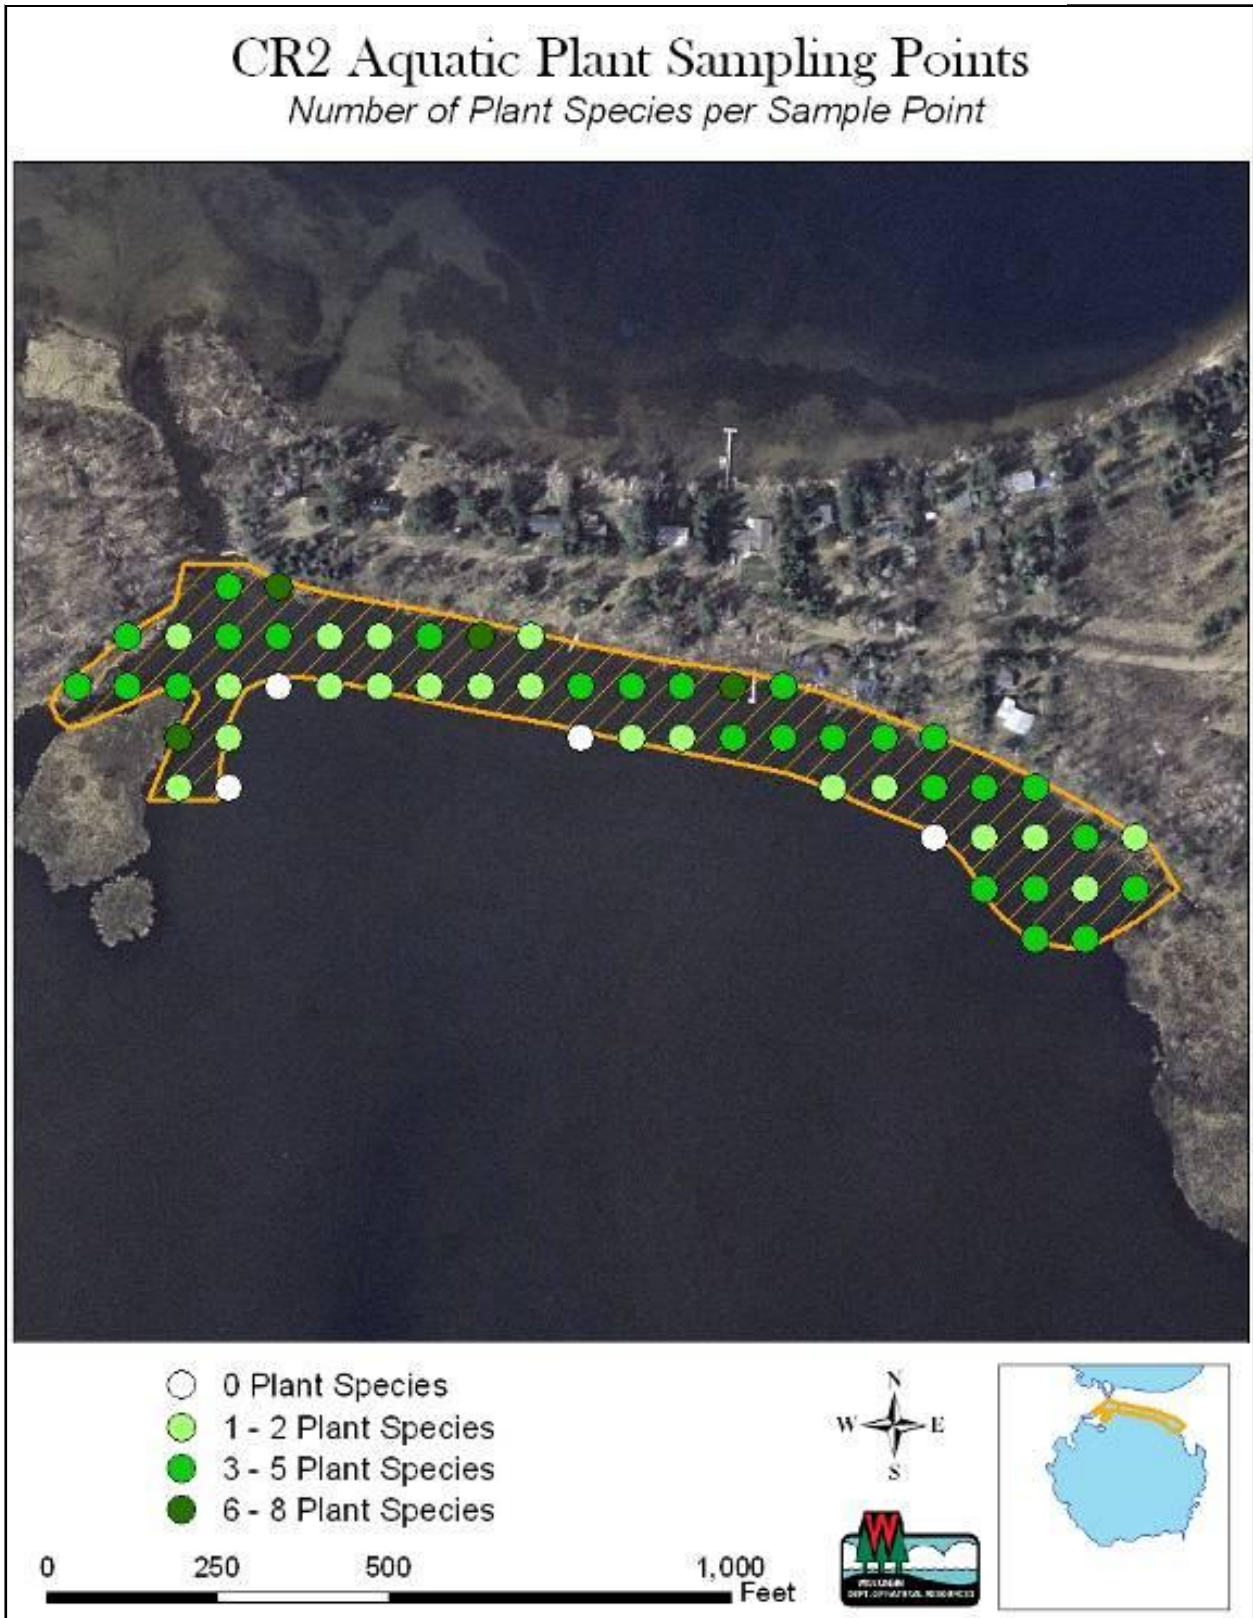
Figure 4. CR2 Aquatic Plant Diversity Map

Critical habitat site CR2 was designated a Sensitive Area because of its Rush Beds (Figures 4 & 5). It is 5.6 acres in size and is located along the Northern shore of Cranberry Lake.

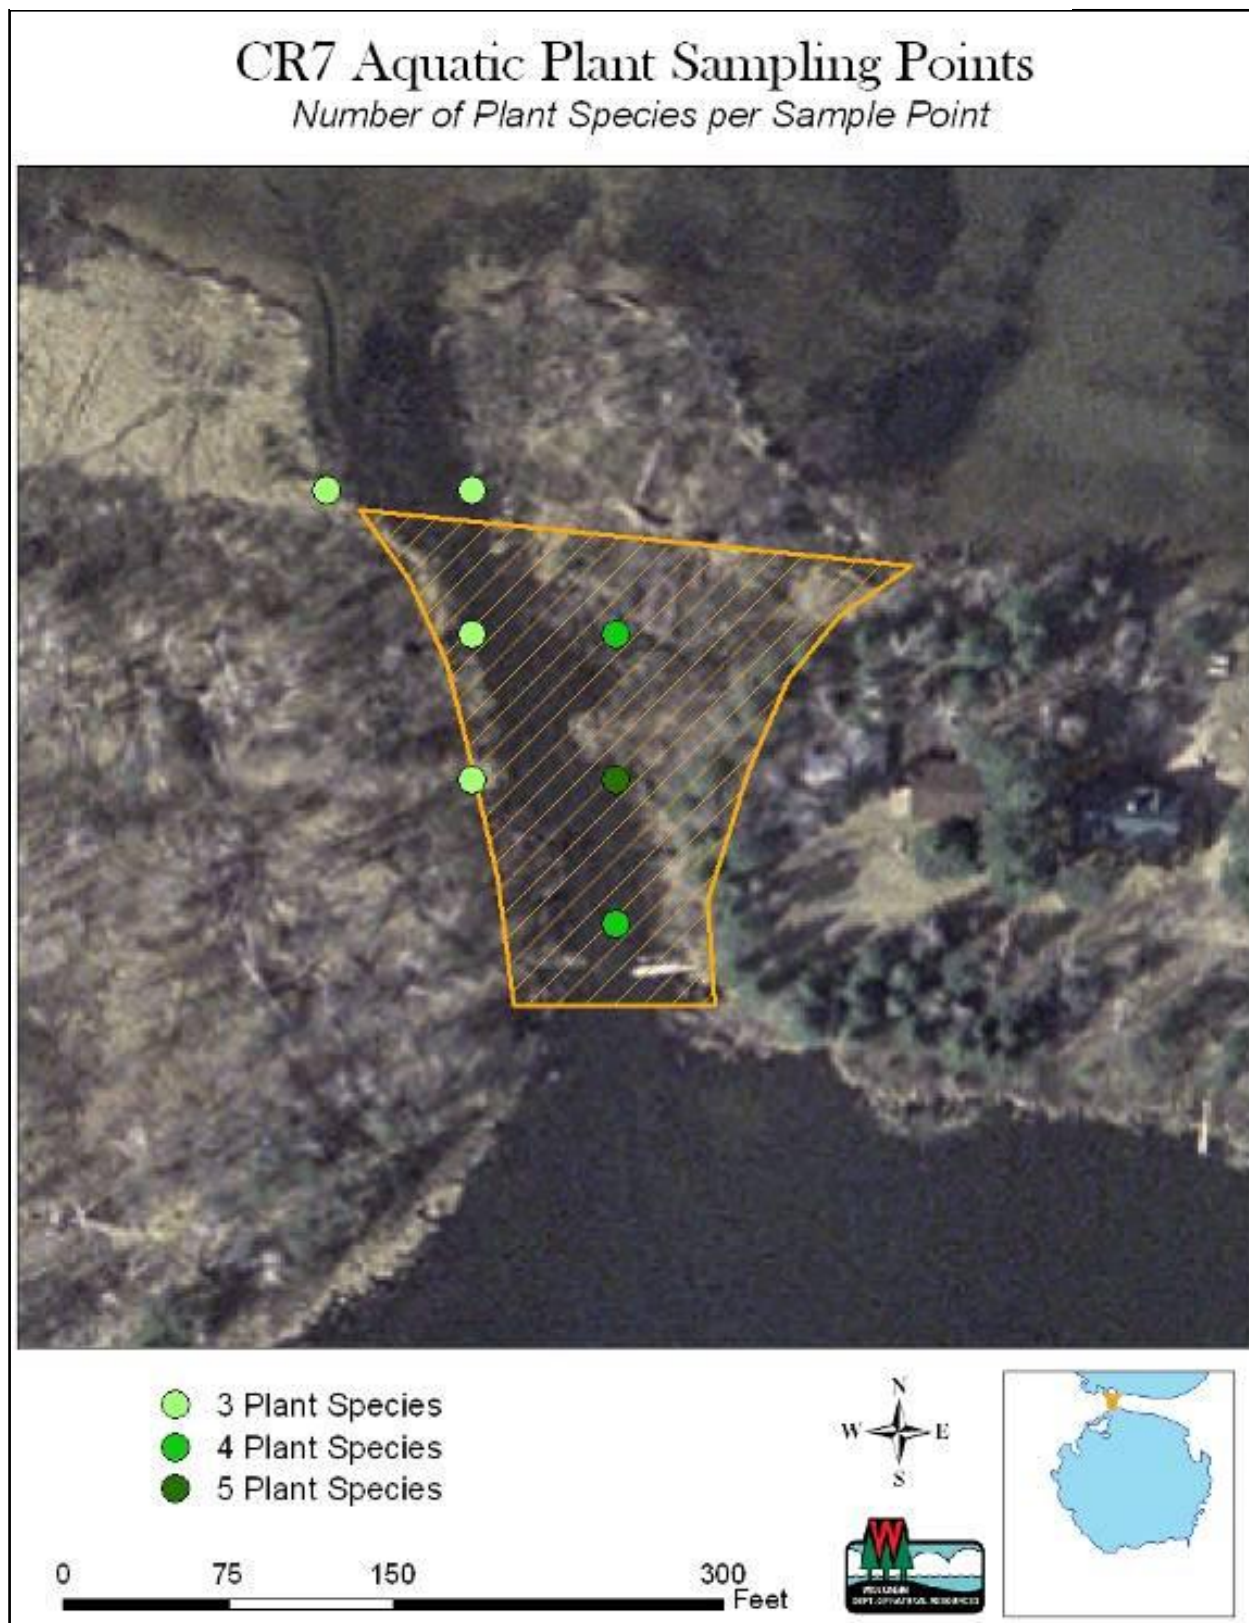
Figure 11. CR7 Aquatic Plant Diversity Map

Critical habitat site CR7 was designated a Sensitive Area because of its Navigational Thoroughfare, Emergent and Floating Leaf Vegetation, and Extensive Riparian Wetland (Figure 11). It is 0.7 acres in size and is located along the channel between Lower Eau Claire Lake and Cranberry Lake.
