AQUATIC PLANT MANAGEMENT PLAN

**VOYAGEUR LAKE
VILAS COUNTY, WISCONSIN**

June 28, 2007
Revised August 6, 2007

Northern Environmental Technologies, Incorporated
1203 Storbeck Drive
Waupun, Wisconsin 53963

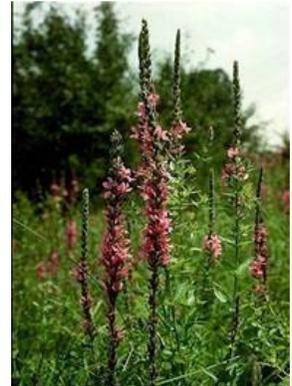
Purple Loosestrife (*Lythrum salicaria*)

Purple loosestrife is a perennial herb 3-7 feet tall with a dense bushy growth of 1-50 stems. The stems, which range from green to purple, die back each year. Showy flowers vary from purple to magenta, possess 5-6 petals aggregated into numerous long spikes, and bloom from July to September. Leaves are opposite, nearly linear, and attached to four-sided stems without stalks. It has a large, woody taproot with fibrous rhizomes that form a dense mat

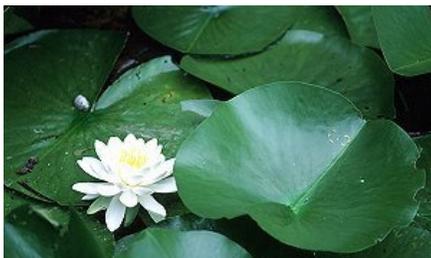
White Water Lily
Source: UW Herbarium Website

Nymphaea odorata (White Water Lily) has a flexible stalk with a round floating leaf. White Water Lily can be found growing in a variety of sediment types in less than 6 feet of water. Fragrant white flowers occur throughout the summer. The floating leaves provide shelter and shade for fish as well as habitat for invertebrates (Borman, et al., 1997).

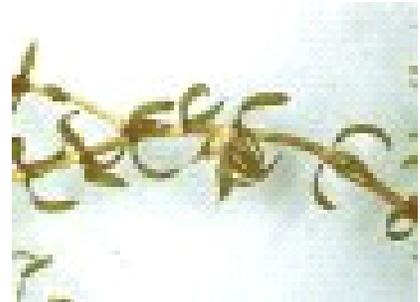
Elodea
Source: UW Herbarium Website

Elodea canadensis (Elodea or common waterweed) is an abundant native plant species that is distributed statewide. It prefers soft substrate and water depths to 15 feet (Nichols, 1999). Elodea reproduces by seed and sprigs (USDA, 2002). The stems of elodea offer shelter and grazing to fish, but very dense elodea can interfere with fish movement. Elodea can be considered invasive at times and out-competes other more desirable plants.

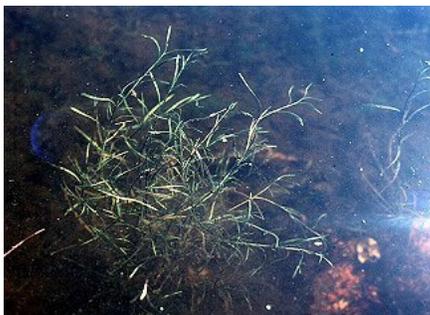
Water Stargrass
Source: UW Herbarium Website

Heteranthera dubia (Water stargrass) is a submergent aquatic plant with freely-branched flattened stems and long narrow leaves. The plant is found growing to 3 meters, has no substrate preference, and is turbidity tolerant (Nichols, 1999). Water stargrass is often mistaken for Flat-Stem Pondweed (*Potamogeton zosteriformis*), however can be distinguished by its prominent mid-vein and many fine, parallel veins.

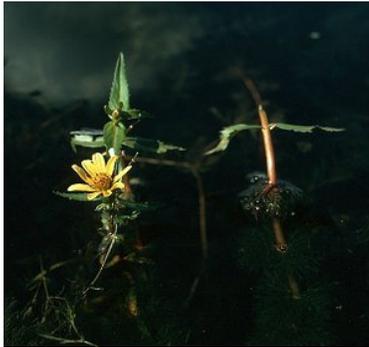
Watermarigold
Source: UW Herbarium Website

Megalodonta beckii (Watermarigold) is a submergent aquatic plant. Stems from the watermarigold emerge from a buried rootstalk and submersed leaves are finely cut into many thread-like divisions. Often only the underwater portion of the plant is present. Water marigold is usually found growing in soft sediment in clear water lakes. It will grow from ankle-deep water up to almost 10 feet deep (Borman, et al., 1997).

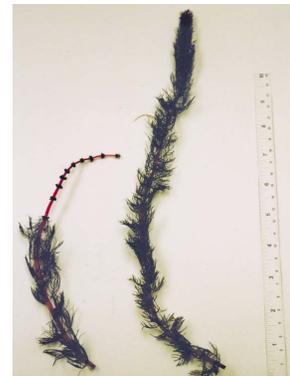
Northern watermilfoil
Source: UW Herbarium Website

Myriophyllum sibiricum (Northern watermilfoil) is usually found growing in soft sediment in fairly clear-water lakes. Leaves are divided like a feather, with five to twelve pairs of thread-like leaflets. Leaves are arranged in whorls. Northern watermilfoil is more desirable than its invasive cousin, Eurasian watermilfoil. Waterfowl eat the foliage and fruit, while beds of this plant provide cover and foraging opportunities for fish and invertebrates.

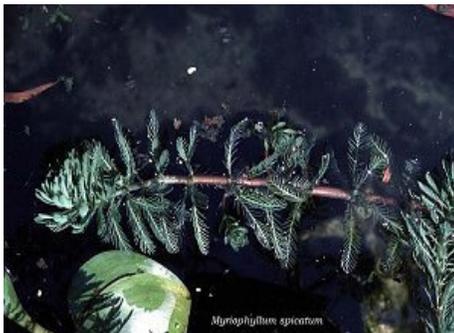
Eurasian watermilfoil
Source: UW Herbarium Website

Myriophyllum spicatum (Eurasian watermilfoil or EWM) is a submersed aquatic plant native to Europe, Asia and northern Africa. It was introduced to the United States by early European settlers. EWM was first detected in Wisconsin lakes during the 1960's. In the past three decades, this AIS has significantly expanded its range to about 61 of Wisconsin's 72 counties and continues to infest new water bodies every year. Because of its potential for explosive growth and its incredible ability to regenerate, EWM can successfully out-compete most native aquatic plants, especially in disturbed areas.

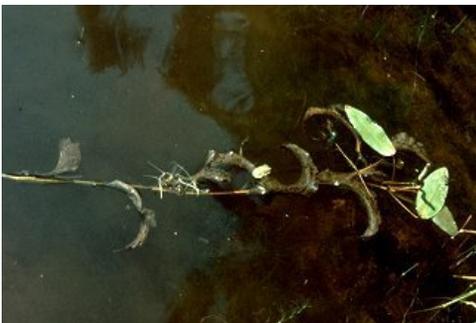
Large-leaf Pondweed

Potamogeton amplifolius (Large-leaf Pondweed) is also often referred to as musky weed or cabbage by anglers. Large leaf pondweed has robust stems and broad submersed leaves, which are slightly folded and lined with many veins. Floating leaves are oval and on long stalks. It is found mainly in soft sediments in water one to several feet deep and is sensitive to increased turbidity. The plant is commonly grazed by waterfowl, offers habitat for invertebrates, and foraging opportunities for fish (Borman, et al., 1997).

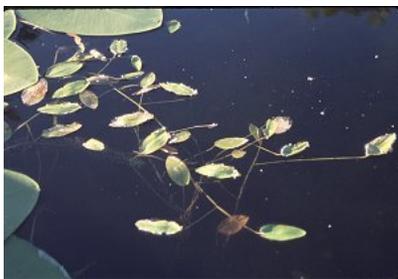
Floating-leaf Pondweed
Source: UW Herbarium Website

Potamogeton natans (Floating-Leaf Pondweed) has stems that emerge from red-spotted rhizomes. Submersed leaves are stalk-like, with no obvious leaf blade. Floating leaves are heart-shaped at their base. Floating-leaf pondweed is usually found in water less than 1.5 meters deep. Fruit of floating-leaf pondweed is held on the stalk until late in the growing season. It provides valuable grazing opportunities for ducks and geese. It may also be consumed by muskrat, beaver and deer (Borman et al. 1997).

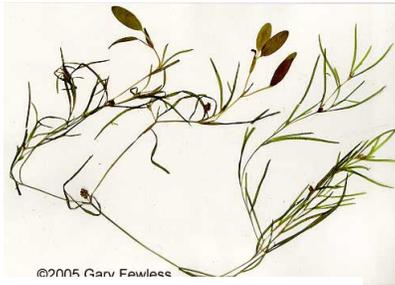
Spiral-Fruited Pondweed
Source: UW-Green Bay website

Potamogeton spirillus (Spiral-Fruited Pondweed) is another pondweed with frequently branched stems and narrow, submersed leaves. When present, the floating leaves are elliptical in shape. This can be easily distinguished from other narrow-leaved pondweeds by its spiral-shaped fruit. Spiral-fruited pondweed grows abundantly when present and is important in stabilizing the sediment in shallow water. It also provides a food source for waterfowl, habitat for invertebrates, and foraging opportunities for fish (Borman, et al., 1997).

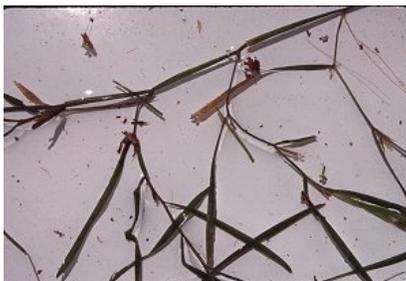
Flat- Stem Pondweed
Source: UW Herbarium Website

Potamogeton zosteriformis (Flat-Stem Pondweed) is a submergent pondweed with freely-branched flattened stems. Flat stem pondweed is commonly confused with water stargrass (*Heteranthera dubia*) but Flat-stem Pondweed can be distinguished by its prominent mid-vein and many fine, parallel veins.

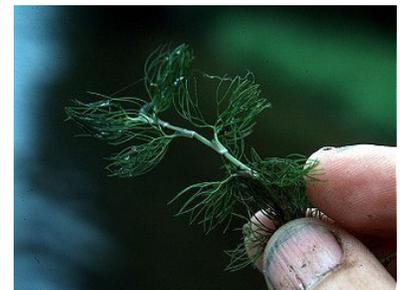
Stiff water crowfoot
Source: UW-Herbarium Website

Ranunculus longirostris (Stiff water crowfoot) has long branched stems with finely thread like leaves. At first glance, it may resemble a watermilfoil, but the alternate leaf position helps distinguish this genus. Stiff water crowfoot is found in lakes and slow moving streams in less than 2 meters of water. The fruits and foliage are a food source for ducks (Borman, et al, 1999).

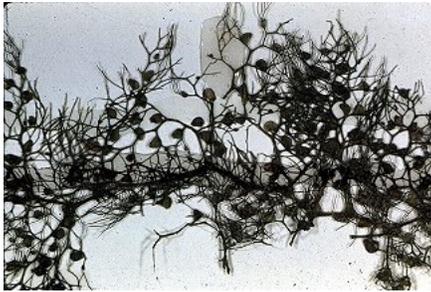
Common bladderwort
Source: UW-Herbarium Website

Utricularia vulgaris (Common bladderwort) has floating stems that can reach 2-3 meters in length. Along the stem are leaf-like branches that are finely divided. The divisions are filament-like, have no midrib, and fork 3-7 times. Scattered on these branches are the bladders that trap prey. Young bladders are transparent and green tinted, but they become dark brown to black as they age. The branches also have fine spines (spicules) scattered along their margins. Yellow, two-lipped flowers are produced on stalks that protrude above the water surface. Common bladderwort is free-floating and can be found in water ranging from a few inches to several meters deep. The trailing stems of common

bladderwort provide food and cover for fish. Because they are free-floating, they can grow in areas of very loosely consolidated sediment. This provides needed fish habitat in areas that are not readily colonized by rooted plants (Borman, et al., 1997).

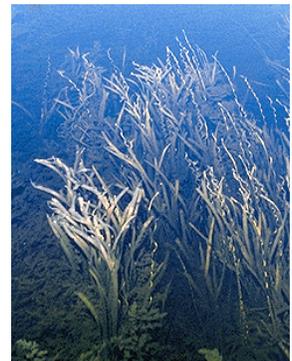
Wild Celery
Source: UW Herbarium Website

Valisneria americana (Wild Celery) also known as eel-grass or tape-grass, and has ribbon-like leaves that tend to grow until they emerge in clusters along the water's surface. Wild celery is a premiere source of food for waterfowl. All portions of the plant are consumed. Beds of wild celery are also considered good fish habitat providing shade, shelter and feeding opportunities (Borman, et al., 1997).

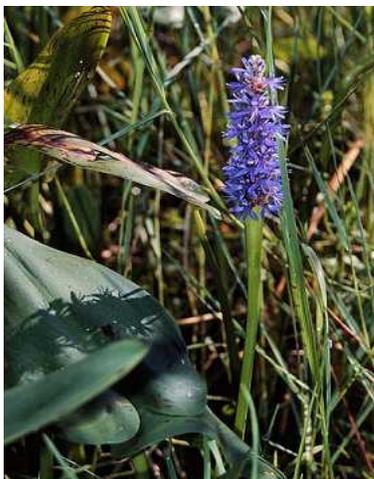
Pickerelweed
Source: UW Herbarium Website

Pontederia cordata (Pickerelweed) *Pontederia cordata* (Pickerelweed) has glossy, heart-shaped leaves that emerge from a robust, sprawling rhizome. The leaves have long, air-filled stalks with firm blades. The flower spike is crowded with small blue flowers. The blue-flowered spike of pickerelweed is distinctive. When it is not in flower, the leaves might be mistaken for arrowhead (*Sagittaria* sp.), water plantain (*Alisma* spp.) or wild calla (*Calla palustris*). The flowering stalk of pickerelweed is a haven for many insects—some seeking nectar and others a spot to rest. The seeds are consumed by waterfowl as well as muskrats. Beds of pickerelweed can be important shoreline stabilizers and help dampen wave action (Borman, et al., 1997).

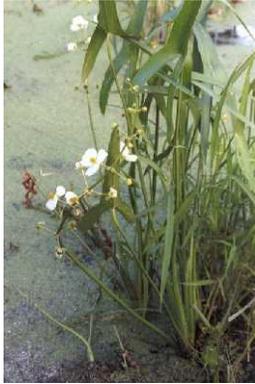
Sagittaria spp.
Source: UW Herbarium website

Sagittaria spp. (Arrowhead) is an emergent plant that usually produces leaves that are true to its name – shaped like an arrowhead. The size and shape of the leaf is highly variable with blades that range from a slender “A” shape to a broad wedge. Arrowhead is found in the shallow water of lakes, ponds, streams and marshes and usually found in water only ankle-deep, but will sometimes grow in water about 1 meter deep. Arrowhead is one of the highest value aquatic plants for wildlife and waterfowl depend on the high-energy tubers during migration. The seeds are also consumed by a wide variety of ducks, geese, marsh birds and shore birds. (Borman, et al., 1997).

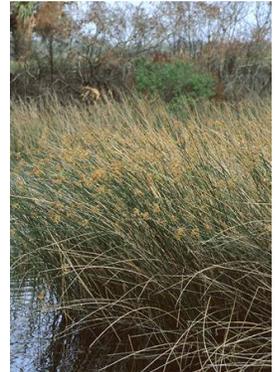
Softstem Bulrush
Source: UW Herbarium Website

Schoenoplectus tabernaemontanti (Softstem Bulrush) has tall cylindrical, bluish-green stems. They are spongy when pressed between your fingers. Softstem bulrush usually grows in water less than 2 meters deep, but it has been found considerably deeper and shows no preference for substrate (Nichols, 1999). Softstem bulrush offers habitat for invertebrates and shelter for young fish, especially northern pike. The nutlets are consumed by a wide variety of waterfowl, marsh birds and upland birds. (Borman, et al., 1997).
