# Presque Isle Wilderness Waters Program

## Aquatic Plant Management Plan – Morton Lake

Date: March 2014

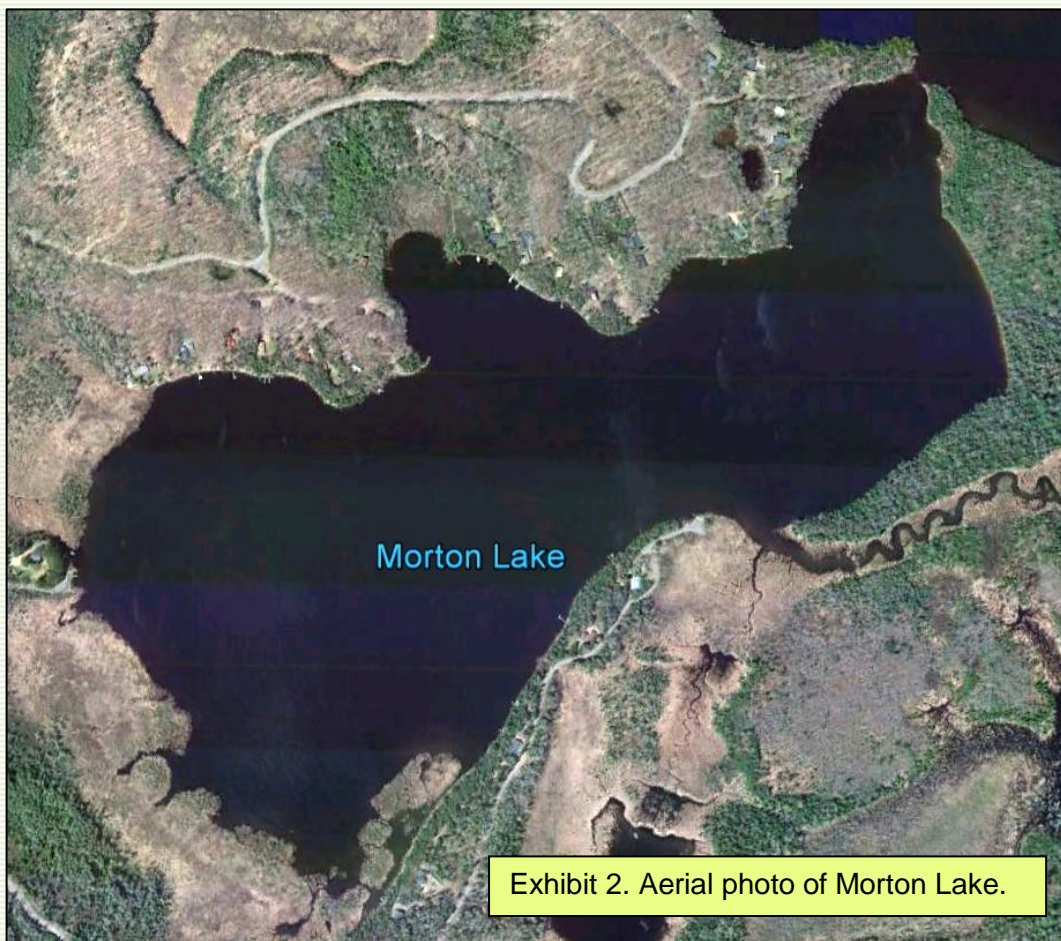
Exhibit 2. Aerial photo of Morton Lake.

Descriptive parameters for Morton Lake are in Exhibit 3. It is a groundwater drainage lake of about 165 acres and maximum depth of 29 feet. It has a typical shoreline development index. The shoreline development index is a quantitative expression derived from the shape of the lake. It is defined as the ratio of the shoreline length to the length of the circumference of a circle of the same area as the lake. A perfectly round lake would have an index of 1. Increasing irregularity of shoreline development in the form of bays and projections of the shore is shown by numbers greater than 1. For example, fjord lakes with extremely irregularly shaped shorelines sometimes have SDI's exceeding 5. A higher shoreline development index indicates that a lake has relatively more productive littoral zone habitat. Of the 12 lakes considered in the Wilderness Waters Program, the shoreline development index ranged from 1.2 to 3.2 (median value = 1.9).

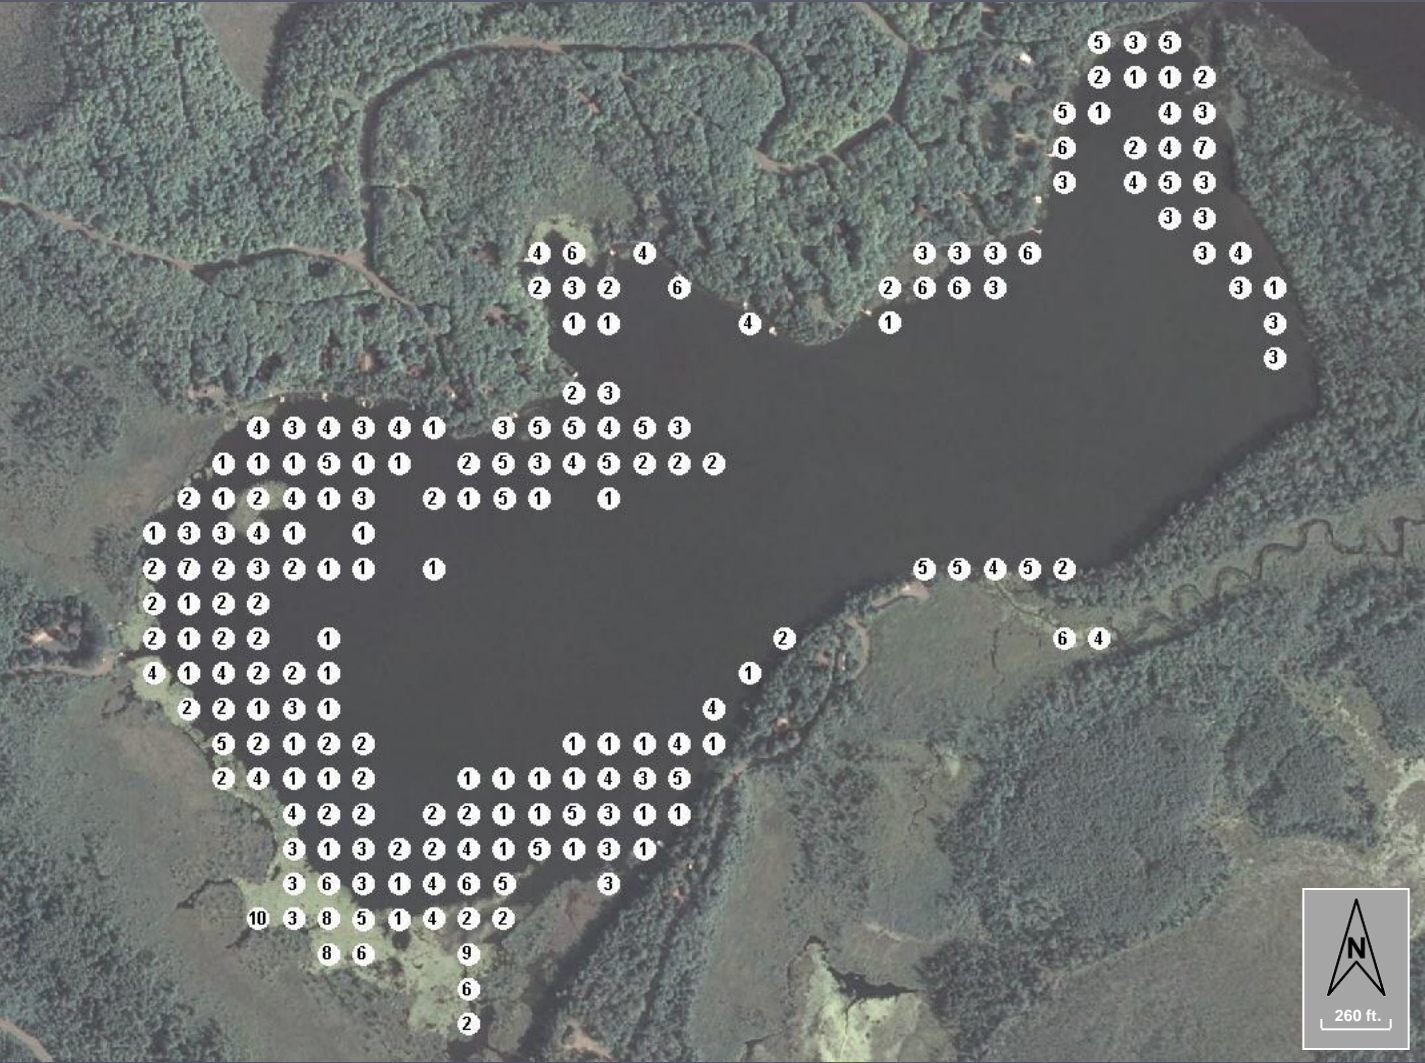
Figure 1. Number of plant species recorded at Morton Lake sample sites (2011).

Figure 1. Number of plant species recorded at sample sites.

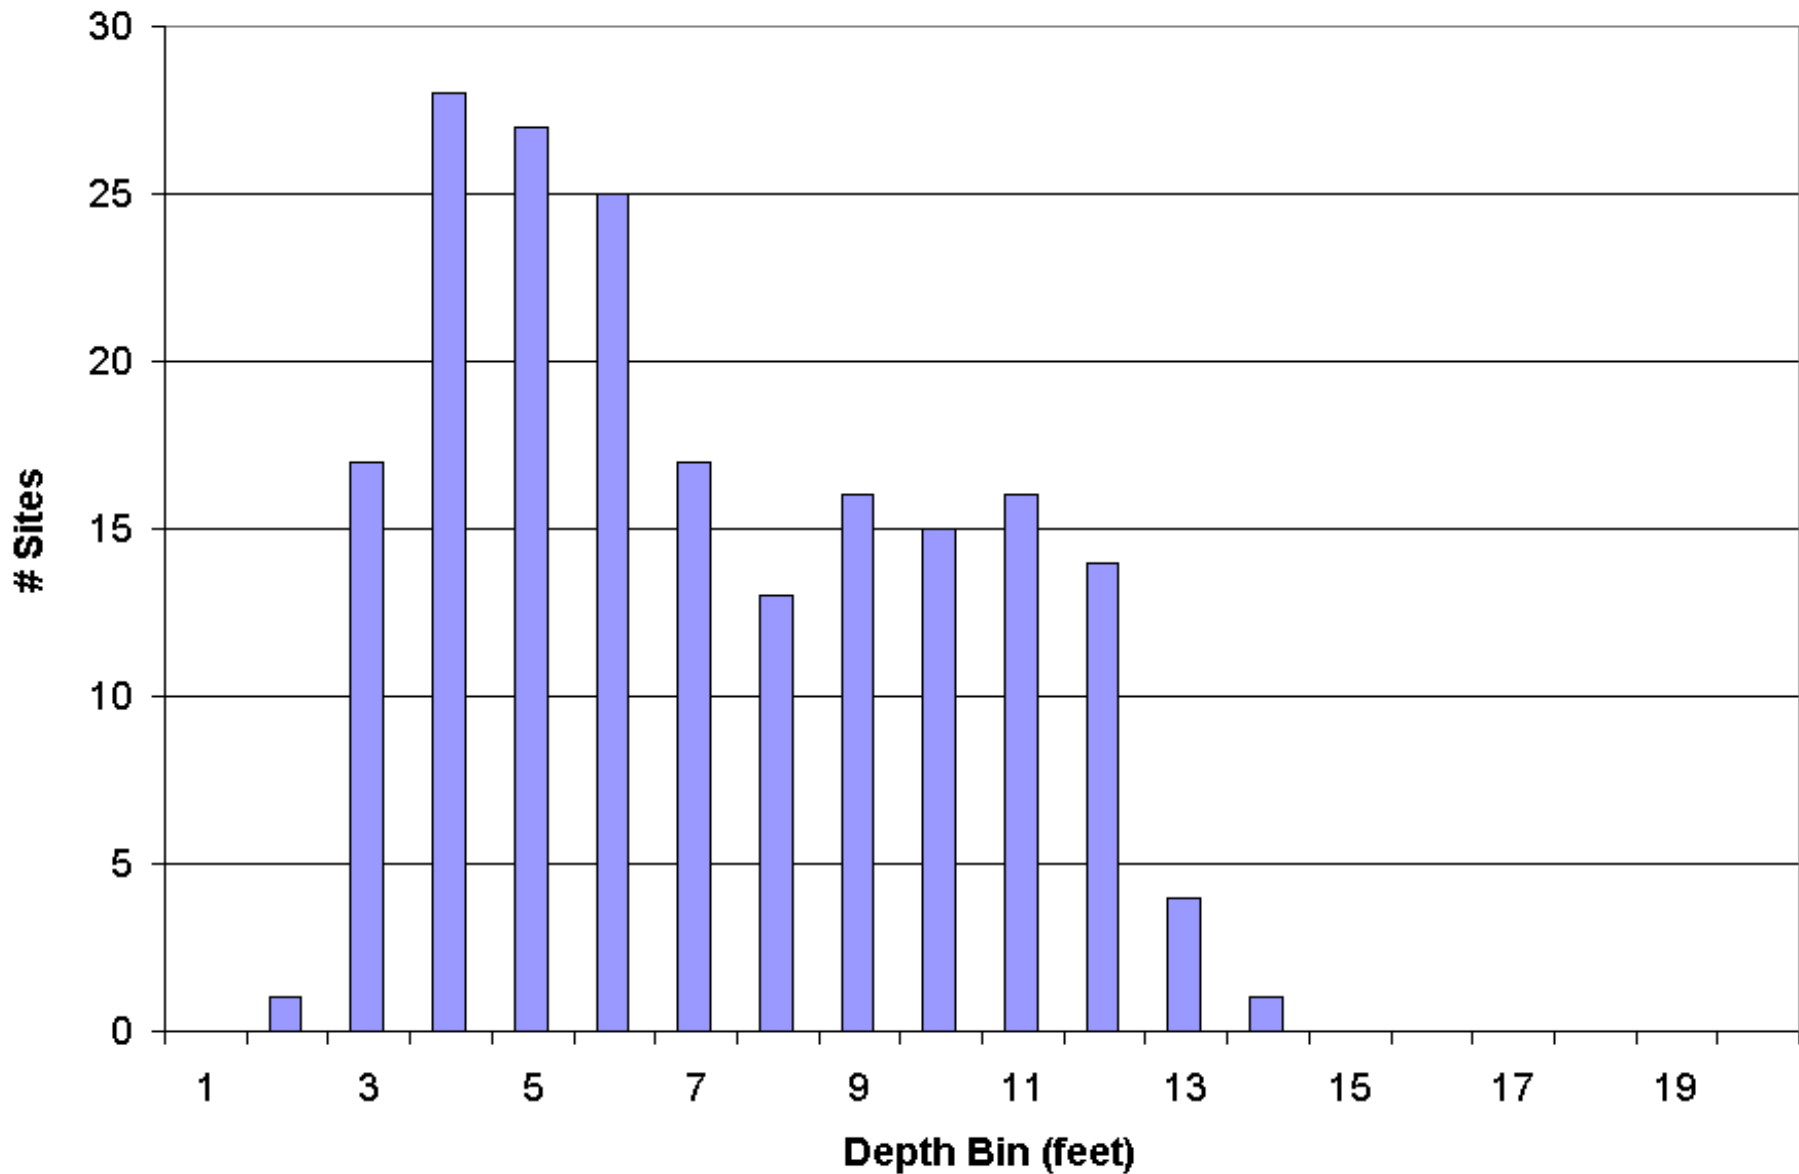
**Figure 3. Maximum Depth of Plant Colonization in Morton Lake.**

The maximum depth of plant colonization is 14 feet (Table 1 and Figure 3). Rooted vegetation was found at 194 of the 243 sample sites with depth  $\leq$  the maximum depth of plant colonization (79.8% of sites). These sites are displayed as a black dot within a circle on Figure 4. This indicates that although availability of appropriate depth may limit the distribution of plants, it is not the only habitat factor involved. Substrate is another feature that influences plant distribution (e.g., soft substrate often harbors more plants than hard substrate). Figure 5 presents the substrates encountered during the aquatic plant survey (mud, sand, or rock).

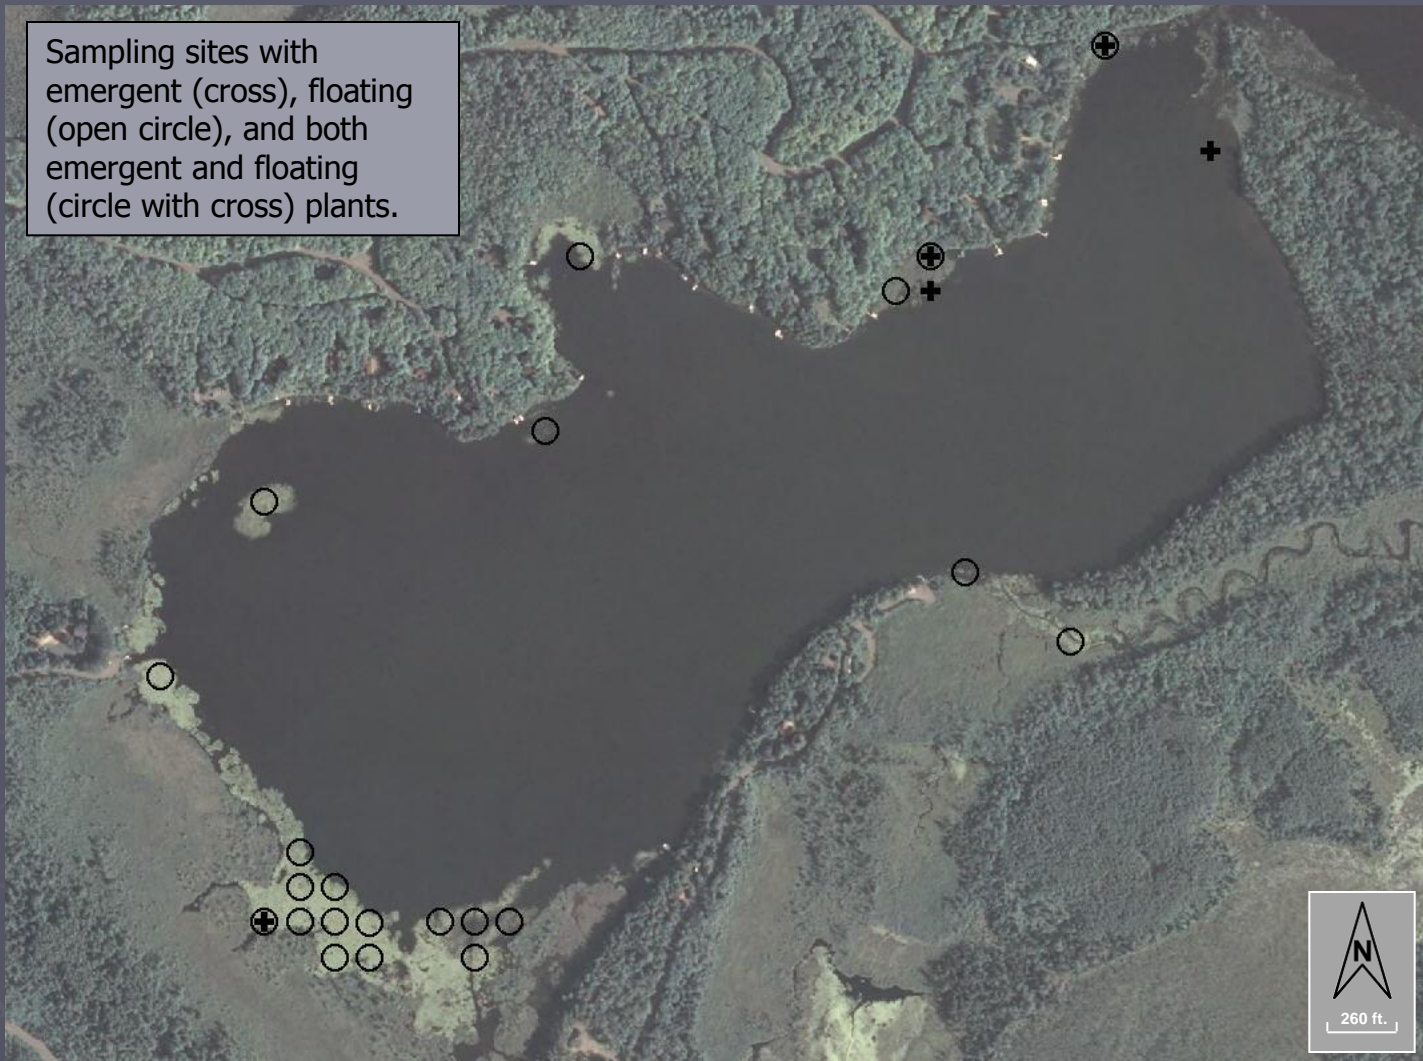
Figure 7. Morton Lake point-intercept plant sampling sites with emergent and floating aquatic plants (2011).

Figure 7. Point-intercept plant sampling sites with emergent and floating aquatic plants.
